GOVERNMENT OF NEWFOUNDLAND AND LABRADOR Department of Transportation and Infrastructure	<b>BRIDGE INSPECTION REPORT</b> <b>B10072021-10</b>	
<b>Date:</b> 10/5/2021	<b>Inspected By:</b> Mike Button	<b>Category:</b> Office - Bridge Office	
<b>BRIDGE INFORMATION</b>			
<b>Site:</b>	TCH-012 - BLACK BROOK BRIDGE (TCH)		
<b>Route:</b>	1	<b>Overall Length:</b>	27.1 m
<b>Year Built:</b>	1964	<b>Est:</b> No	<b>Overall Width:</b> 17.5 m
<b>Year Last Rehab.:</b>	1992	<b>Est:</b> No	<b>Roadway Width:</b> 16 m
<b>Region:</b>	CENTRAL EAST	<b>Sidewalk Width:</b>	0 m
<b>Jurisdiction:</b>	Provincial	<b>Clearance to R.D. or N.W.L.:</b>	11 m
<b>Type of Structure:</b>	01 - AASH to Girder	<b>Max Depth of N.W.L.:</b>	1 m
<b>Purpose of Structure:</b>	04 - Over Non-Navigable Waters	<b>Spans:</b>	
<b>Type of Handrail:</b>	01 - Aluminum Rail	<u>Span No.:</u>	<u>Length</u>
<b>Roadway Surface:</b>	02 - Asphalt	1	15.2
<b>Alignment Vertical:</b>	01 - Good	2	0

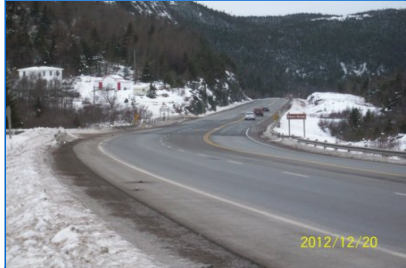
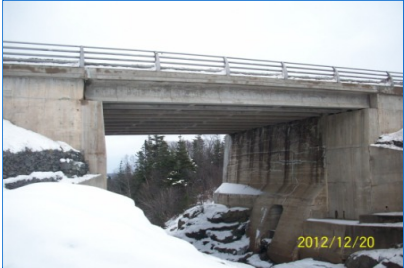
<b>Alignment Horizontal:</b>	01 - Good	3	0
<b>Restrictions:</b>	No	<b>Span No.:</b>	<b>Length</b>
		4	0
		5	0
		6	0
<b>BRIDGE PHOTOS</b>

<b>SUBSTRUCTURE</b>			
<b>Condition:</b>	P3 - Poor	<b>Bearings:</b>	U - Uninspectable
		<b>Bearing Seat:</b>	U - Uninspectable
<b>Comments:</b>	- North abutment west (20% of abutment width) extension in fair condition, F1. Main eastern section (80% of abutment width) has medium horizontal & vertical cracks throughout. Past rehabs placed a superficial patch to seal the cracks but they have re-opened. Bearing seat has mild spalling under three girders on the east side of structure, F1. Abutment face has medium rust staining just under the bearing seat, F1. At roughly the center line of abutment at the rover level, large constructed opening present, at least 2m wide by 2m high. Northeast abutment corner has medium-heavy spalling with heavy efflorescence. - South abutment has medium horizontal & vertical cracks throughout. Past rehabs placed a superficial patch to seal the cracks but they have re-opened, F1. - Southeast corner of abutment is heavily cracked with heavy-severe efflorescence. Many areas about to spall or delaminate, P3. Abutment face has medium rust staining just under the bearing seat, F1. - All abutment bearings and bearing seats too high for inspection. - Northeast retaining structure and its footing has heavy alligator cracking with medium-heavy efflorescence throughout. Top portion of wingwall is totally disintegrated with an area (2.5m wide x 1m high) of vertical and horizontal rebar exposed, P3. - Southeast retaining structure has two large-wide vertical cracks with medium alligator cracking with efflorescence throughout, P3. - Both

western retaining structures have mild alligator cracking throughout, F1. - Both eastern wingwalls have heavy alligator cracking with efflorescence. Old Construction joint opening up with spalling between the top of wingwall and curb, P3. - Both western wingwalls in fair condition, F1.
