GOVERNMENT OF NEWFOUNDLAND AND LABRADOR Department of Transportation and Infrastructure	BRIDGE INSPECTION REPORT B10132021-2	
Date: 10/6/2021	Inspected By: Mike Button	Category: Office - Bridge Office	
BRIDGE INFORMATION			
Site:	2-164 - GEORGE'S BROOK BRIDGE #1		
Route:	230A	Overall Length:	8 m
Year Built:	1962	Est: Yes	Overall Width: 8 m
Year Last Rehab.:		Est: No	Roadway Width: 7.4 m
Region:	CENTRAL EAST	Sidewalk Width:	0 m
Jurisdiction:	Provincial	Clearance to R.D. or N.W.L.:	1 m
Type of Structure:	03 - Reinforced Concrete Beam/Slab	Max Depth of N.W.L.:	0.5 m
Purpose of Structure:	04 - Over Non-Navigable Waters	Spans:	
Type of Handrail:	06 - None	<u>Span No.:</u>	<u>Length</u>
Roadway Surface:	02 - Asphalt	1	4.5
Alignment Vertical:	01 - Good	2	0
Alignment Horizontal:	01 - Good	3	0
Restrictions:	No	6	0
BRIDGE PHOTOS

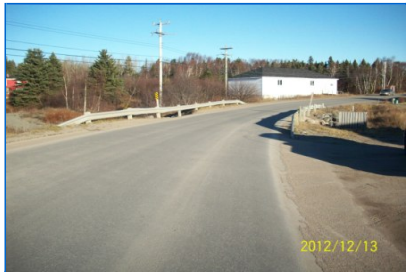
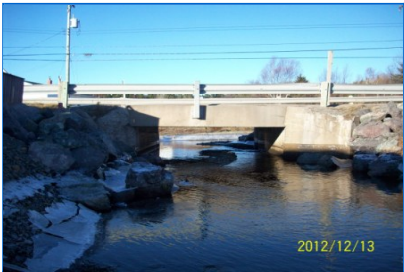
Comments:	- West wingwalls have medium alligator cracking with efflorescence. - Southeast wingwall's top half is totally disintegrated and roadway gravels are washing into the brook below, P1. - Northeast wingwall top quarter also total disintegrated. Remainder portion is heavily cracked with efflorescence, P1. Wingwall has an overlay joint with the north abutment (likely from construction) that is heavily eroded and spalling. - South abutment in fair condition, with the exception of the southeast corner which has mild cracking with medium efflorescence. - North abutment in fair condition, mild concrete erosion on the upstream extension footing construction joint on the northwest side. - Construction joint between the upstream extension and old structure opened up and deteriorating with spalls and efflorescent leakage on both abutment faces, P3.		
SUPERSTRUCTURE			
Condition:	P1 - Poor	Expansion Joints:	I - Inapplicable

Water Velocity:	0.3 m/s	Ice Problem:	N - No Problem
Water Depth:	0.3 m	Scour Problem:	P - Possible Problem
Waterway:	01 - Adequate	Debris Problem:	N - No Problem
Comments:	- Southeast corner has heavy erosion from roadway to brook. Wingwall disintegrated.
