GOVERNMENT OF NEWFOUNDLAND AND LABRADOR Department of Transportation and Infrastructure	<b>BRIDGE INSPECTION REPORT</b> <b>B05292020-29</b>	
<b>Date:</b> 5/28/2020	<b>Inspected By:</b> AB	<b>Category:</b> Eng. - Engineering	
<b>BRIDGE INFORMATION</b>			
<b>Site:</b>	2-043 - NORTHWEST BROOK BRIDGE		
<b>Route:</b>	2-1-08	<b>Overall Length:</b>	23 m
<b>Year Built:</b>	1992	<b>Est:</b> No	<b>Overall Width:</b> 15 m
<b>Year Last Rehab.:</b>		<b>Est:</b> No	<b>Roadway Width:</b> 7 m
<b>Region:</b>	CENTRAL EAST	<b>Sidewalk Width:</b>	0 m
<b>Jurisdiction:</b>	Provincial	<b>Clearance to R.D. or N.W.L.:</b>	3 m
<b>Type of Structure:</b>	04 - Rigid Frame	<b>Max Depth of N.W.L.:</b>	0.5 m
<b>Purpose of Structure:</b>	04 - Over Non-Navigable Waters		
<b>Type of Handrail:</b>	06 - None	<b>Spans:</b>	
<b>Roadway Surface:</b>	02 - Asphalt	<u>Span No.:</u>	<u>Length</u>
<b>Alignment Vertical:</b>	01 - Good	1	12.4
<b>Alignment Horizontal:</b>	01 - Good	2	0

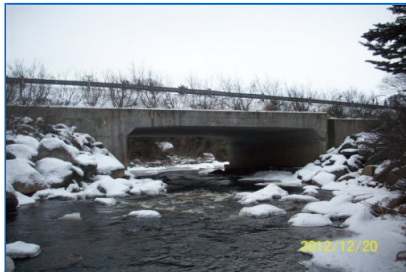
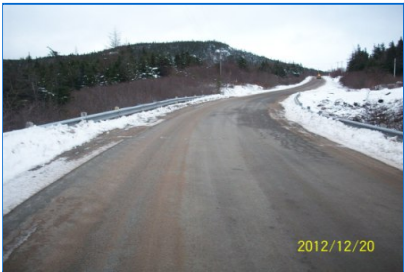
<b>Restrictions:</b>	No	3	0
		<u>Span No.:</u>	<u>Length</u>
		4	0
		5	0
		6	0
<b>BRIDGE PHOTOS</b>

<b>SUBSTRUCTURE</b>			
<b>Condition:</b>	F2 - Fair	<b>Bearings:</b>	I - Inapplicable
		<b>Bearing Seat:</b>	I - Inapplicable
<b>Comments:</b>	Concrete abutments and wing walls. Some light cracking throughout (1-2mm width) continuous through roof. Concrete erosion evident on both abutments below high water mark. Abutment 2 is scoured at solid rock base.		
<b>SUPERSTRUCTURE</b>			
<b>Condition:</b>	F2 - Fair	<b>Expansion Joints:</b>	I - Inapplicable
<b>Comments:</b>			
<b>DECK</b>			
<b>Condition:</b>	U - Uninspectable	<b>Curbs:</b>	I - Inapplicable
<b>Hand Rail:</b>	I - Inapplicable	<b>Roadway Condition:</b>	I - Inapplicable

<b>Approach Rail:</b>	F2 - Fair		
<b>Comments:</b>	Approximately 2 metres of fill over structure. Standard guide rail left and right; three posts, both sides over structure are galvanized steel. Some minor impact damage on left side steel post which has bent the post - the holes in the guiderail no longer match the holes in the post therefore they can no longer be attached. Right side rail missing backfill and/or broken. Rail is damaged throughout.		
<b>HYDROLOGY</b>			
<b>Water Velocity:</b>	.5 m/s	<b>Ice Problem:</b>	N - No Problem
<b>Water Depth:</b>	.8 m	<b>Scour Problem:</b>	K - Known Problem
<b>Waterway:</b>	01 - Adequate	<b>Debris Problem:</b>	N - No Problem
<b>Comments:</b>	Abutment 2 is scoured at solid rock base. Abutment 2 left appears to be losing armor stone into the brook.		
<b>REPLACEMENT/REHABILITATION</b>			
<b>Next Rehab. Date:</b>		<b>Replacement Year:</b>	
<b>Antic. Rehab. Cost:</b>	\$0	<b>Replacement Cost:</b>	\$0
