White Rose Extension Project

Graving Dock Geotechnical and Environmental Report

Memo

Reference: Interim Progress Report – Site A Results Geotechnical and Environmental Services Stage 2 - Geotechnical / Environmental Site Investigation Proposed GBS Construction Site Argentia, NL

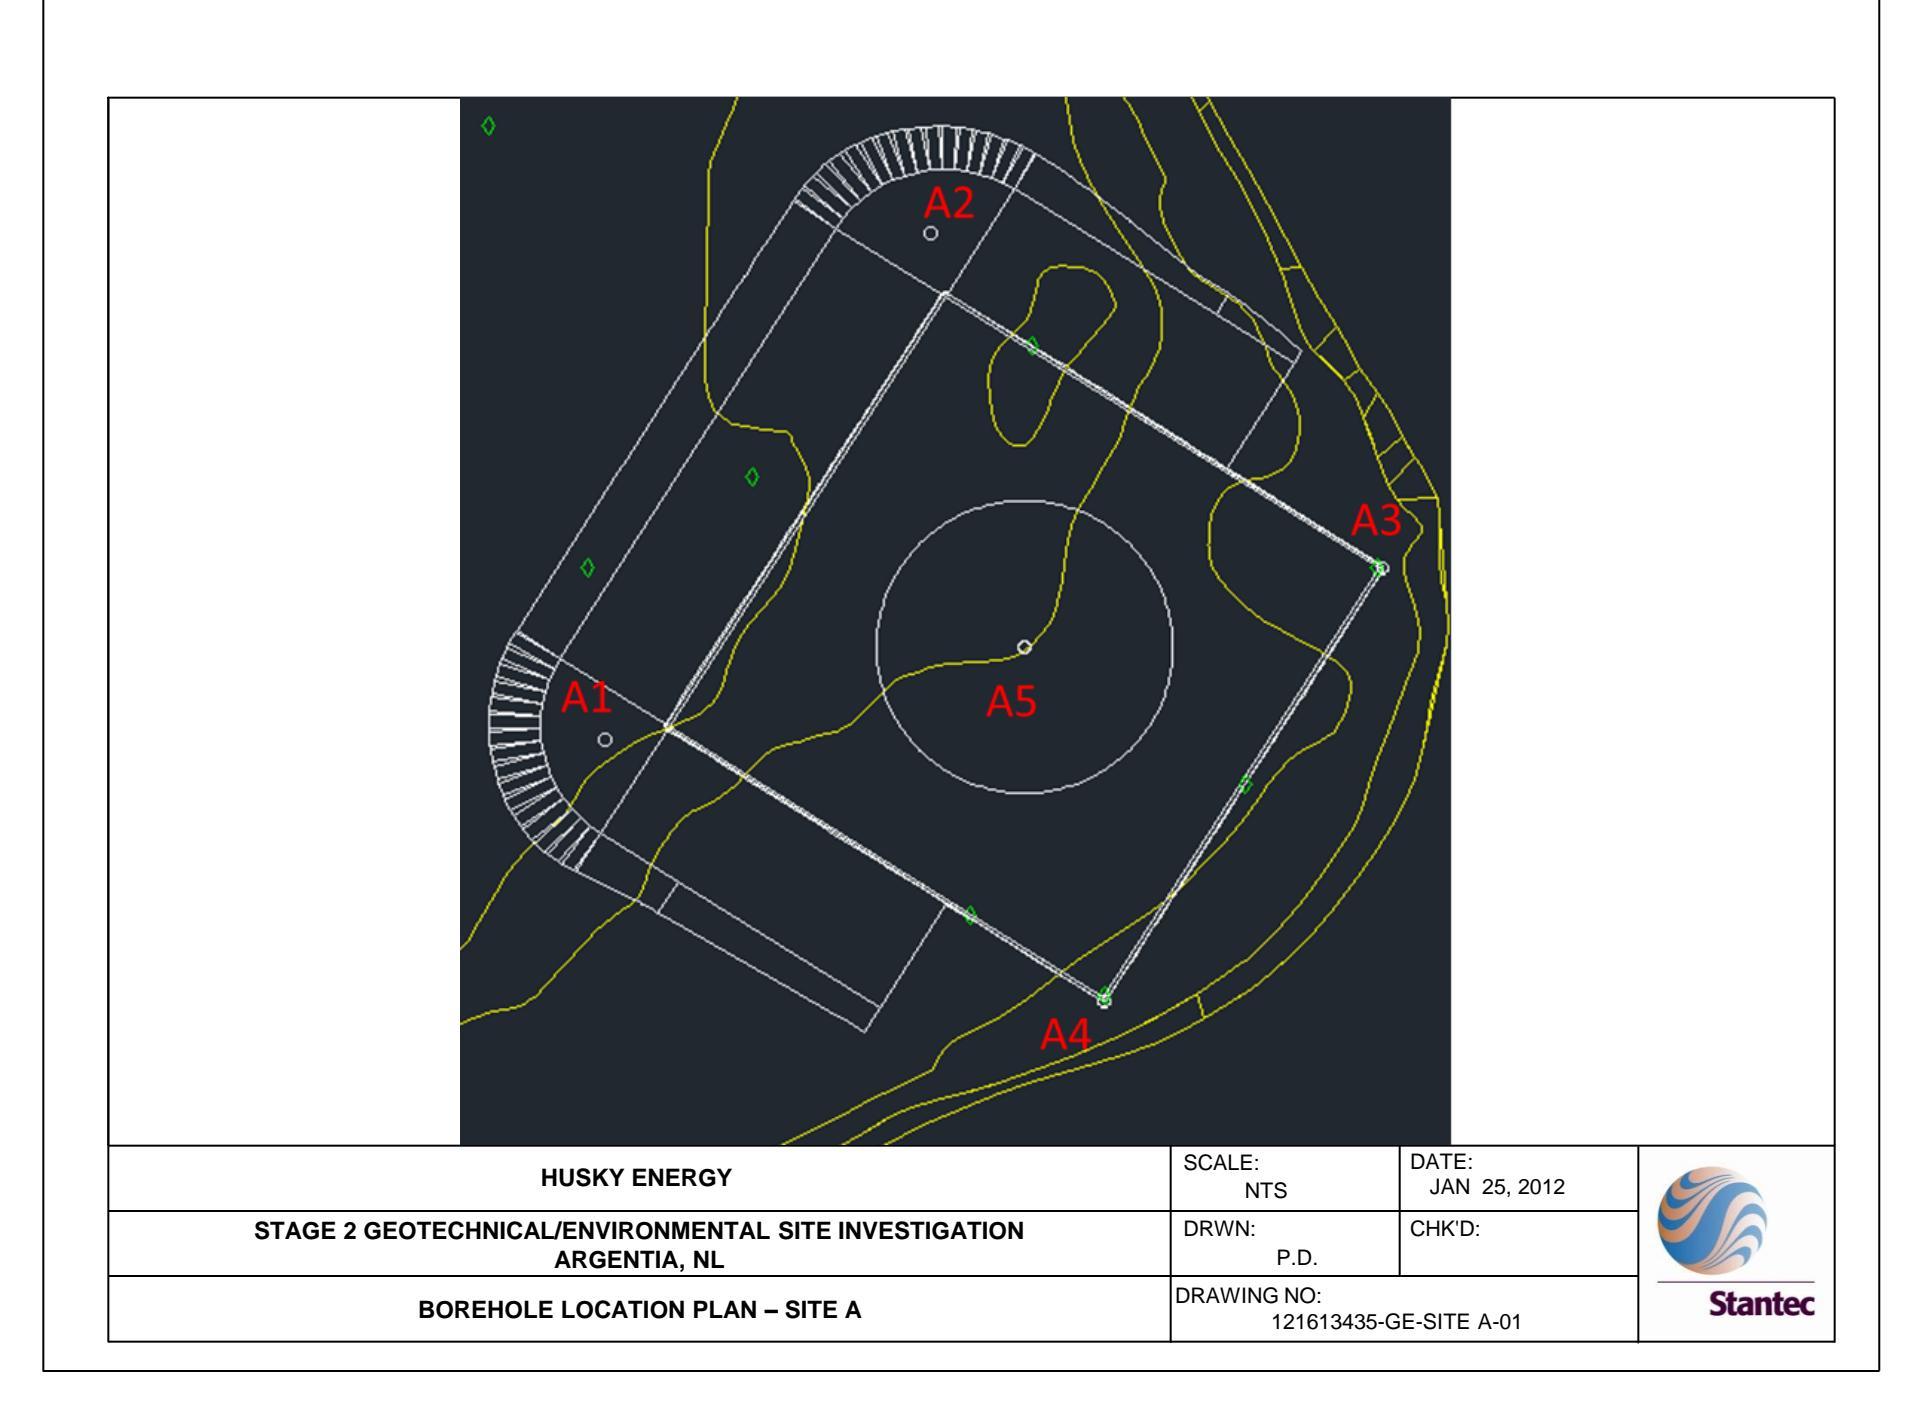
The borehole locations were selected by Stantec and Husky and were established in the field using a handheld GPS unit with an approximate accuracy of ± 6 m. The attached Drawing No. 121613435-GE-SITE A-01 shows the borehole locations.

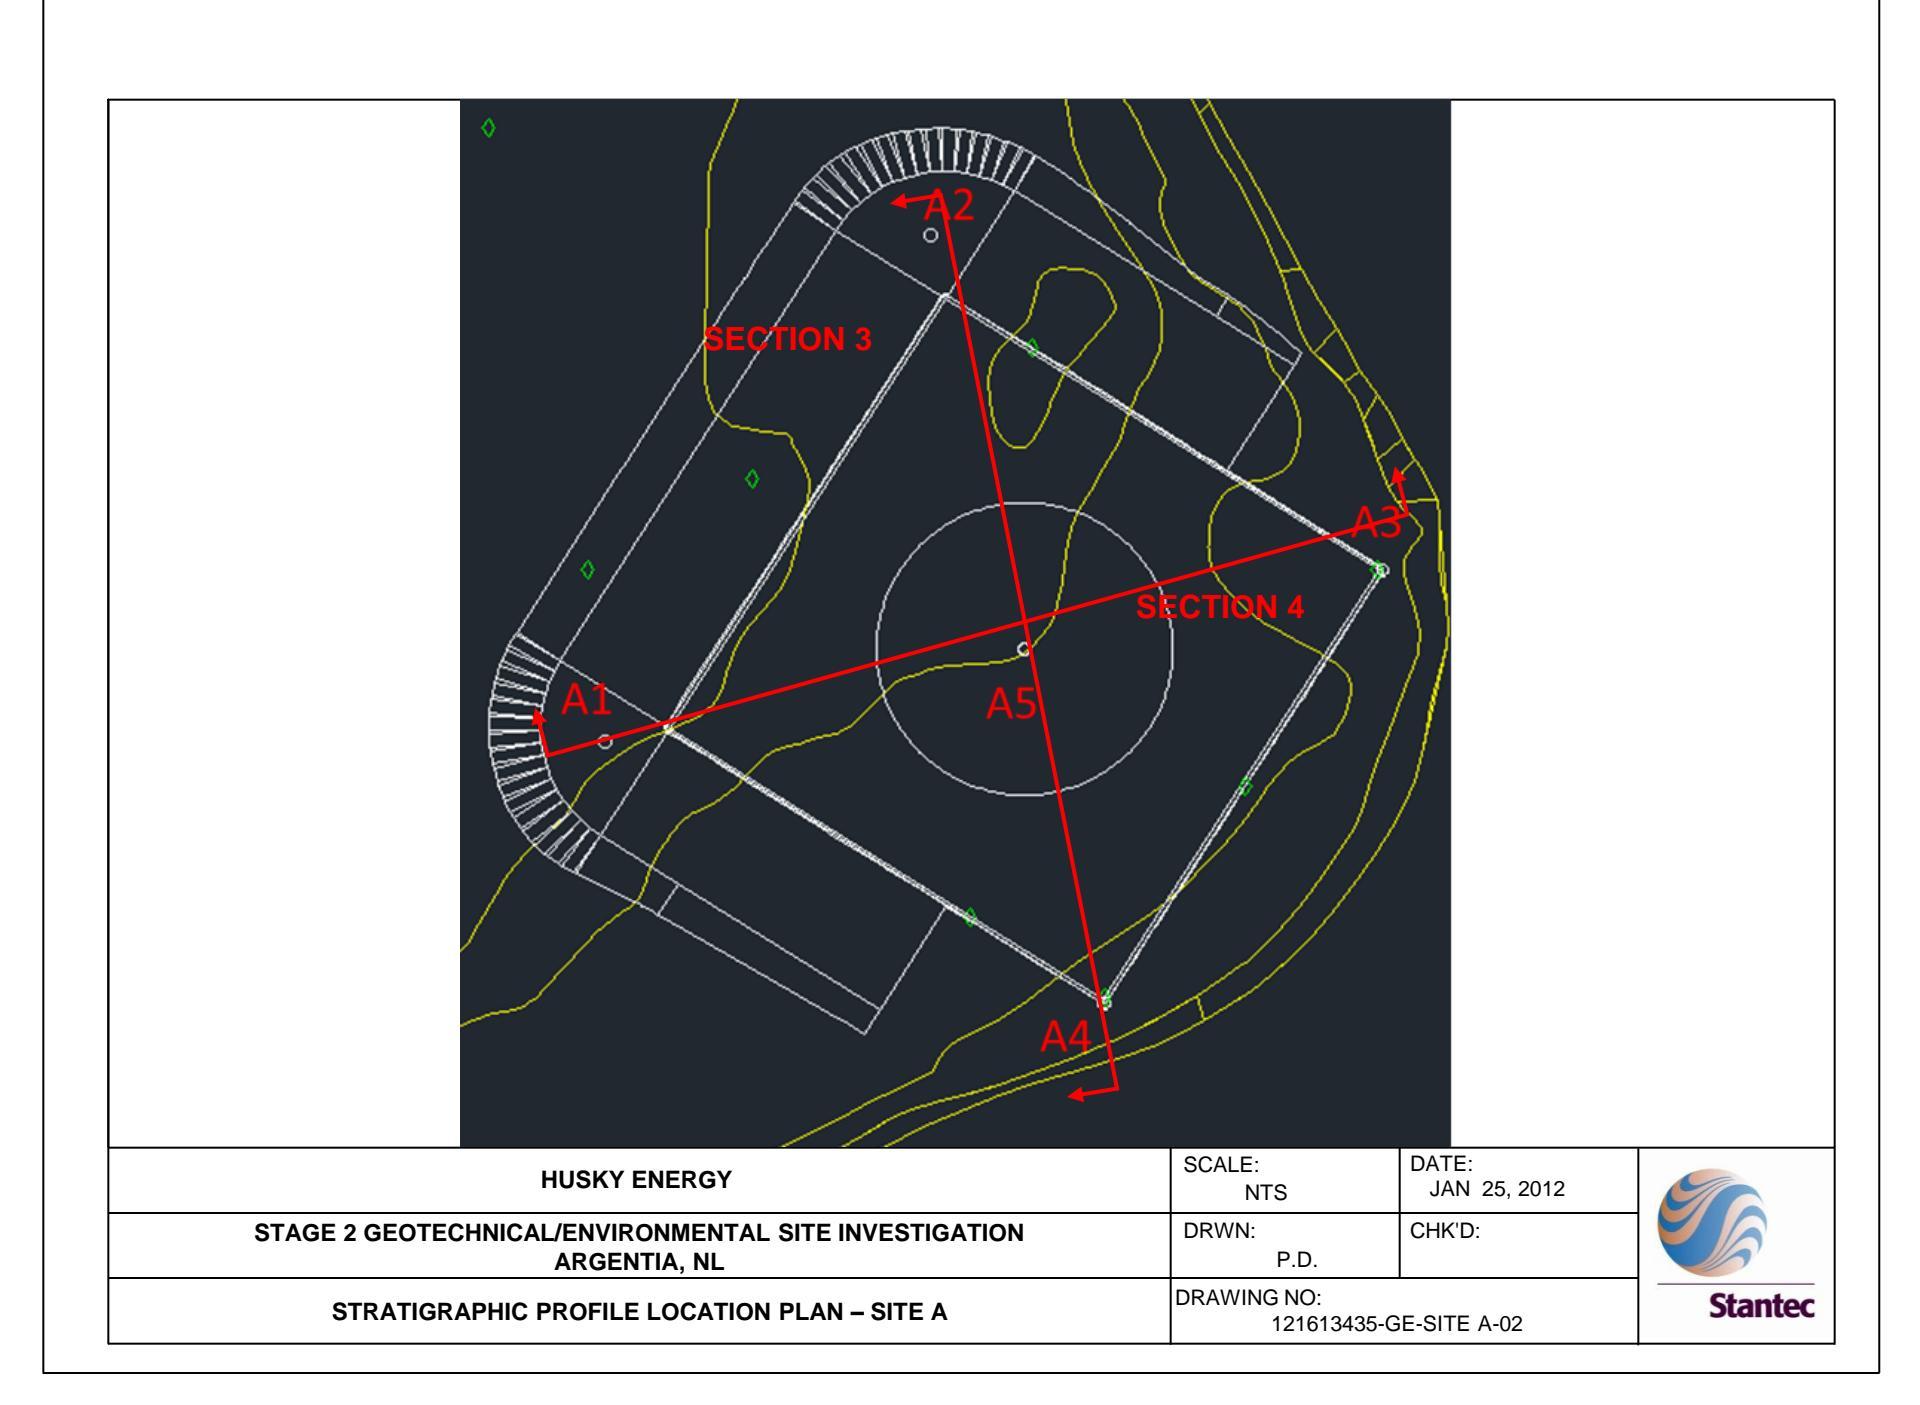
The subsurface conditions encountered in the boreholes are described in detail on the attached Borehole Records, with the strata summarized below. In addition two stratigraphic profiles referred to as Section 3 and 4 are also attached for reference. The locations of the profiles in plan are shown on Drawing No. 121613435-GE-SITE_A-02.
