White Rose Extension Project

Graving Dock Geotechnical and Environmental Report

Memo

Reference: Interim Progress Report – Site A Results Geotechnical and Environmental Services Stage 2 - Geotechnical / Environmental Site Investigation Proposed GBS Construction Site Argentia, NL

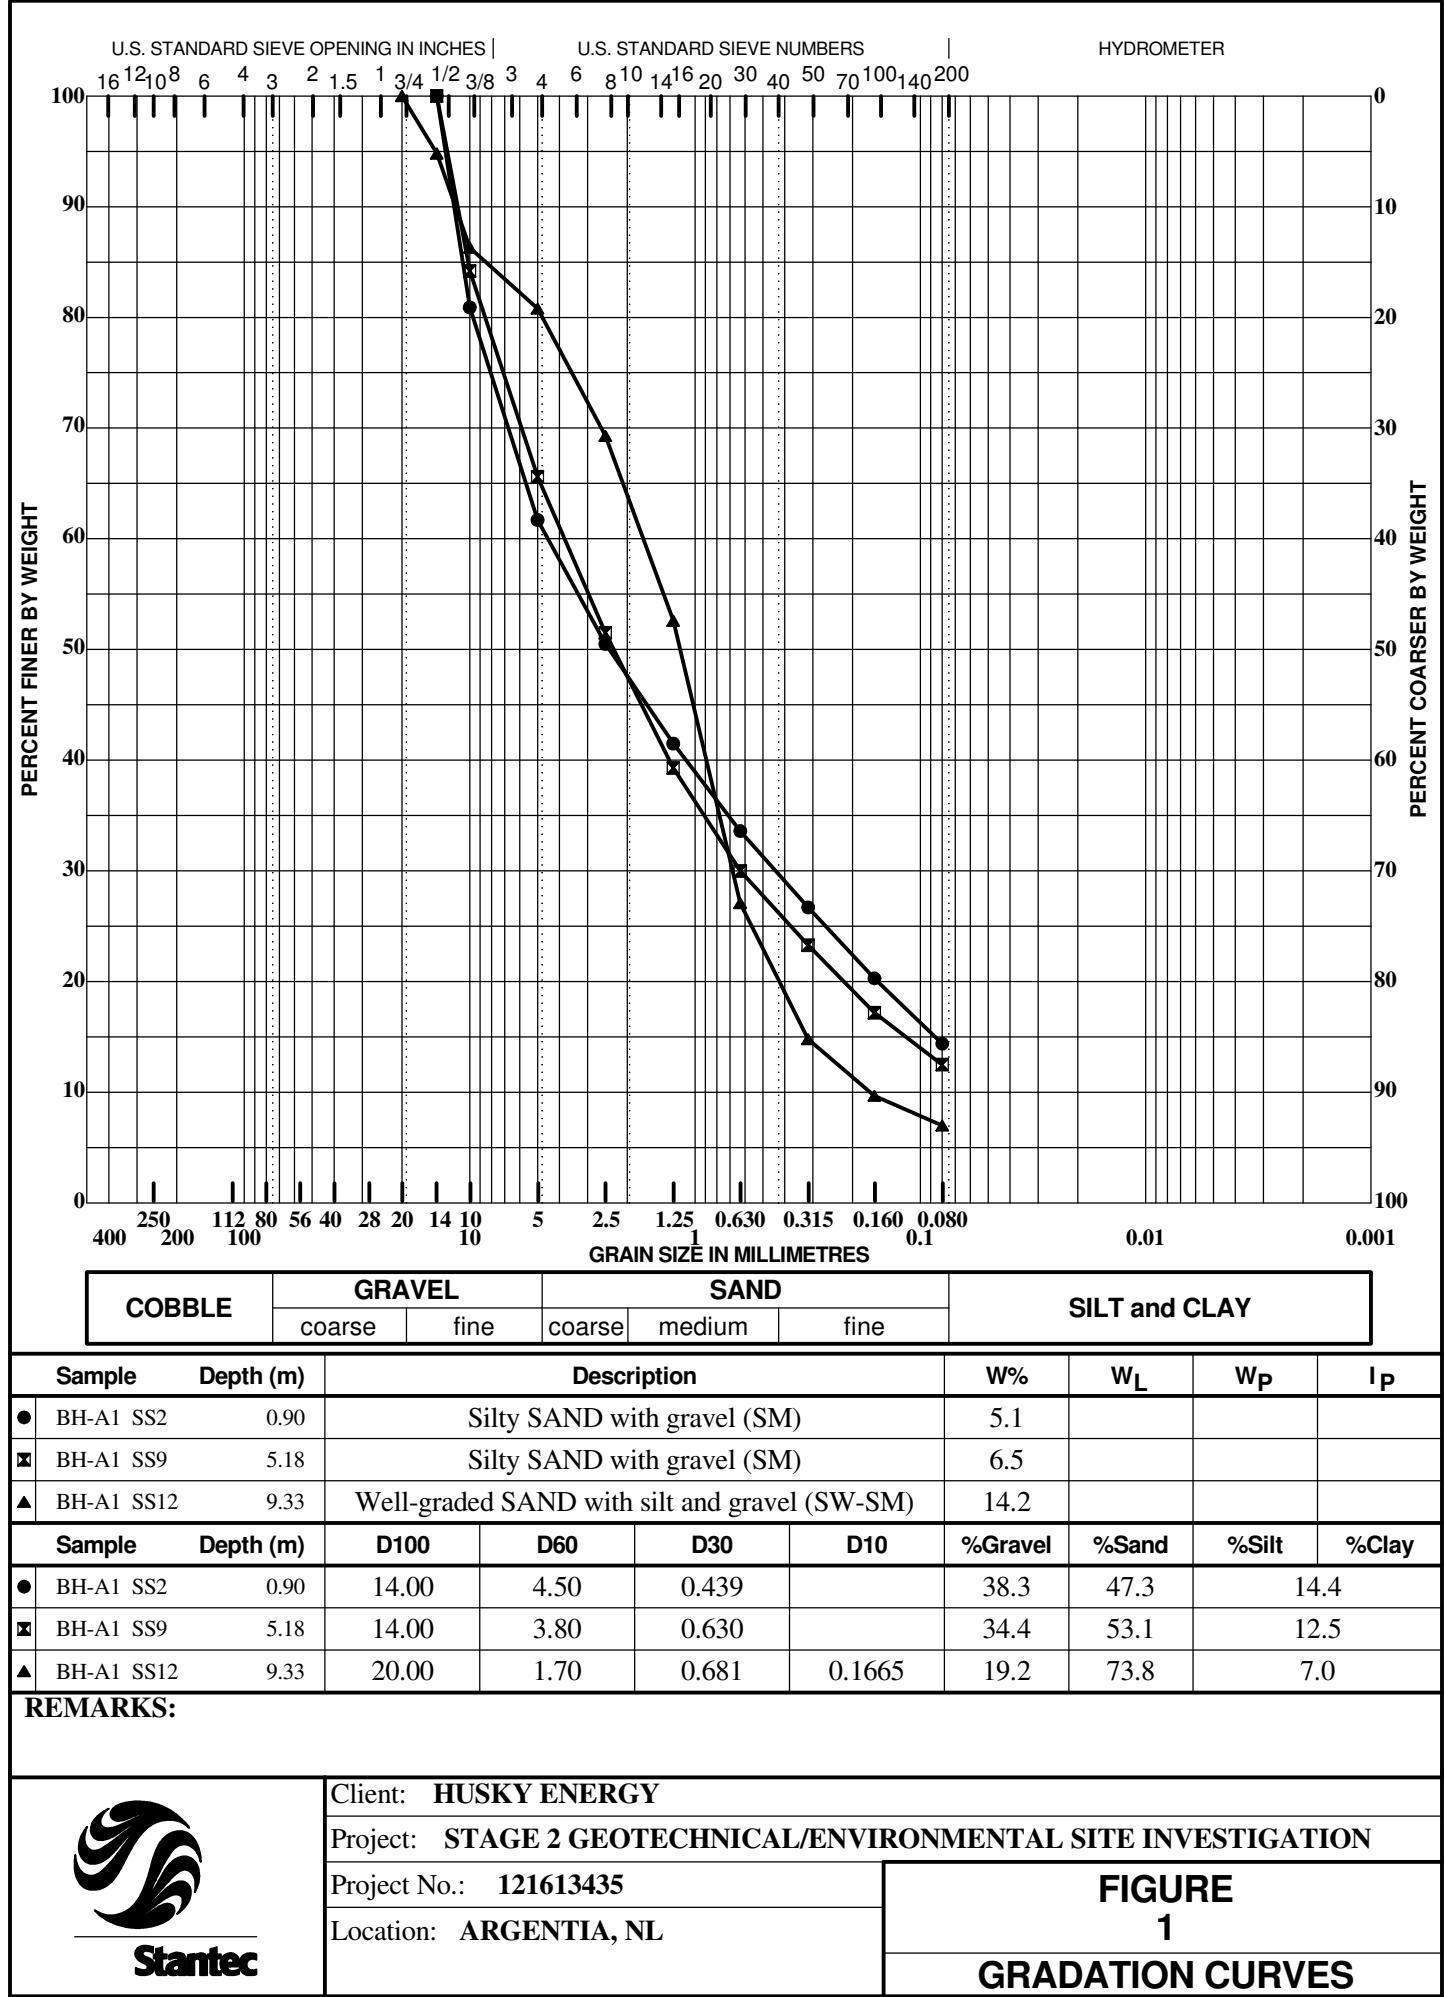
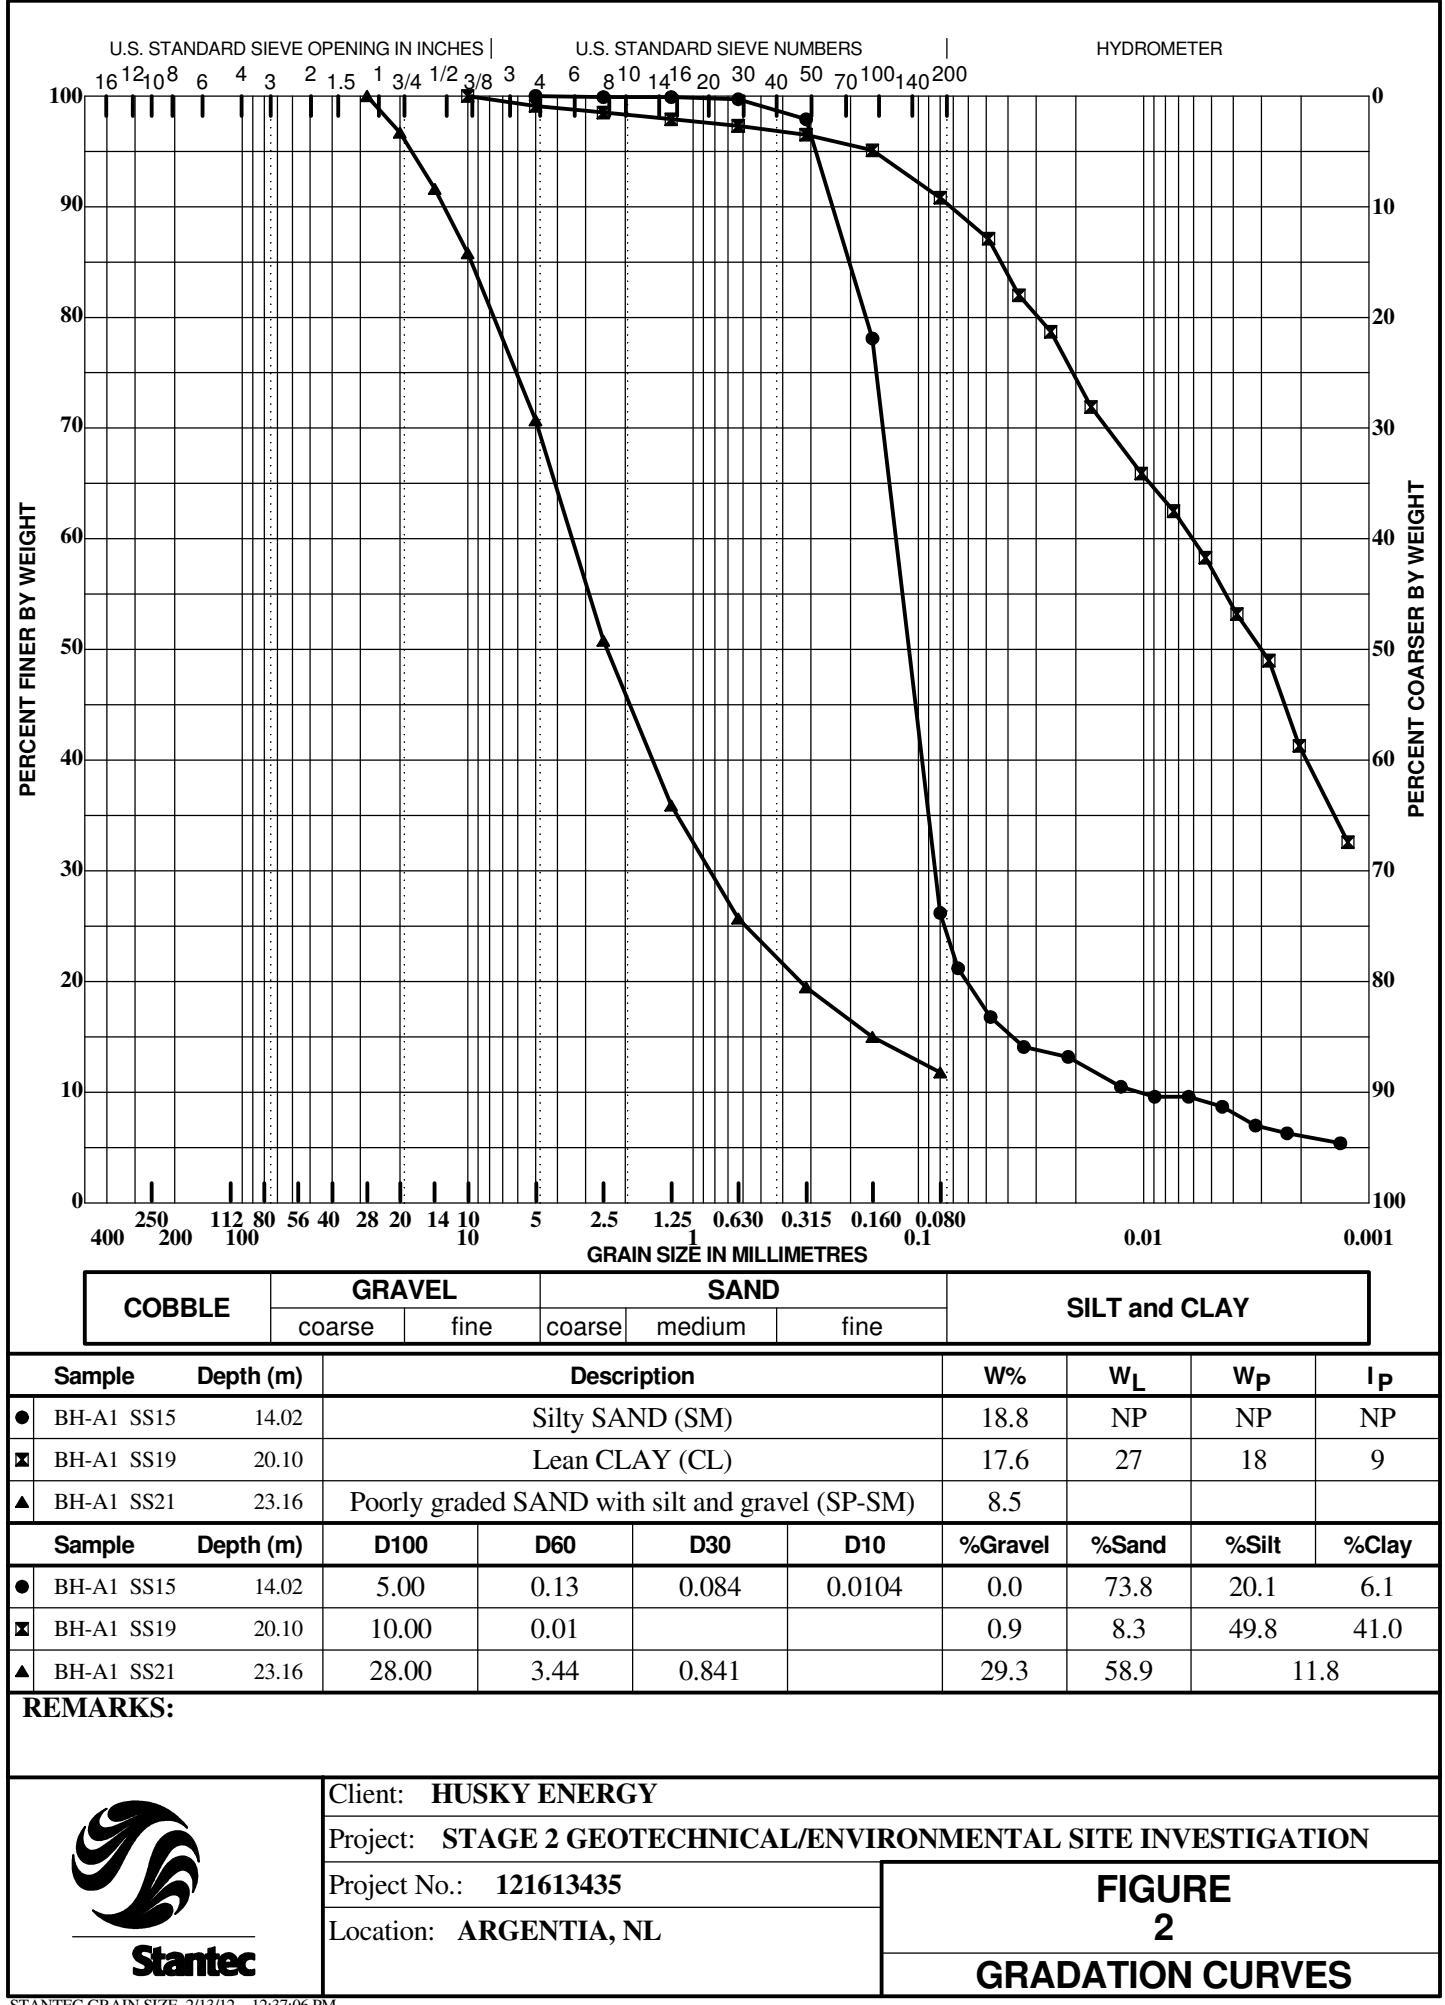
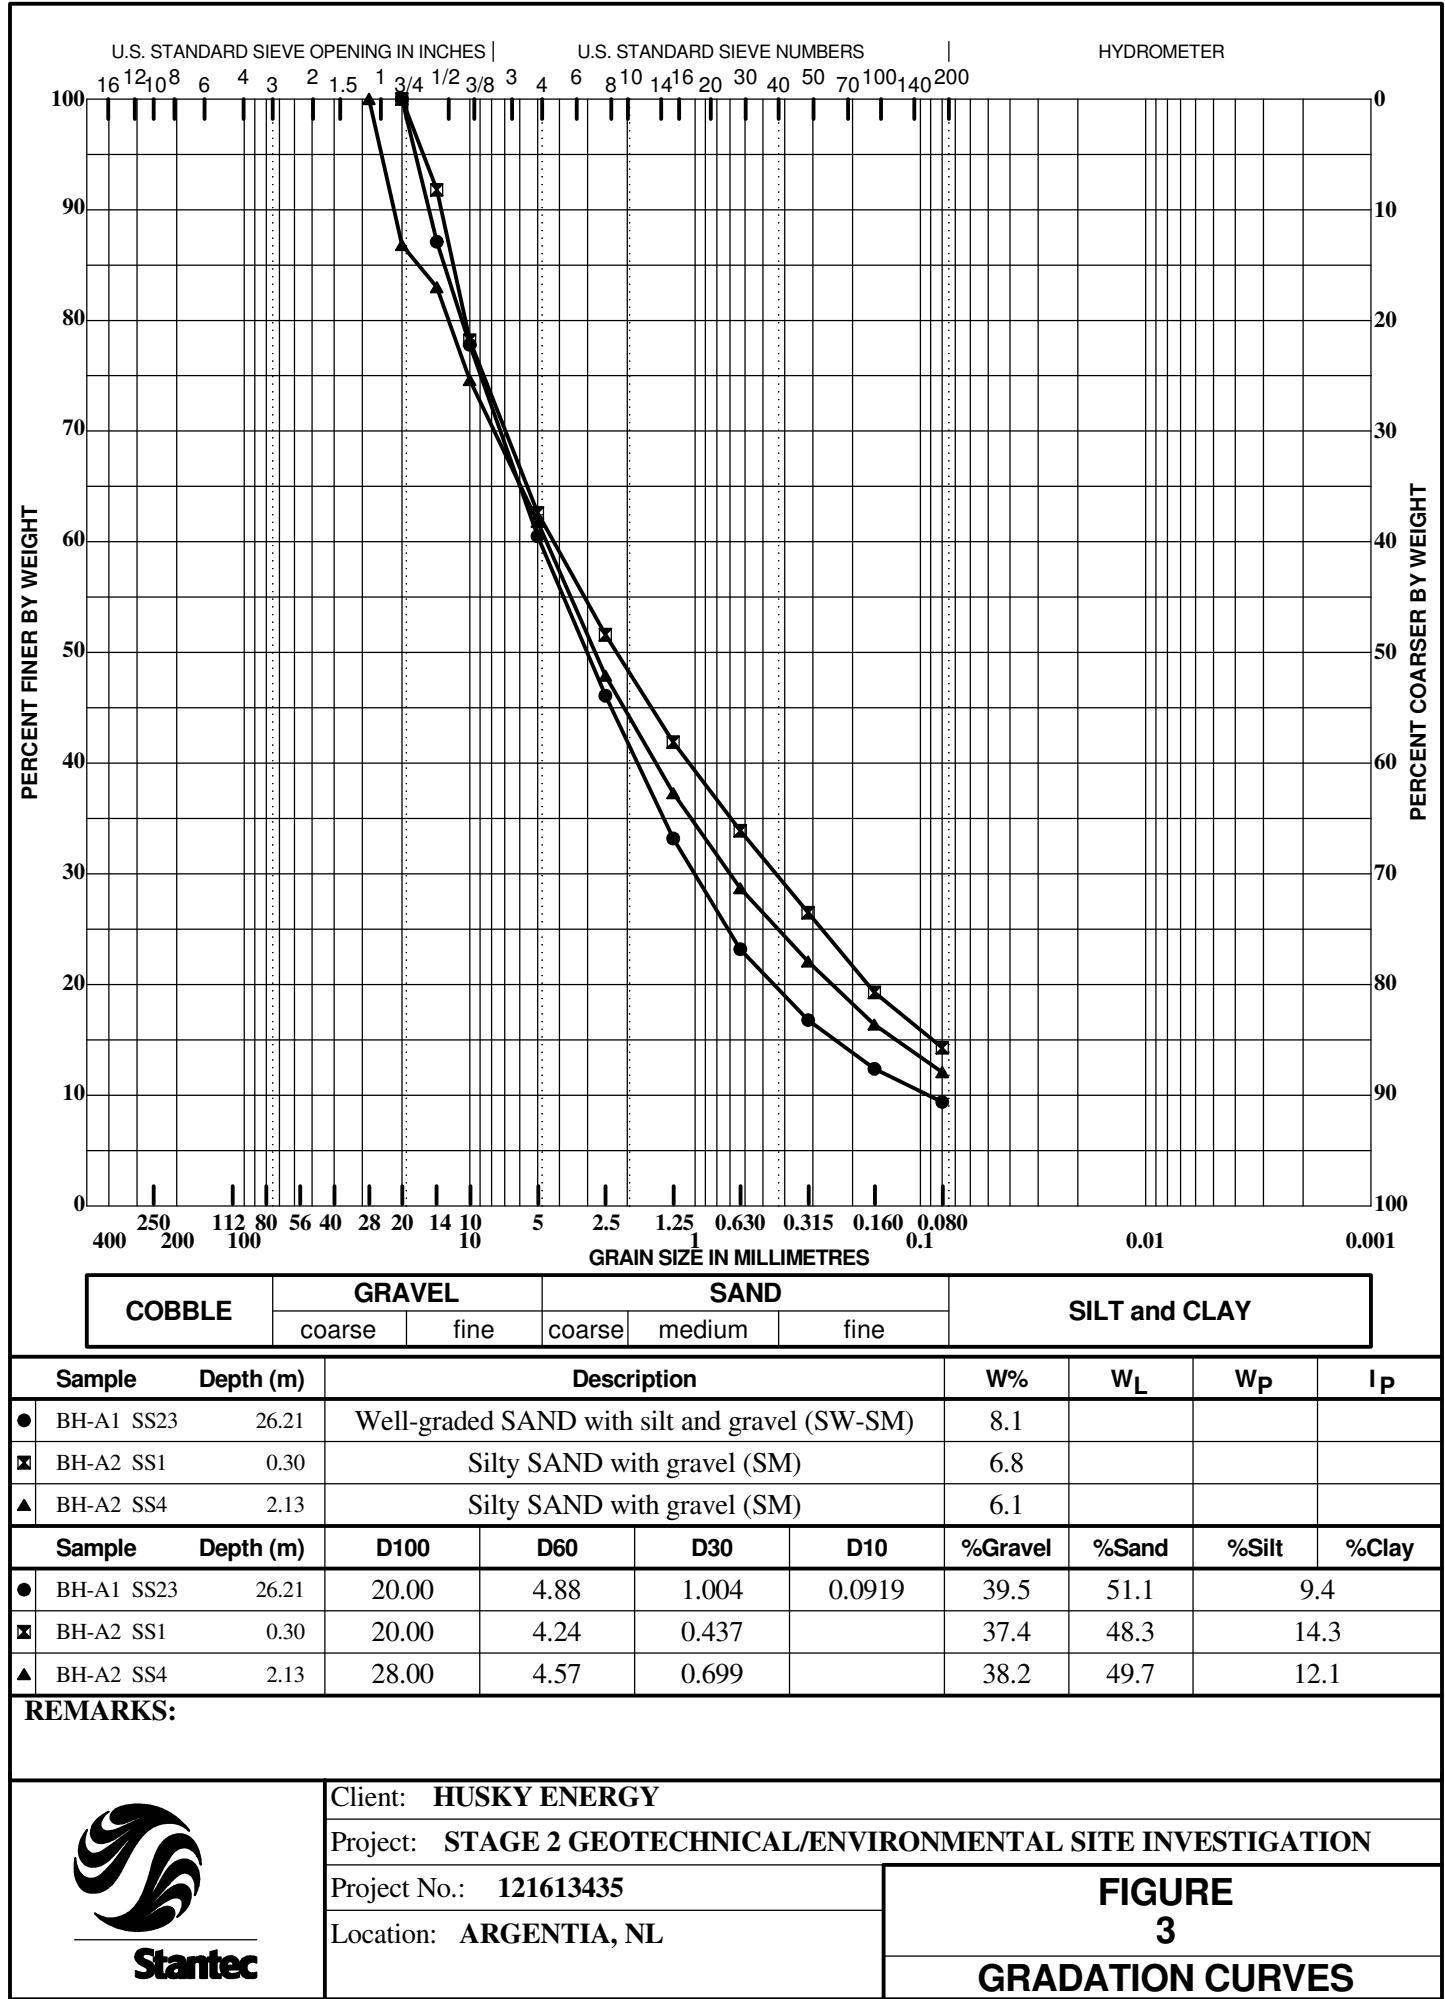
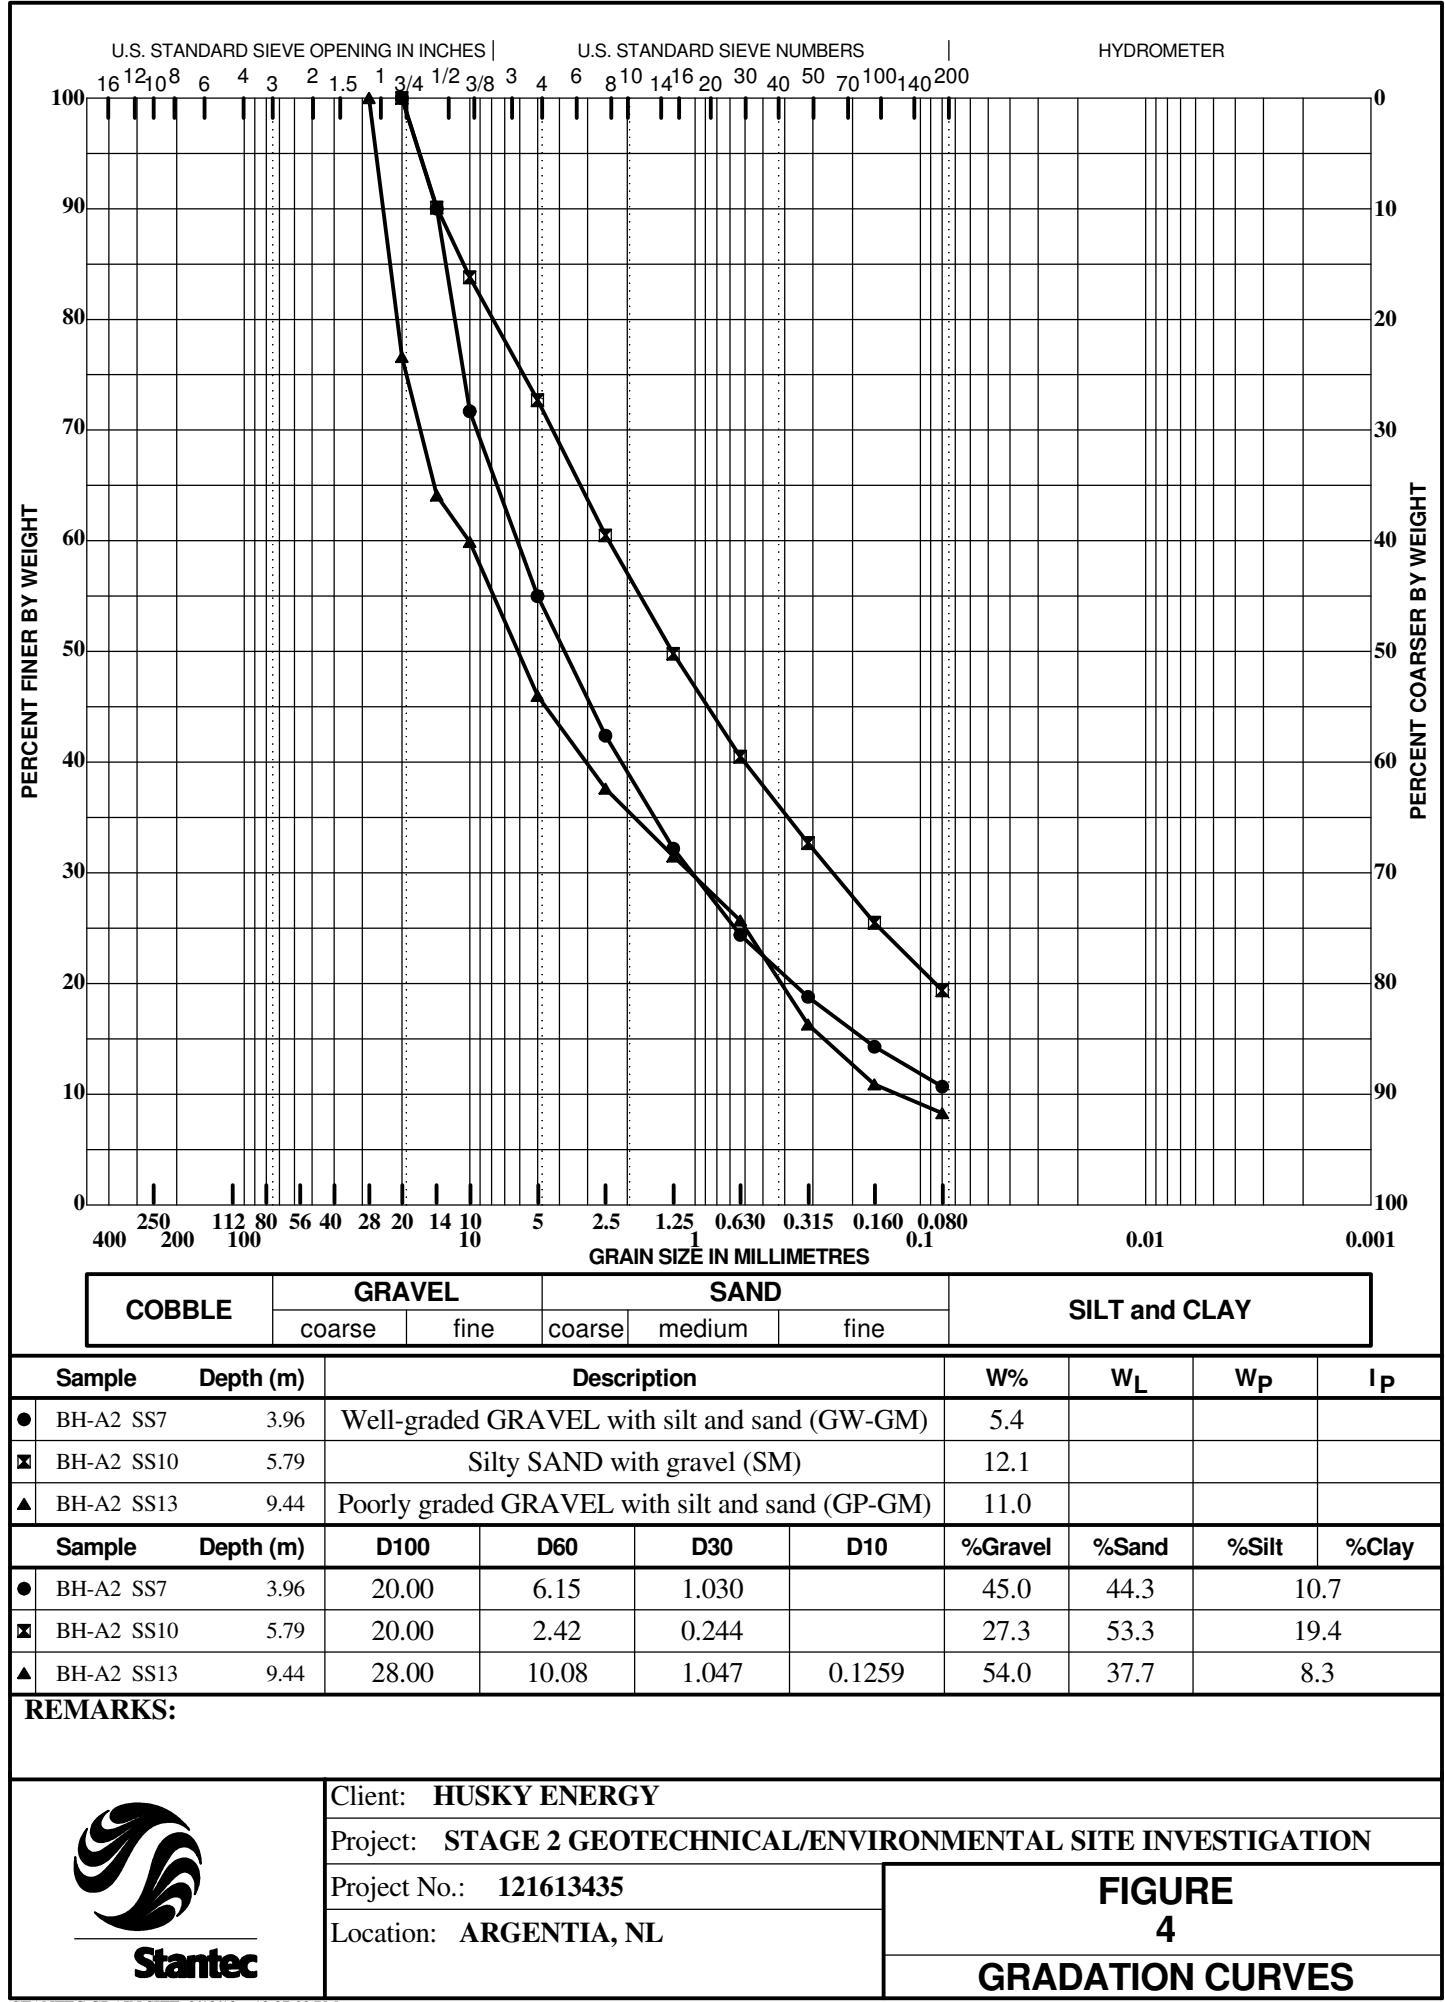
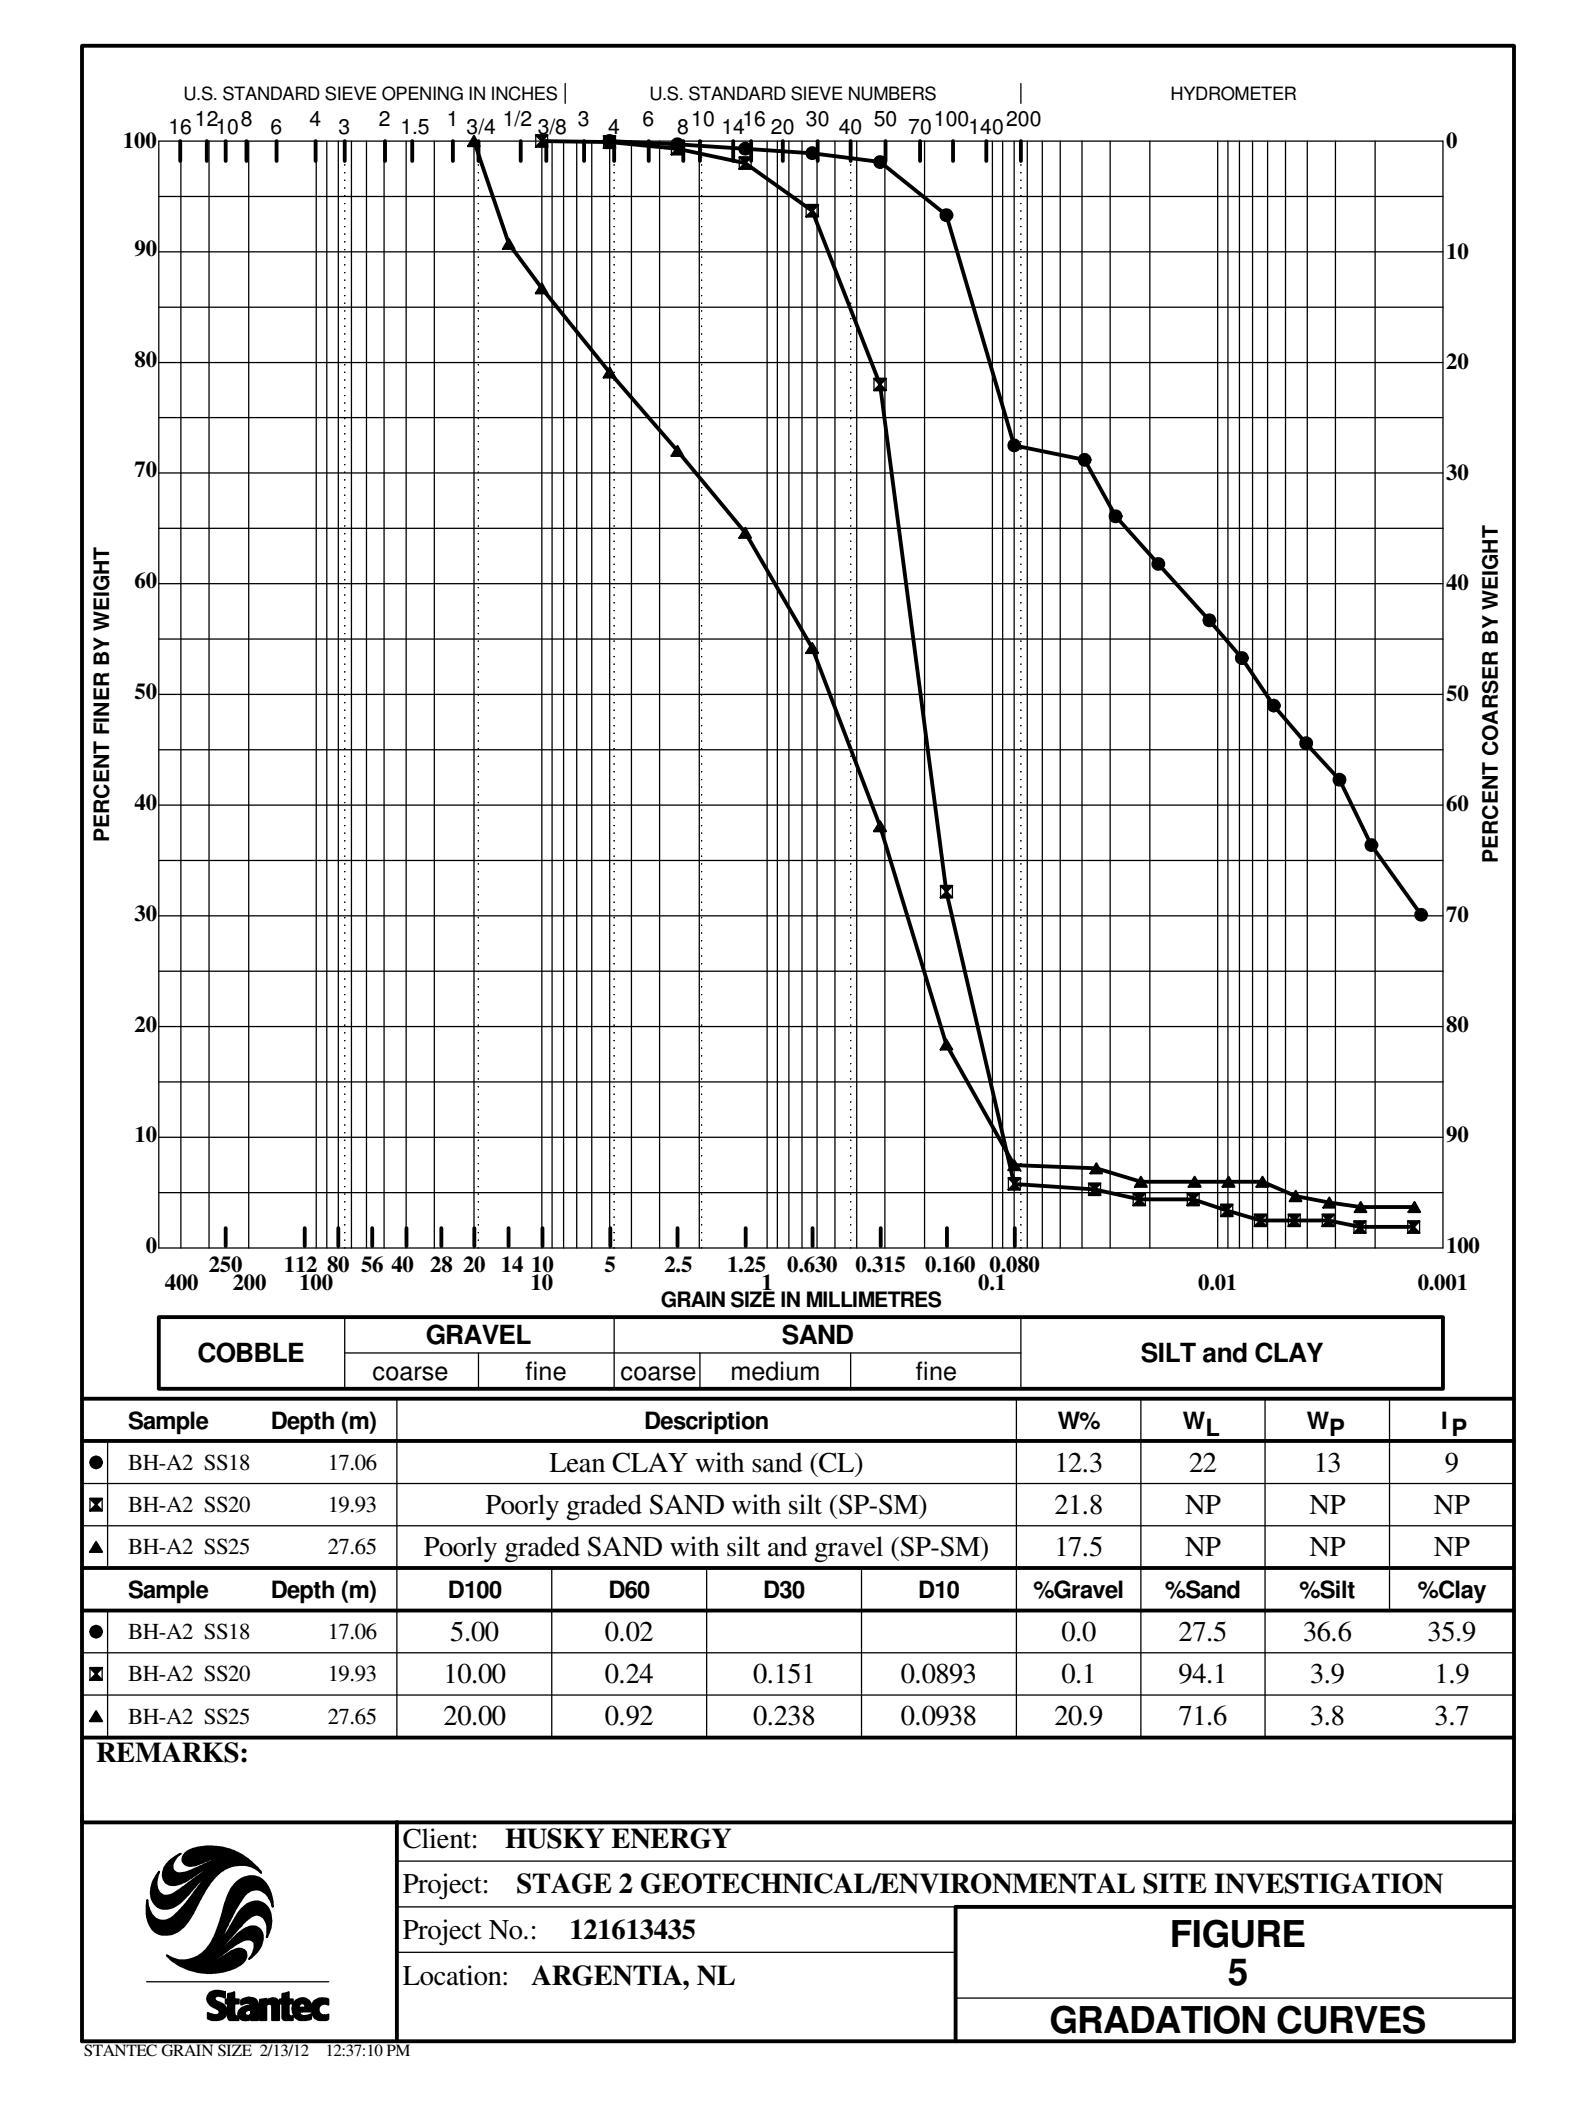
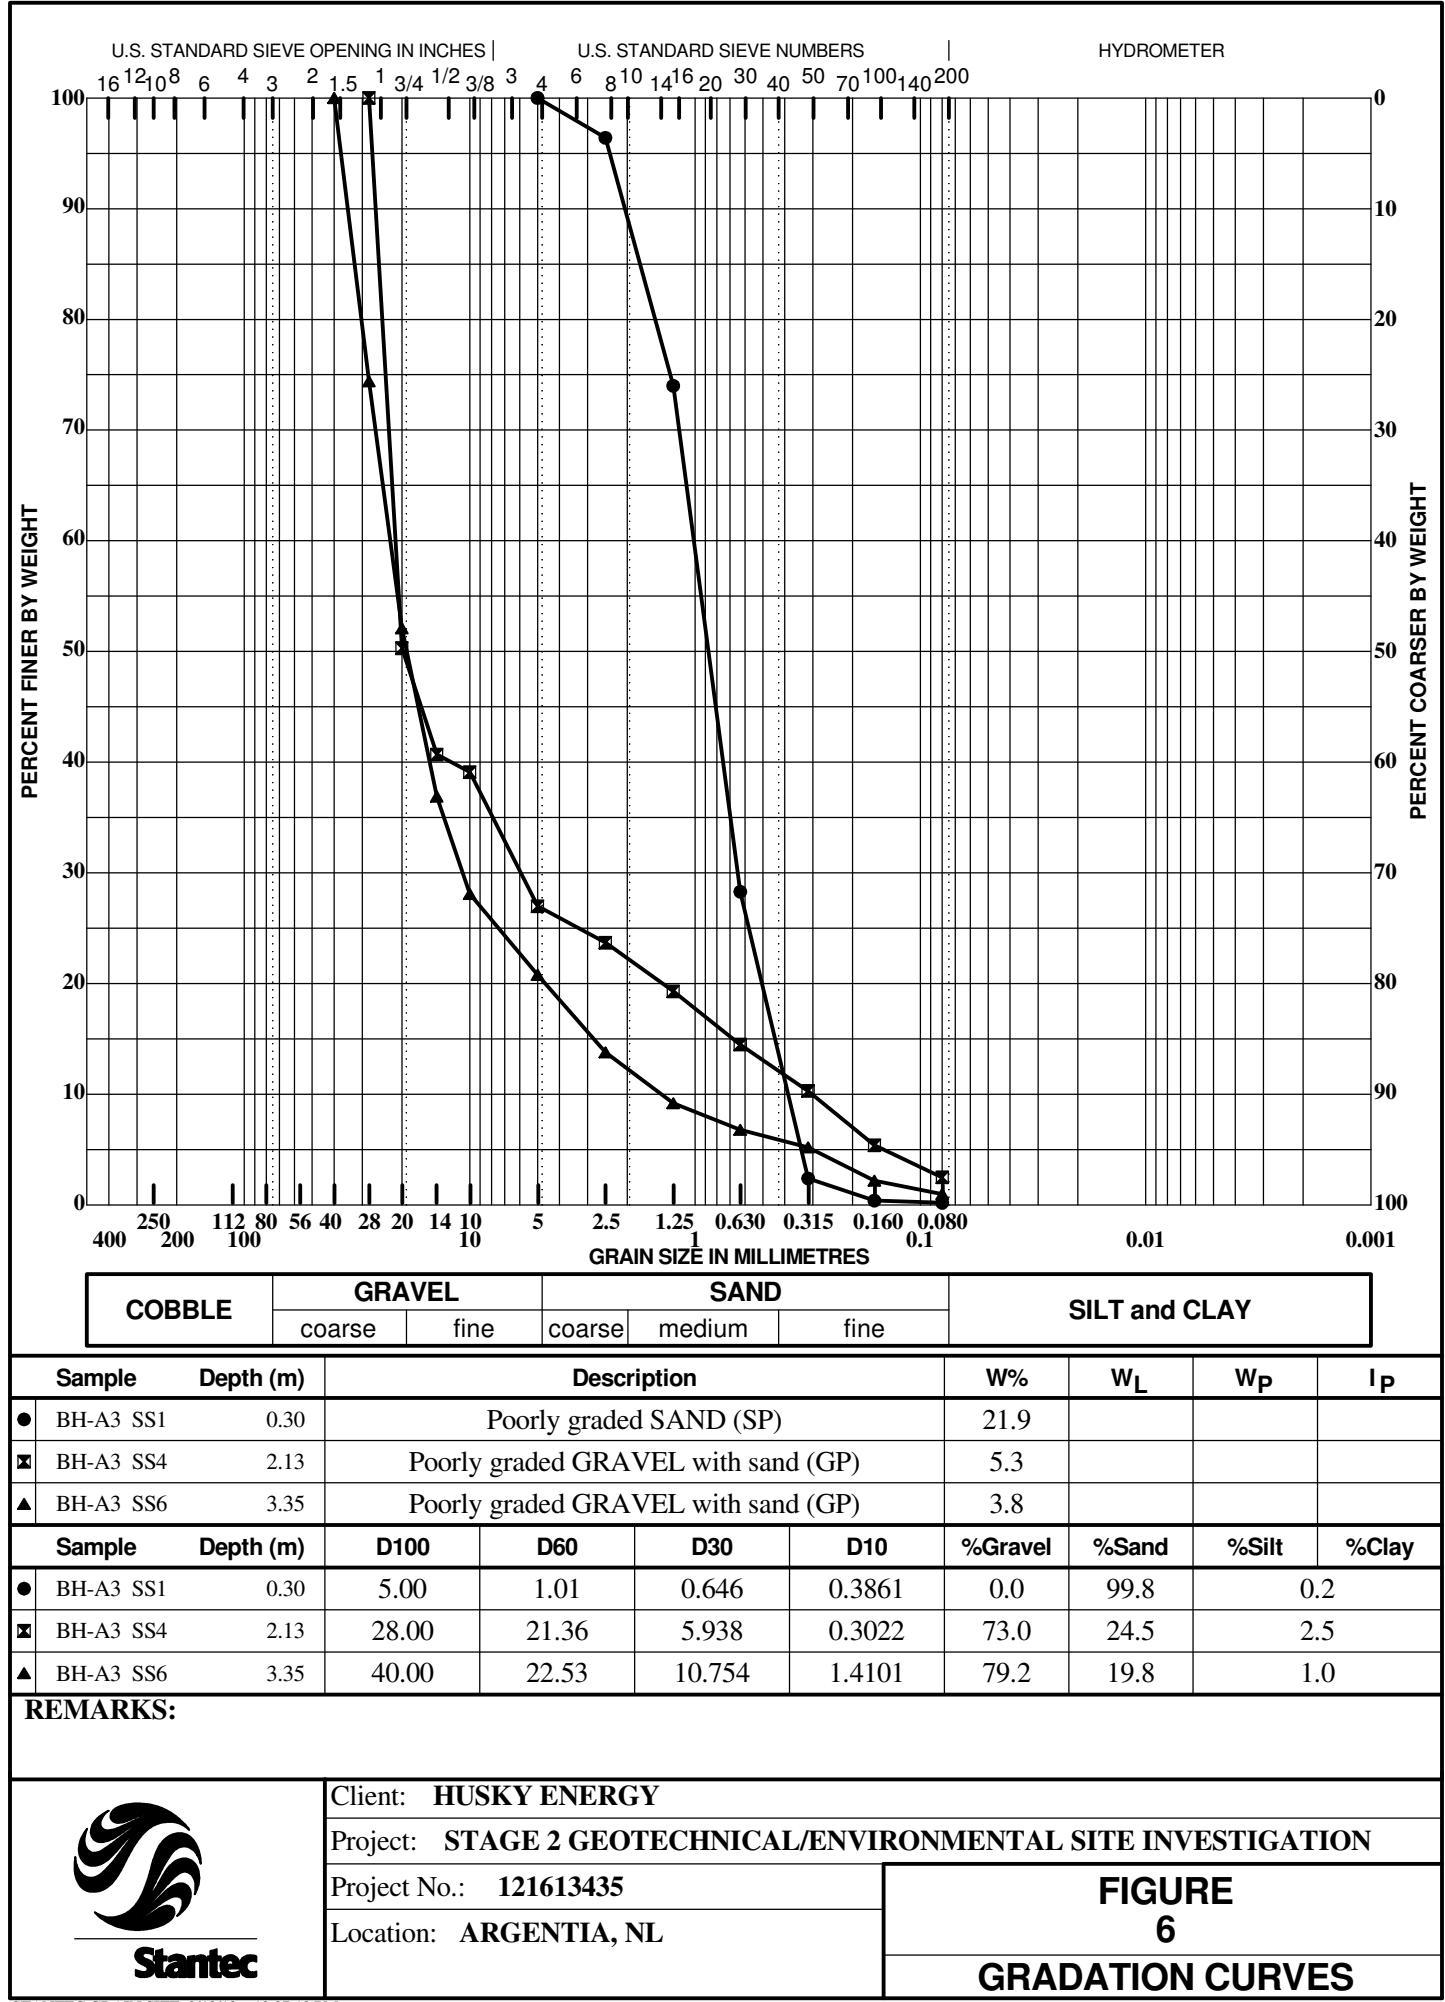
GEOTECHNICAL LABORATORY RESULTS

An explanation of the Symbols and Terms used Borehole Records are attached. Results of soil laboratory tests including gradation by sieve analysis and water content tests, are also attached and reported on the test pit and borehole records where appropriate. Bedrock was not encountered in any of the boreholes. Water levels as measured in the monitoring wells vary from 1.55 to 5.49 m depth.
