White Rose Extension Project

Graving Dock Geotechnical and Environmental Report

Memo

Reference: Interim Progress Report – Site A Results Geotechnical and Environmental Services Stage 2 - Geotechnical / Environmental Site Investigation Proposed GBS Construction Site Argentia, NL

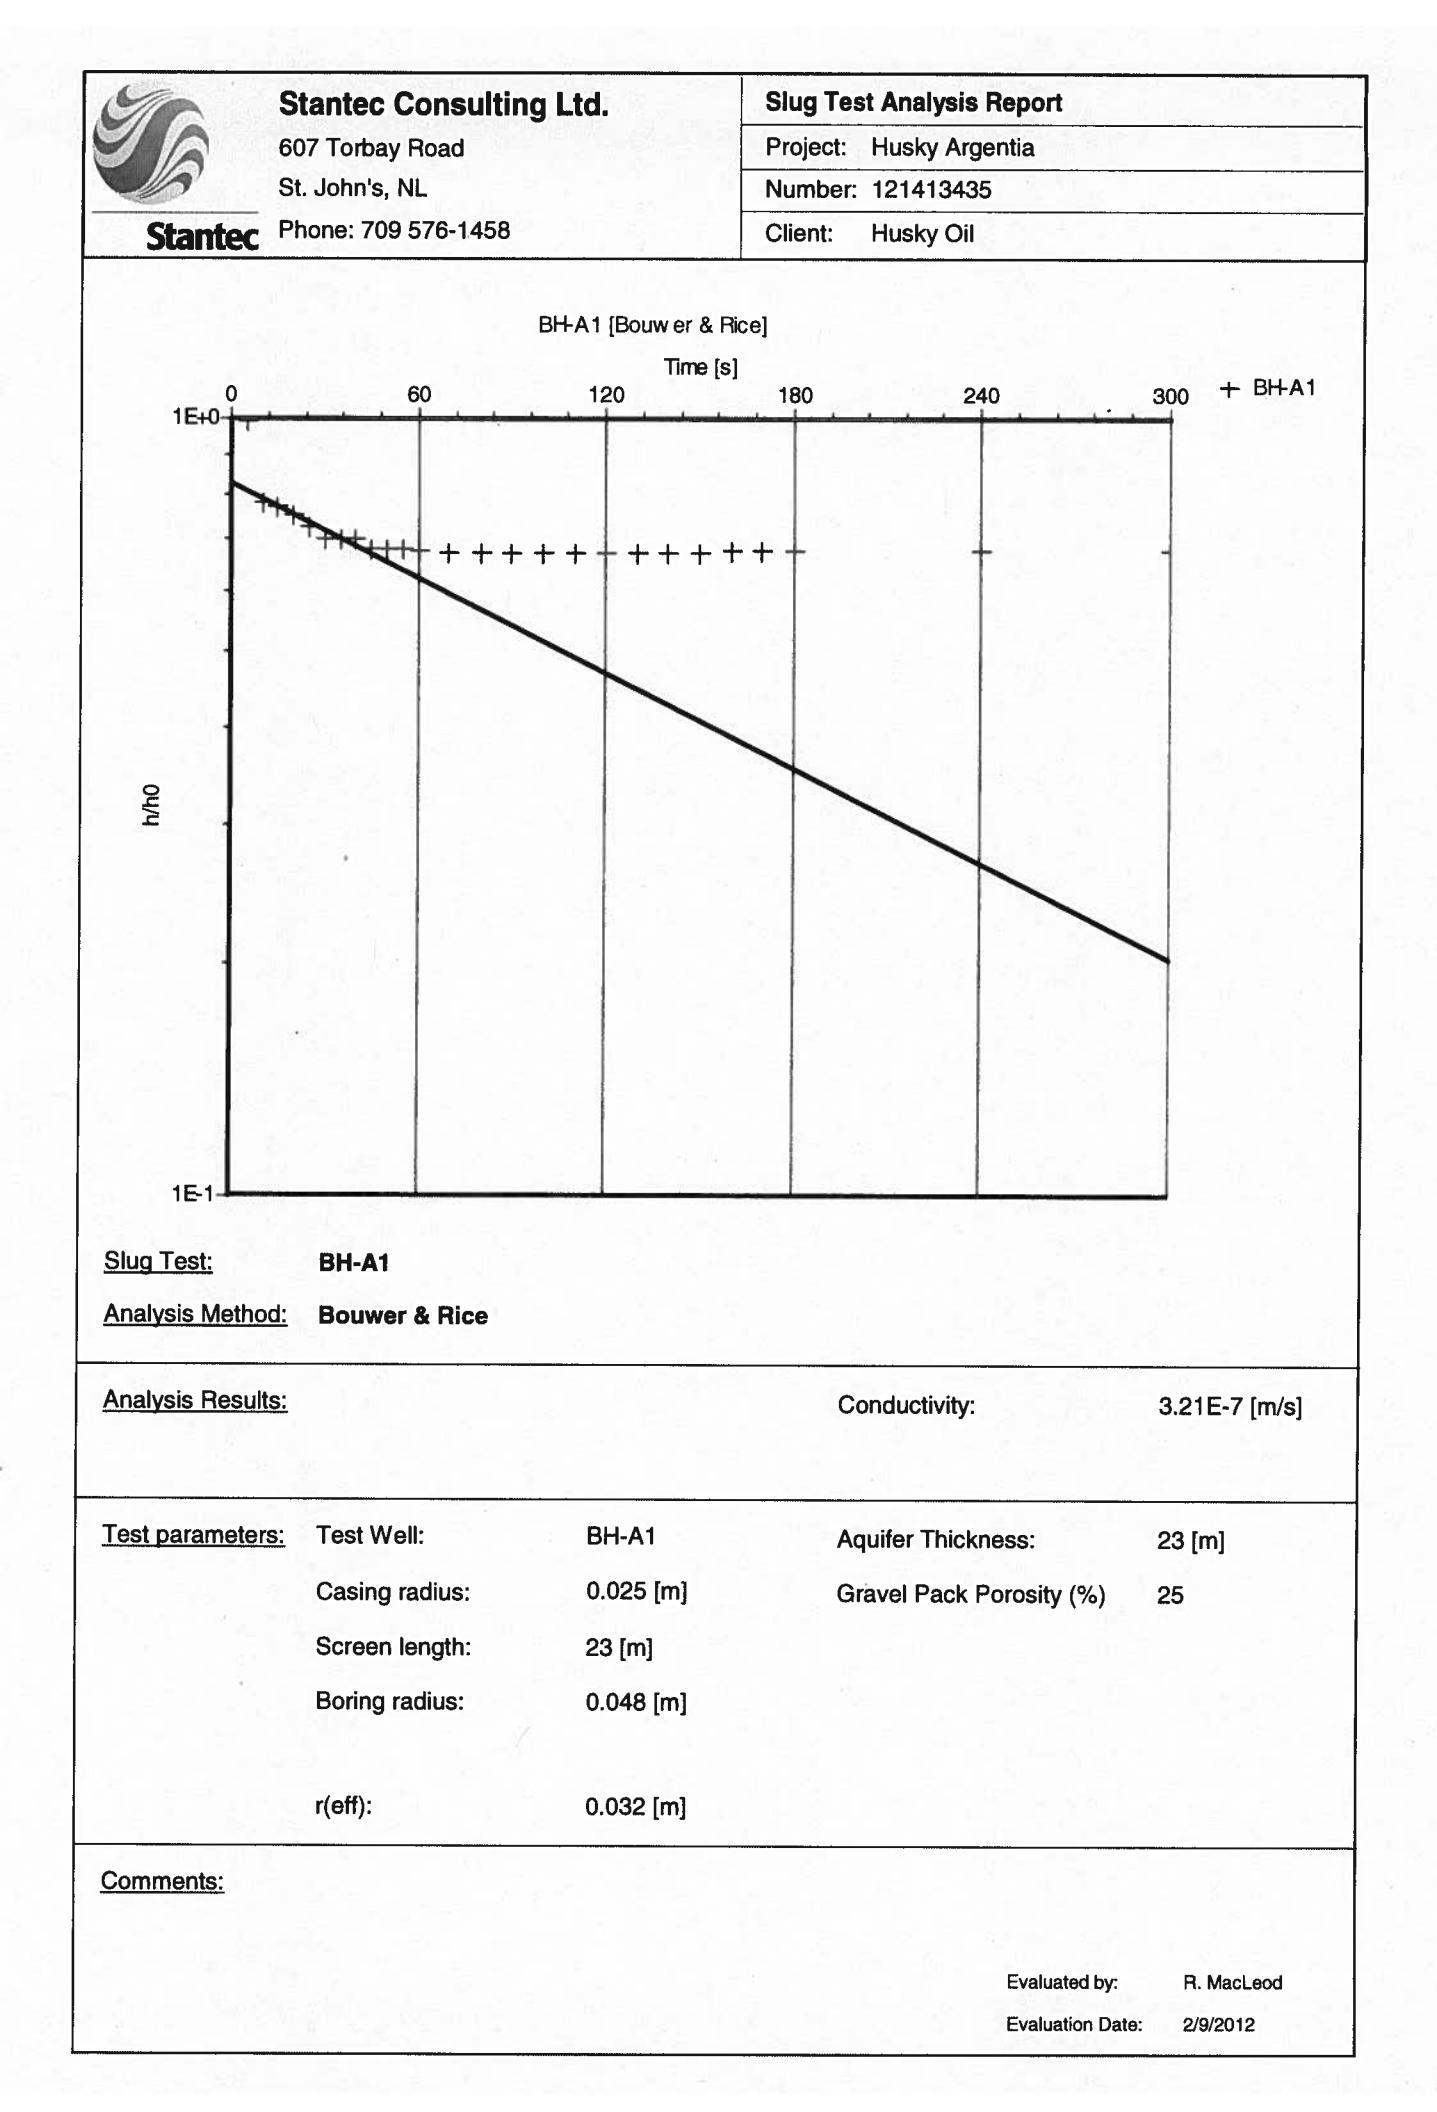
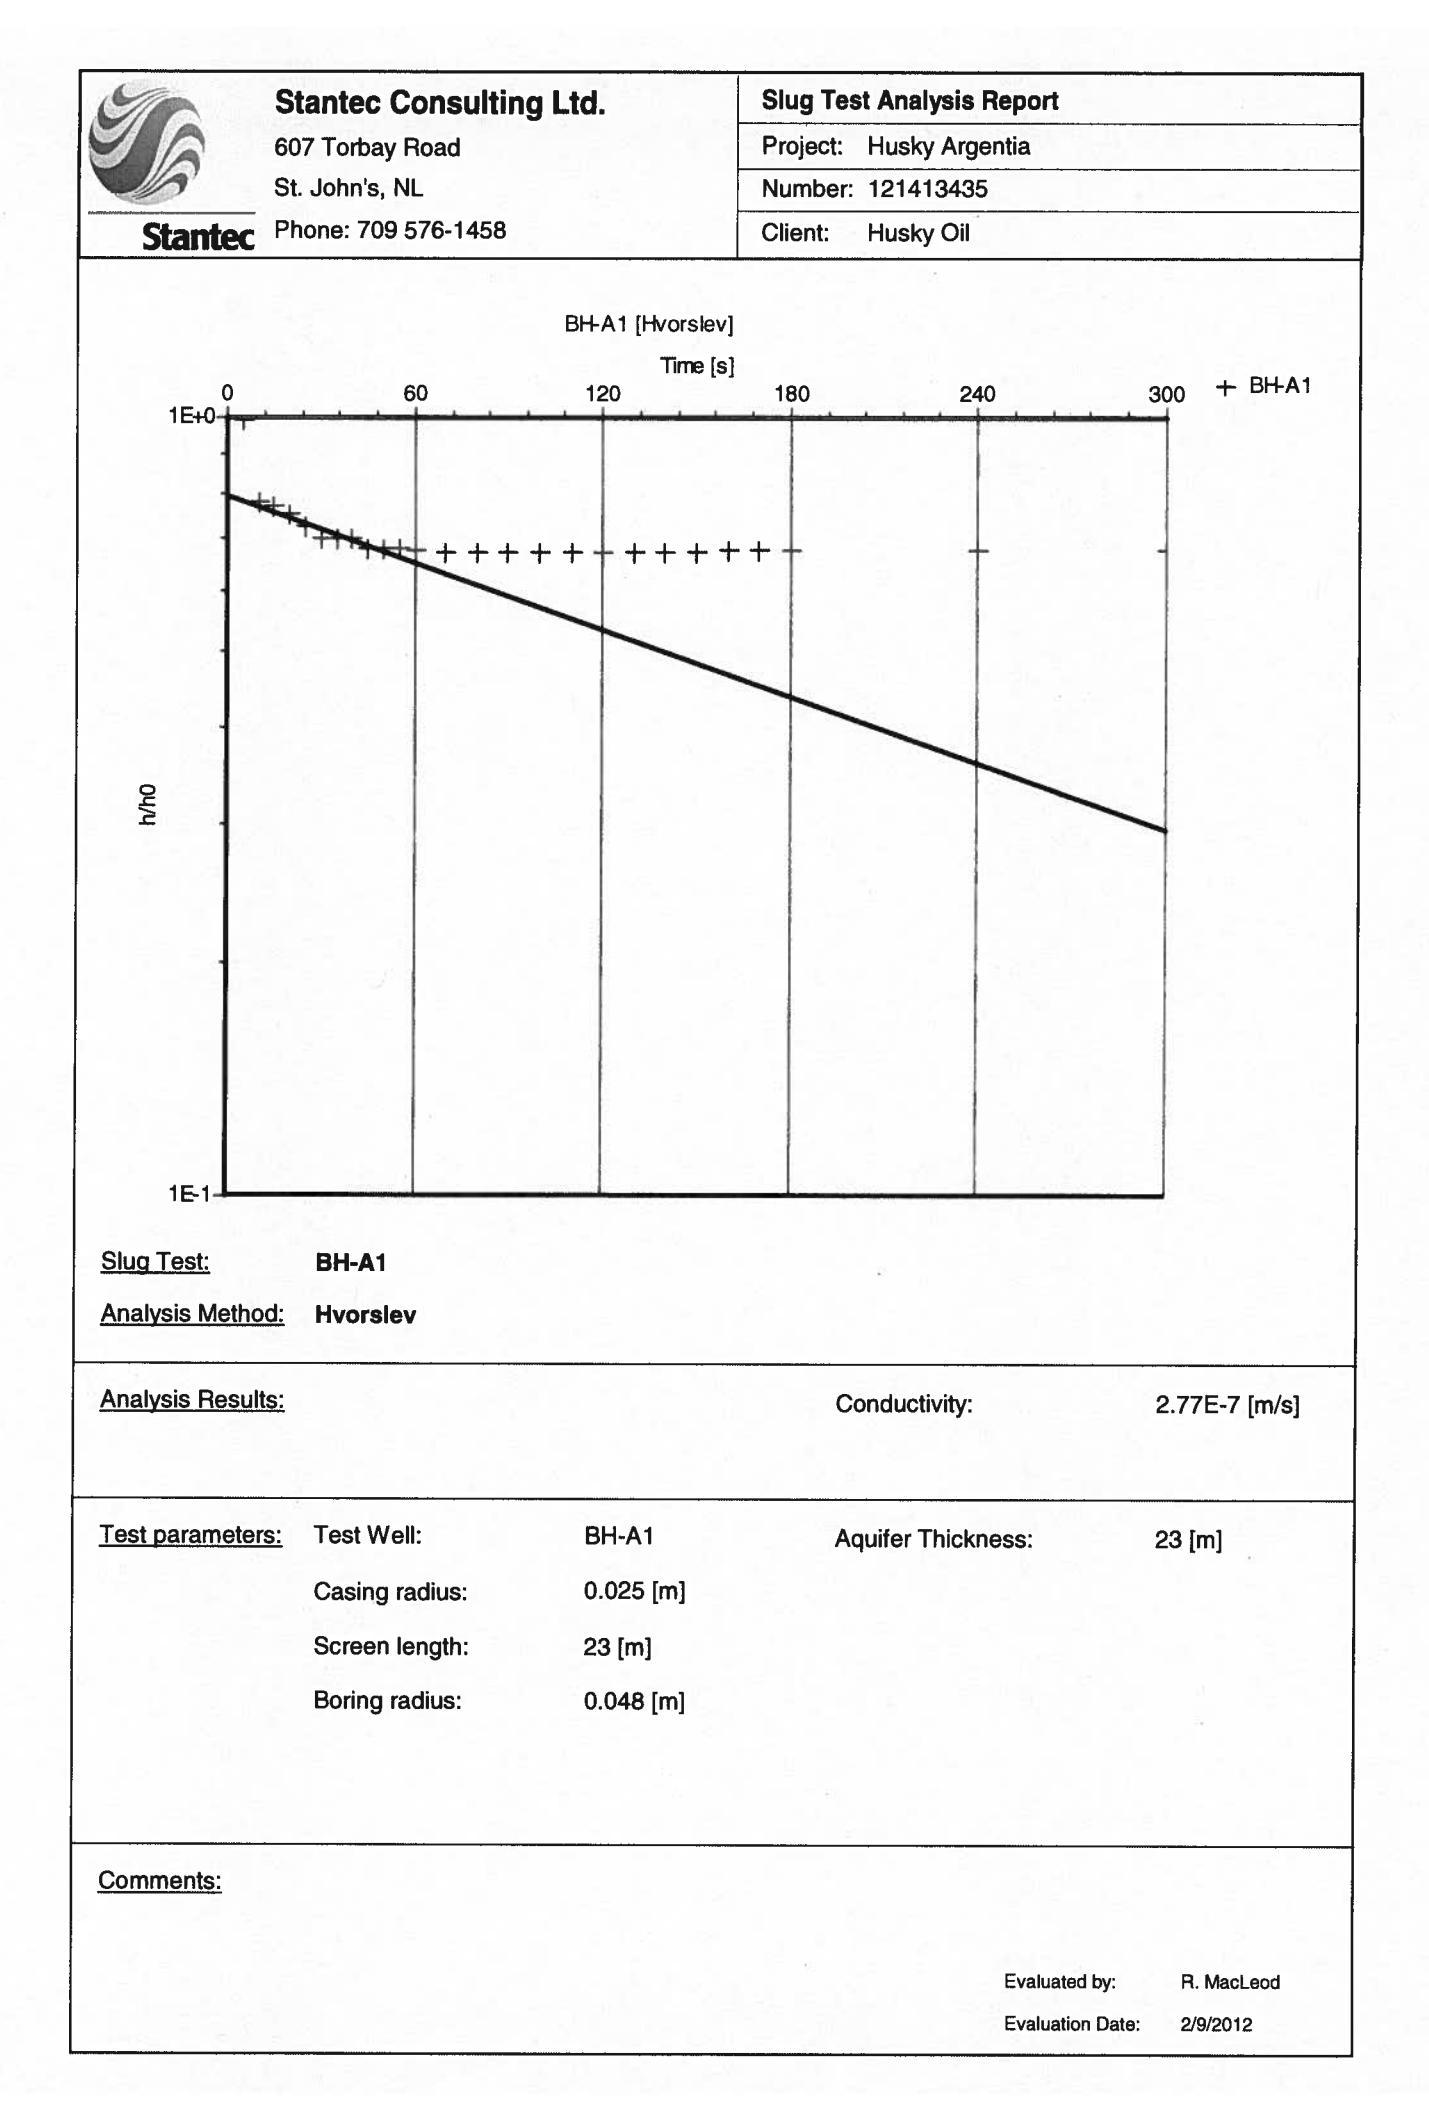
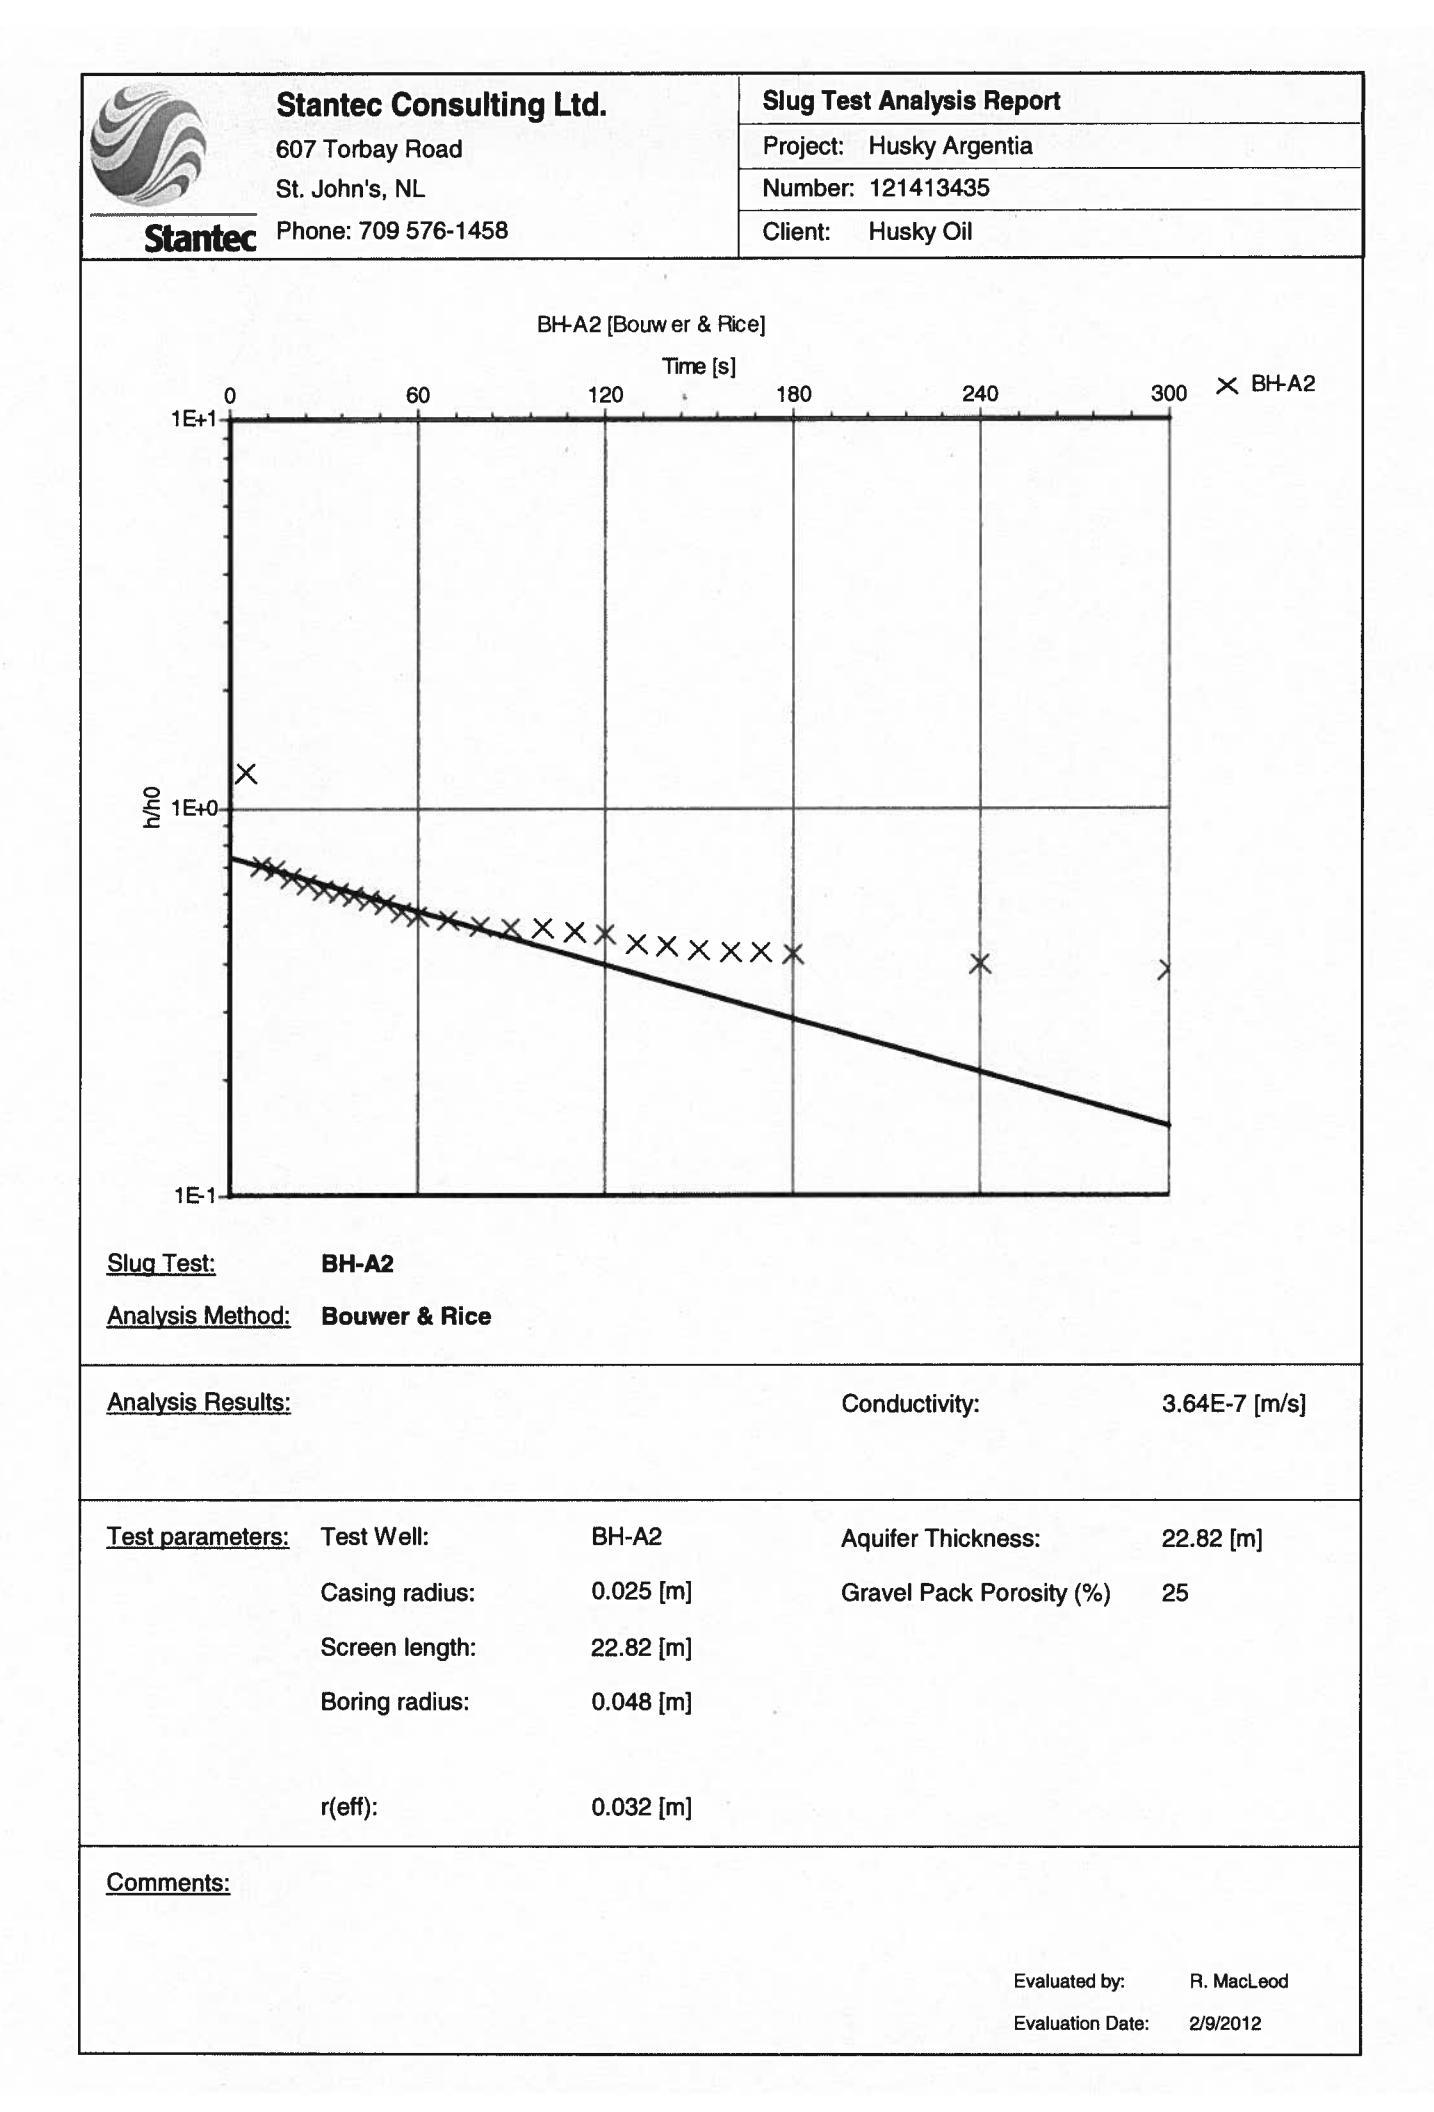
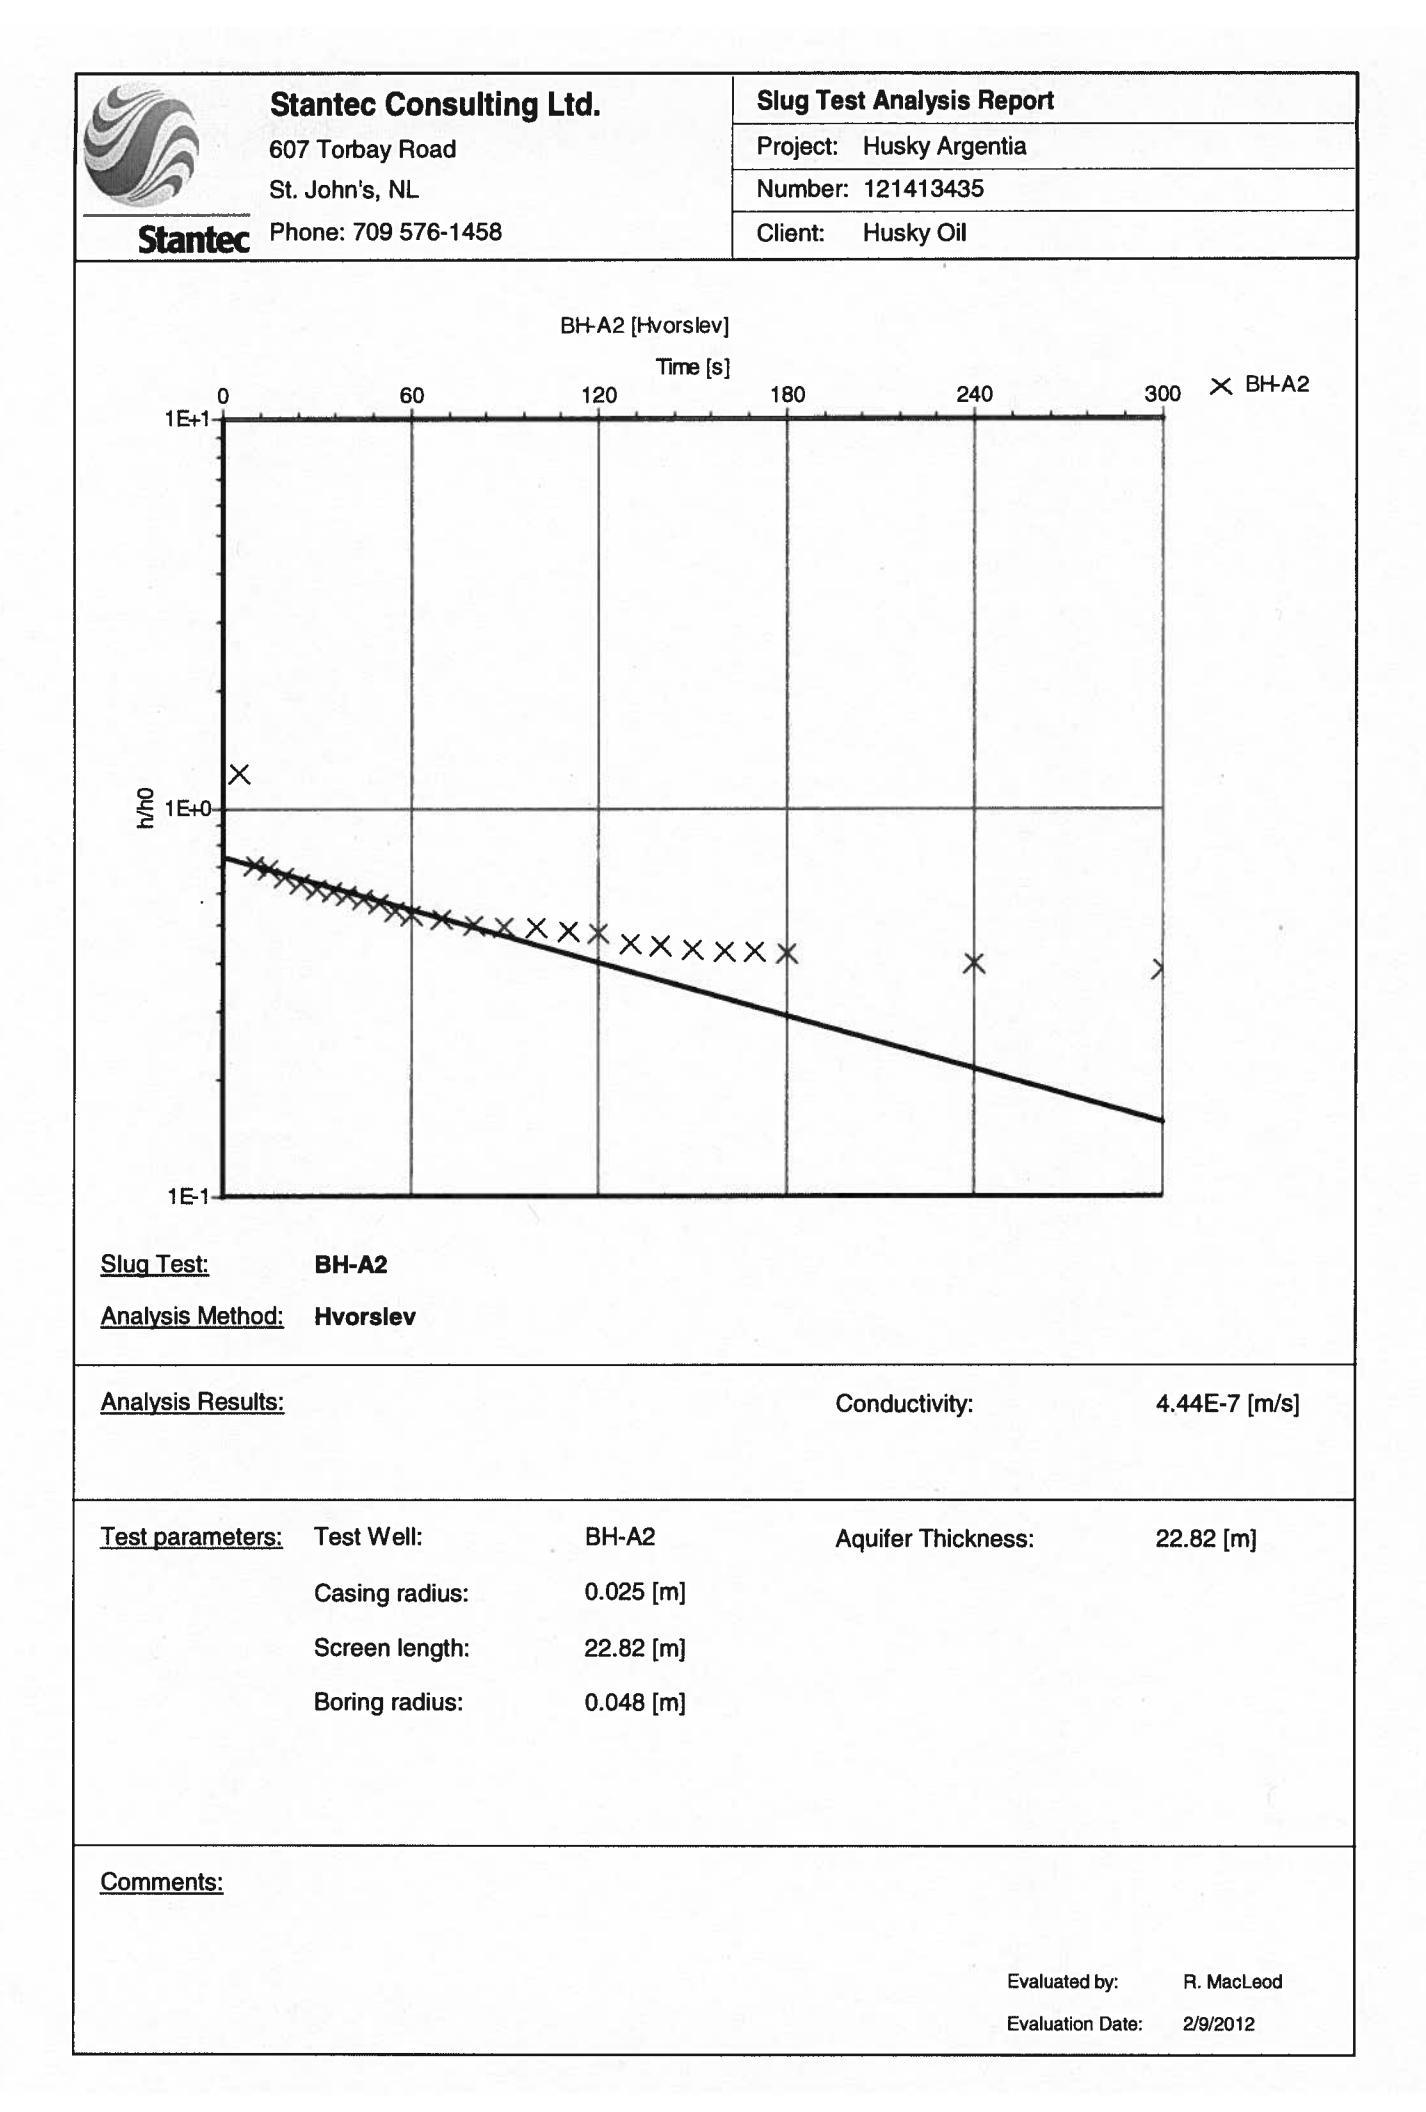
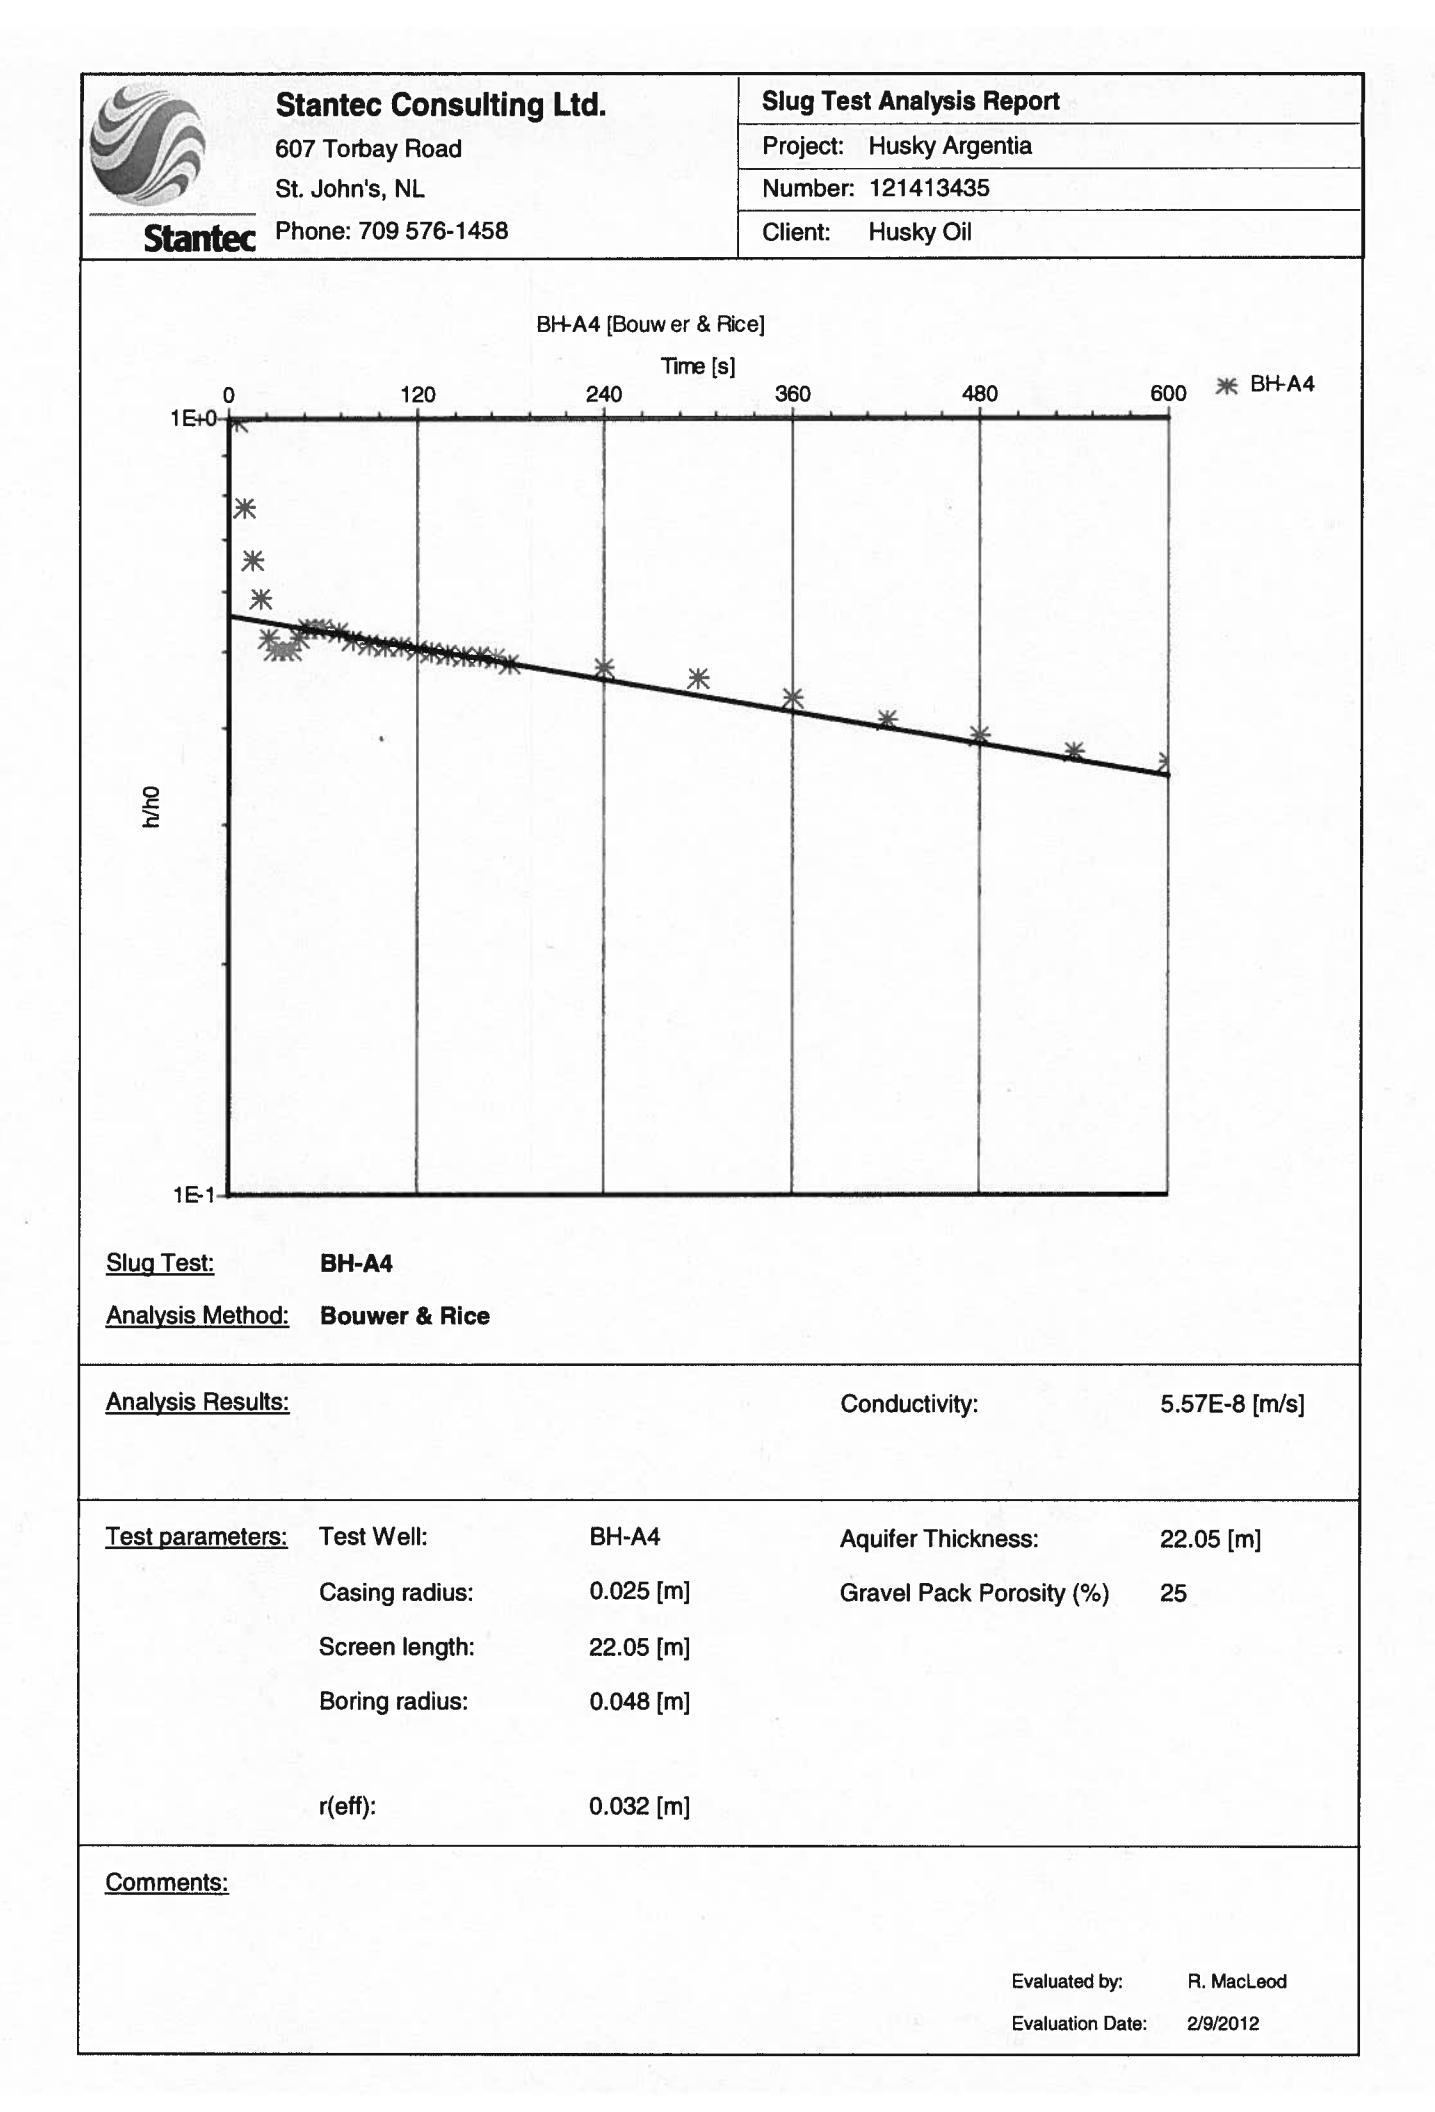
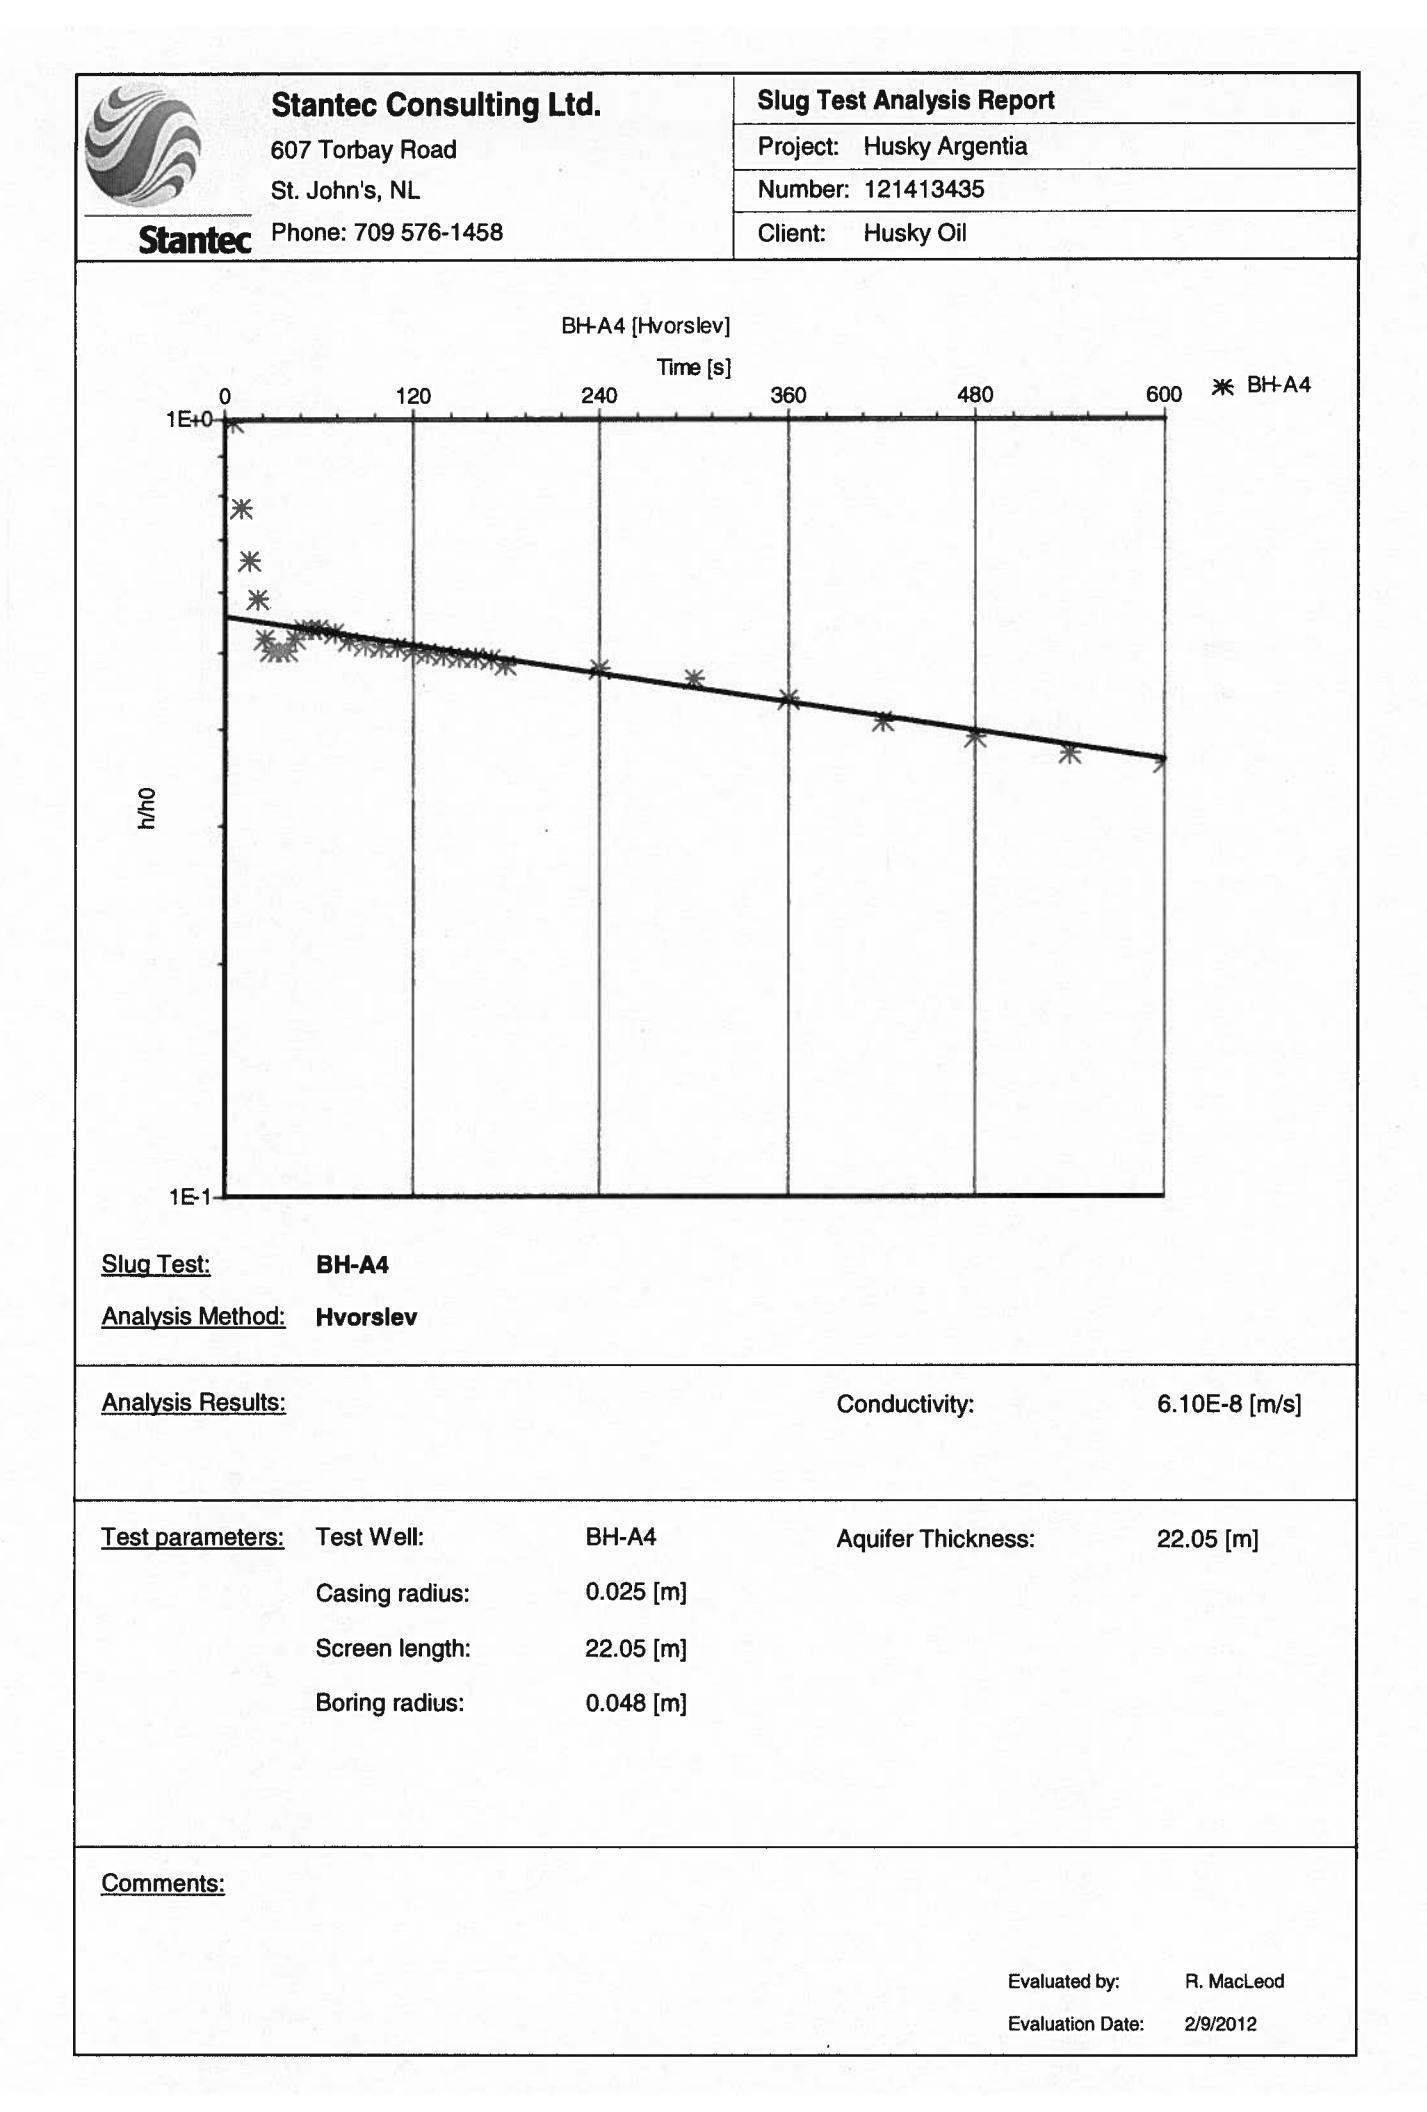
HYDRAULIC RESPONSE TESTING

Hydraulic response (bail-down) tests were carried out on the four monitor wells (i.e., BH-a1, BH-A2, BH-A4, and BH-A5) to determine the permeability of the underlying overburden and bedrock stratigraphy at each location. Bail down tests were conducted by removing a volume of water from each well and recording the water levels in the well at specific time intervals as the water levels recovered. Analysis of the bail down test

data for each test well was performed using the Hvorslev and Bouwer & Rice analysis methods and was conducted with the aid of the computer program AquiferTest, version 3.5 (Waterloo Hydrogeologic Inc.). Plots of analysis of bail-down data are attached and determined hydraulic conductivity values for each monitor well are tabulated below.

Results of analysis of test data indicate mean hydraulic conductivity values for the four monitor wells ranging from 3.0x10⁻⁷ m/s for BH-A1 to 5.9x10⁻⁸ m/s for BH-A4 and are attached to this memorandum. These results are in general agreement with the observed overburden stratigraphy identified in the boreholes at the site and are generally within the range of typical values expected for wells screened in a combination of silty sand overburden.
