ENVIRONMENTAL ASSESSMENT REGISTRATION DOCUMENT

Proposed Aggregate Quarry, Gear Pond

Prepared by: Department of Natural Resources January 18, 2013

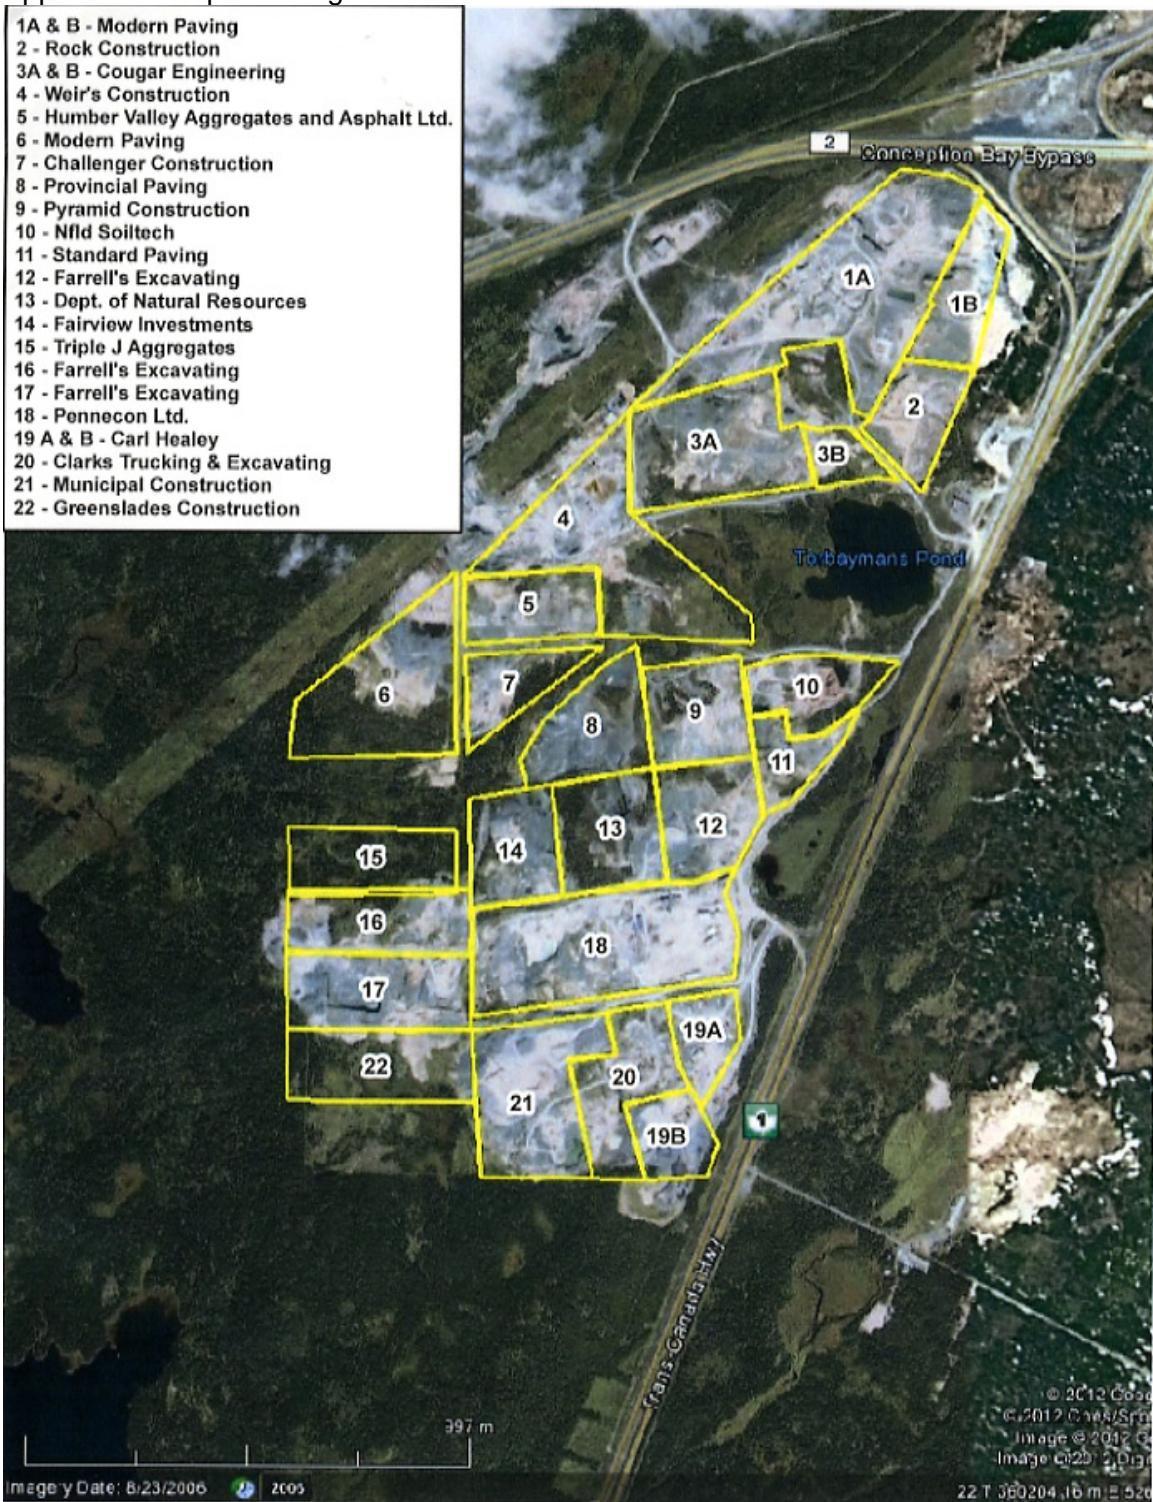
Figure 1: Harbour Arterial Mineral Workings Area (HAMWA) showing location of quarry leases and listing quarry operators.

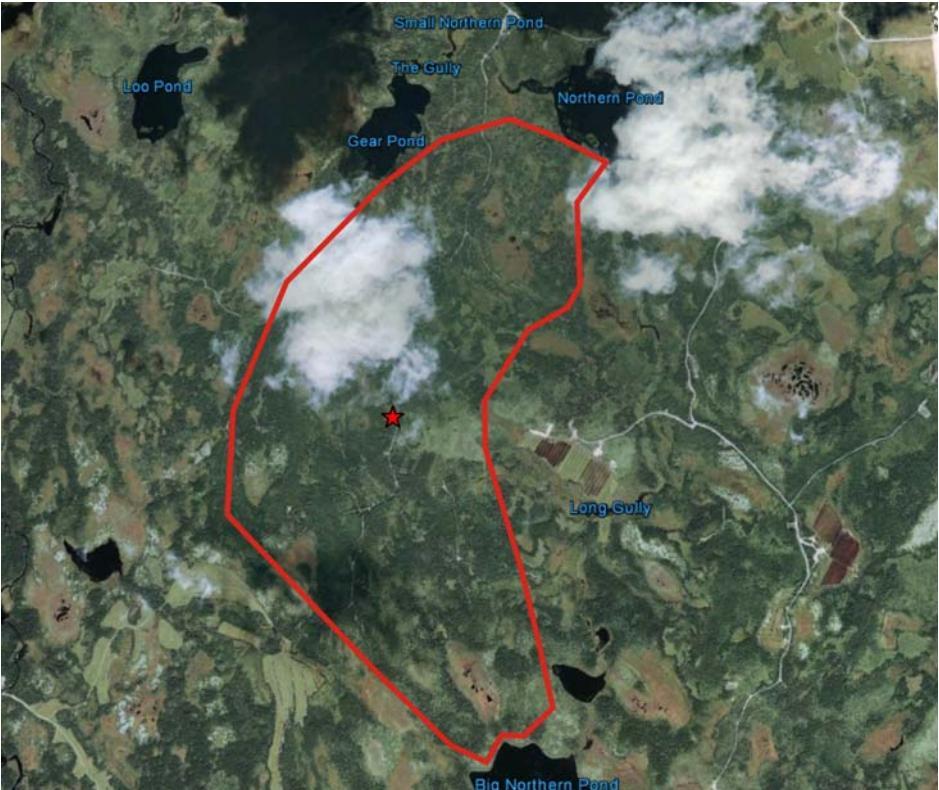
Figure 3: Proposed Gear Pond Aggregate Source area (outlined in red). Red star shows location of 200 lb sample of grey siltstone sampled by Natural Resources personnel on November 27, 2012 (utm coordinates: 356887 m E, 5254170 m N; NAD 27, Zone 22).

The area is located within the Maritime Barrens Ecoregion and wildlife species in the area are typical of boreal forest species of this ecoregion. Most of the area is tree-covered, with minor bogs and fens. Forest access roads cut through the area and these are heavily used for recreational purposes including snowmobile and ATV use (Figure 3). The area is also popular for moose hunting (Management Area 35).

A small outcrop (approximately 1 m x 1.5 m) was identified along a narrow dirt road trending south through the proposed area. The coordinates of the sample site are 356887 m E, 5254170 m N (NAD 27, Zone 22; see Figure 3). The rock is buff- to tanweathering siltstone, medium grey on the fresh surface and is likely part of the Drook Formation of the Conception Group (Figure 6). Approximately 200 pounds of rock (3-4" fragments) were collected from the site and delivered to the Soils Laboratory of the Department of Transportation and Works on November 28, 2012.

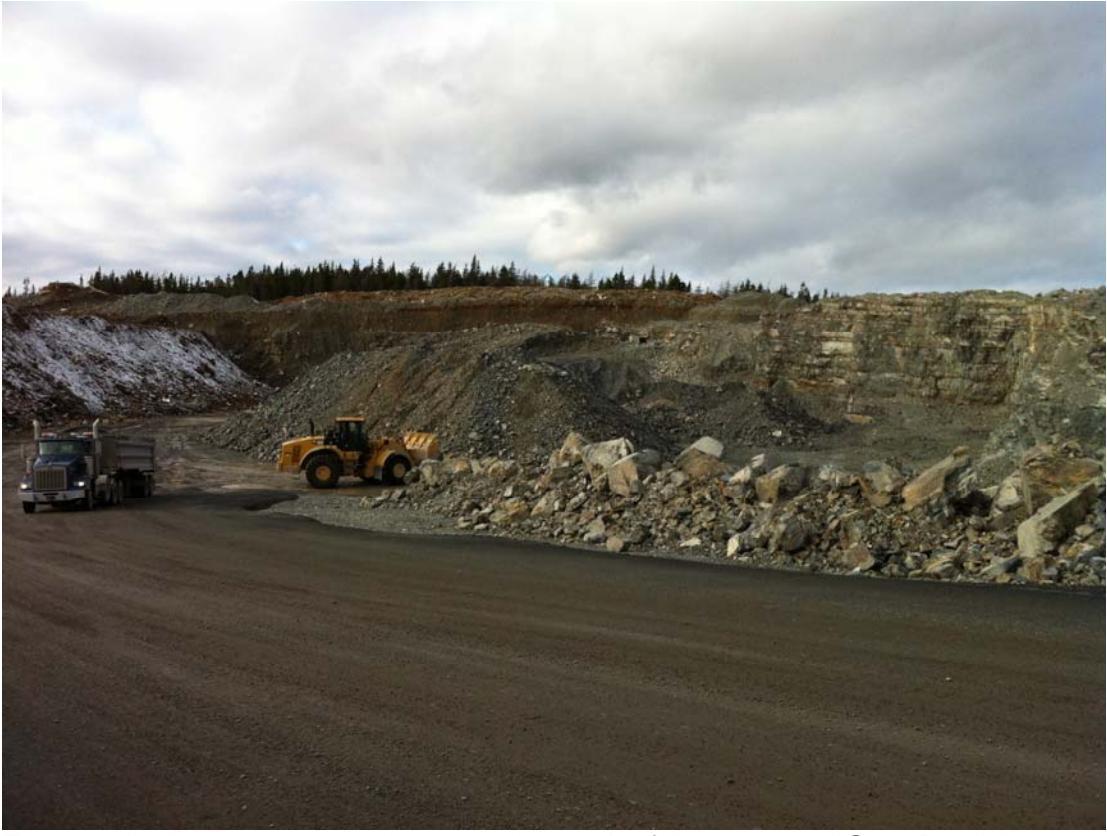
Figure 4: Active quarry operation, ~1.5 km north of the proposed Gear Pond Aggregate Source area.

Major physical features of the undertaking will include open pit aggregate operations, laydown areas, garages, crushers and asphalt plants (Figure 4).

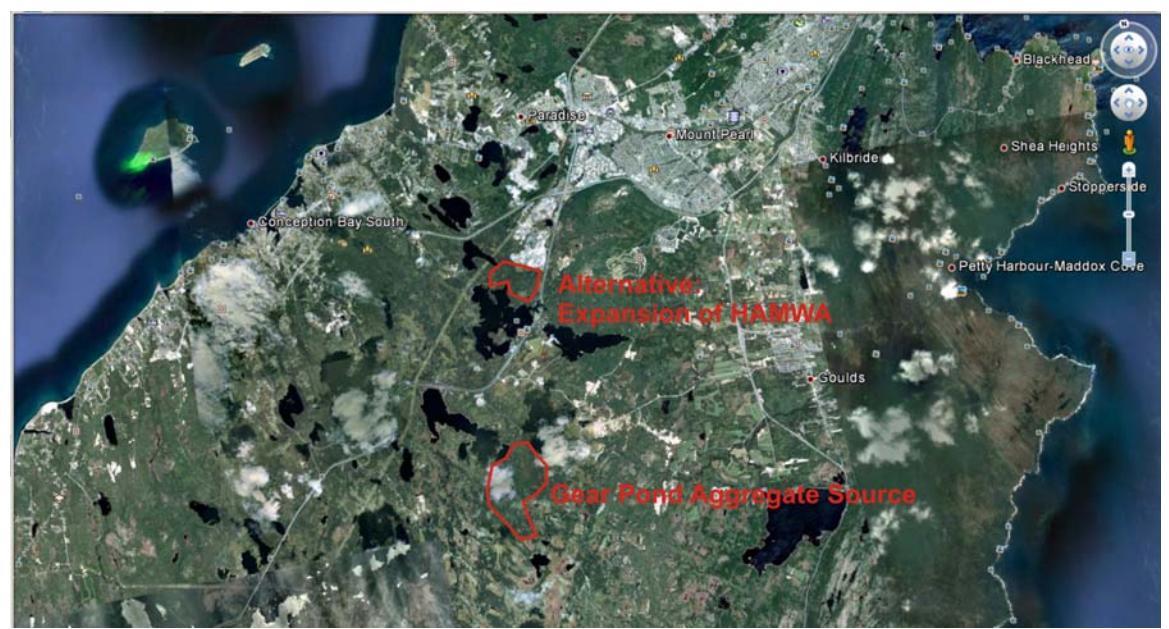
Figure 5: Google Earth image of the southern part of the Northeast Avalon, showing locations of the Gear Pond Aggregate Source area and the alternative site (expansion of the HAMWA).

An alternative site could involve expansion of the HAMWA southward to Paddys Pond (Figure 5). No direct access to the area of expansion is currently available but the area could be accessed by extending existing roads from the current workings. A Conception Bay South Bypass Road has been proposed for the area and this could potentially provide alternative access to the site in future.

The area considered for expansion extends approximately 750 metres south of the current Harbour Arterial Mineral Area Workings area and varies from less than 100 metres wide up to approximately 750 metres wide.

The expansion area is located on a hill and would be visible from the TCH and possibly from the Foxtrap Access Road. Visibility issues are one of the main concerns with this alternative source of aggregate.

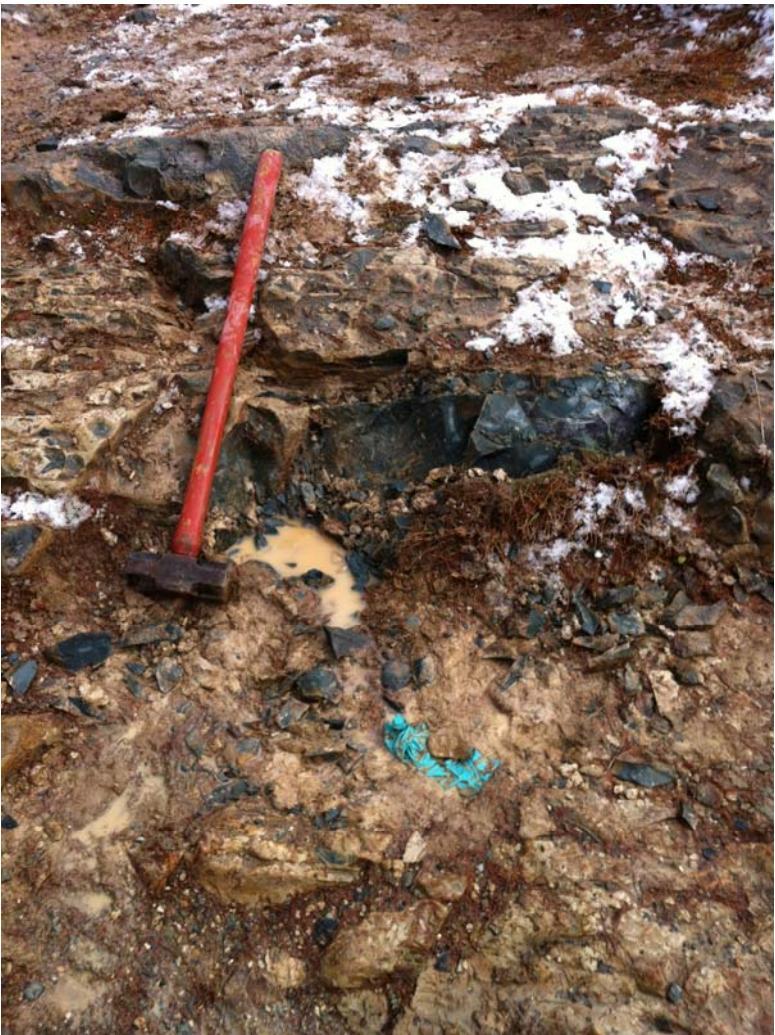
Figure 6: Medium grey siltstone from the Gear Pond sample site (sledge hammer is approximately 60 cm in length).
