Real-Time Water Quality Deployment Report Rattling Brook Network

August 12, 2011 to September 27, 2011

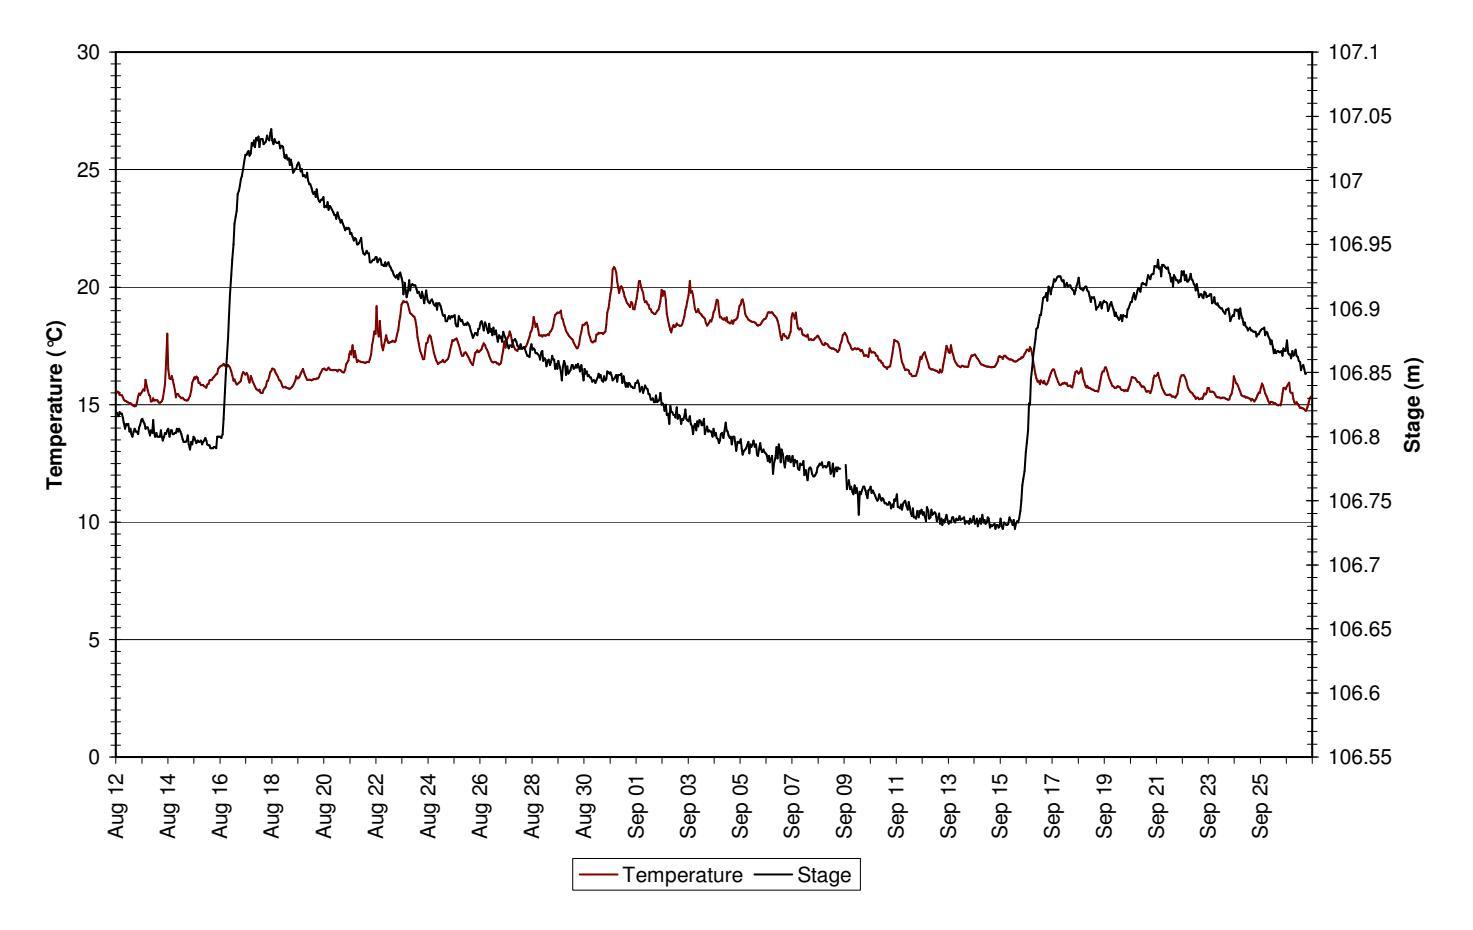
Figure 1: Water Temperature at Rattling Brook Big Pond from August 12th to September 27th, 2011

- Water temperatures normally peak towards the end of August as air temperatures begin to fall heading into the fall season. Temperatures did not change much compared to the previous month in terms of max, min, or median values. During this deployment period, water temperatures ranged from 20.86 to 14.74°C (median value: 16.81°C).
- In 2010, during the same time period, temperatures were somewhat warmer with a median temperature 1.54°C warmer than 2011.

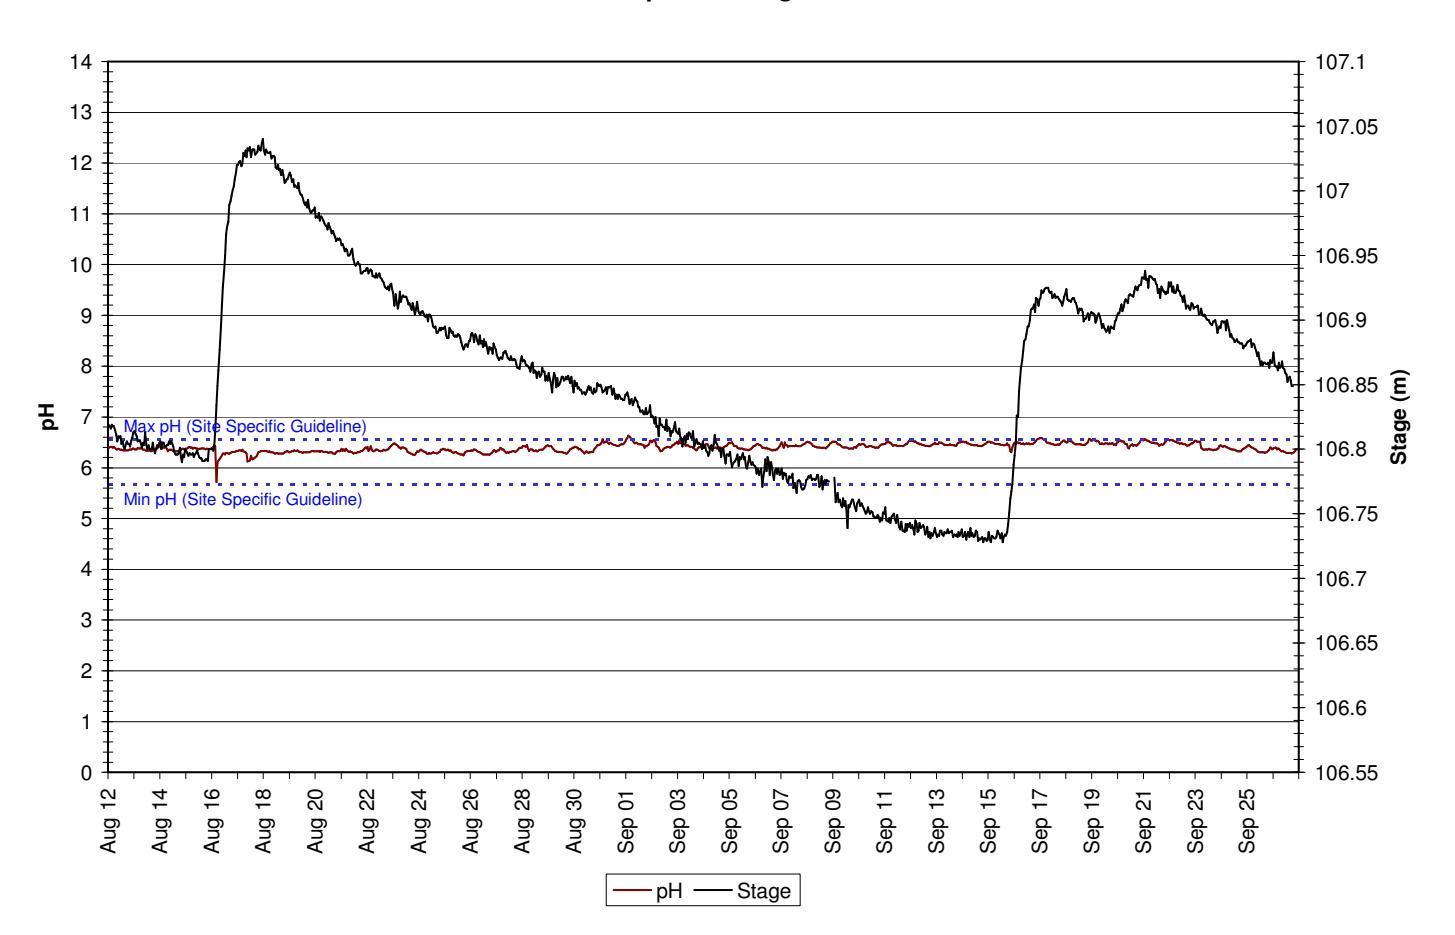
Figure 2: pH at Rattling Brook Big Pond from August 12th to September 27th, 2011

Water pH and Stage Level

Consistently mild acidity and a lack of dramatic change in pH is characteristic of Rattling Brook Big Pond. pH values were almost totally within the Site Specific Guidelines of 5.67 – 6.56 units. The actual recorded range from 5.72 to 6.63 with a median value of 6.40.

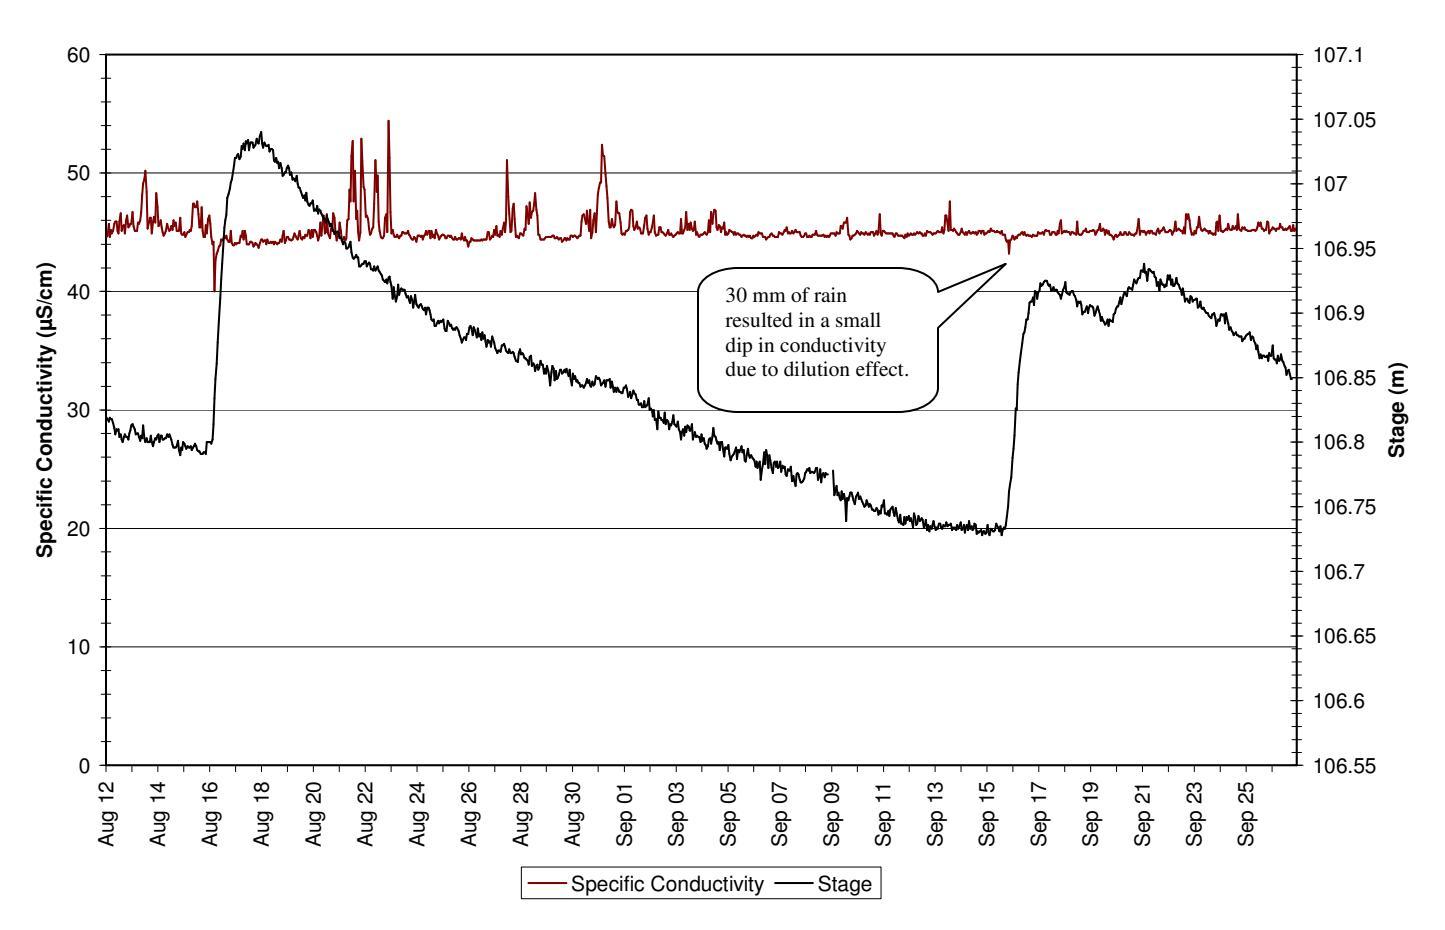
Figure 3: Specific Conductivity at Rattling Brook Big Pond from August 12th to September 27th, 2011

Specific Conductivity of Water and Stage Level

- On the whole, conductivity was stable during this deployment period. Some instances of peaks and dips are evident due to precipitation events.
- Conductivity values fell between 43.4 to 54.7 μ S/cm with a median value of 44.6 μ S/cm.

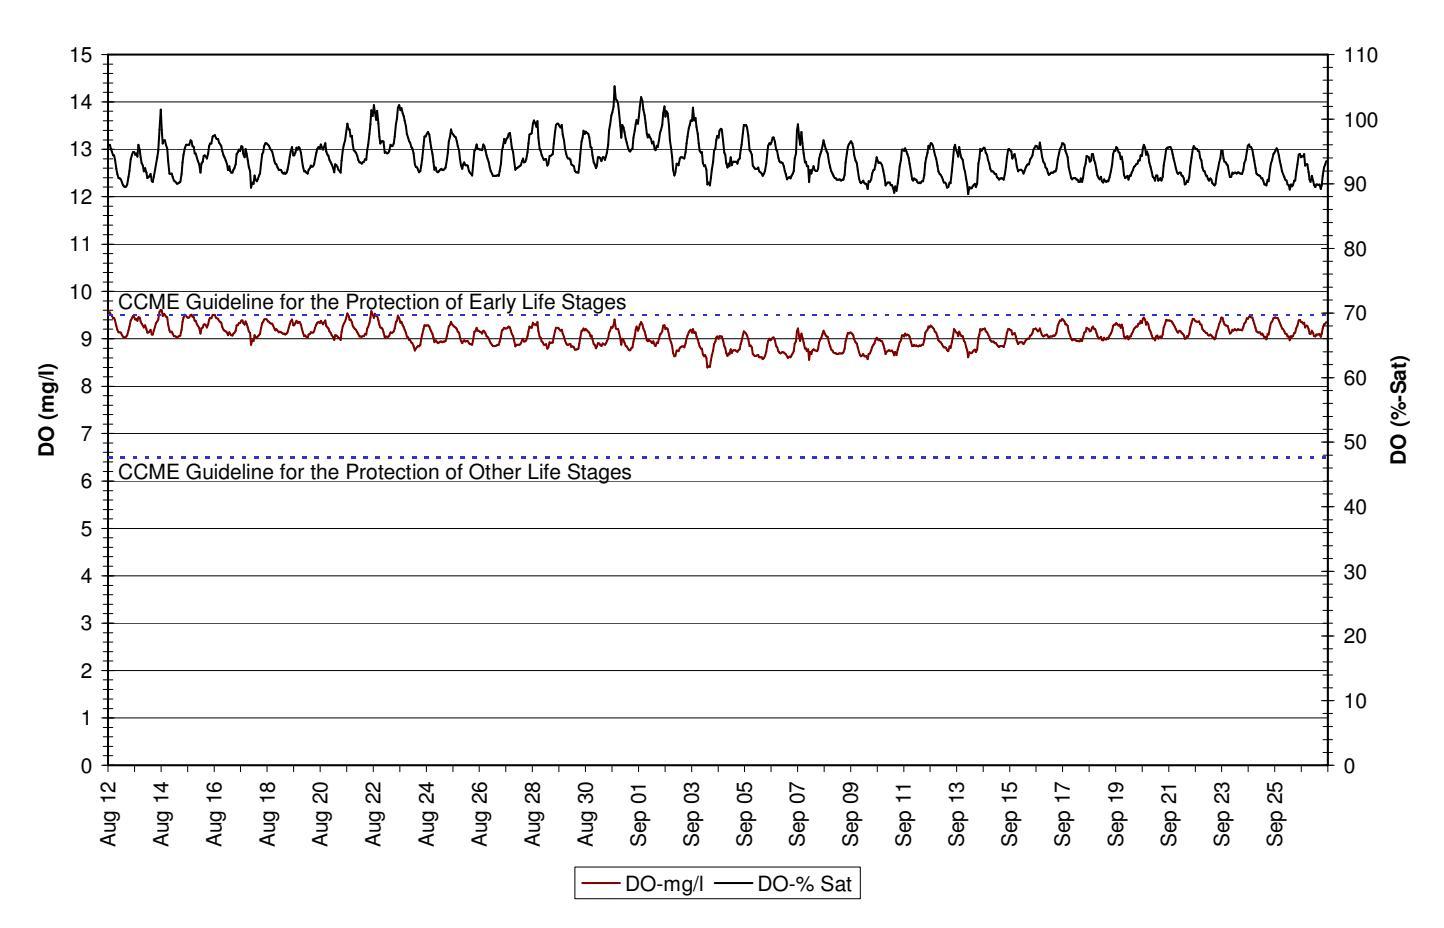
Figure 4: Dissolved Oxygen at Rattling Brook Big Pond from August 12th to September 27th, 2011

Dissolved Oxygen Concentration and Saturation

- Dissolved oxygen hovered just under the CCME Guideline for the Protection of Early Life Stage cold water biota during this deployment. At this time of year, few organisms are stressed by low DO conditions as later life stages are generally achieved long before fall.
- Concentrations of dissolved oxygen ranged from 8.39 to 9.61 mg/l (median: 93.6 mg/l).

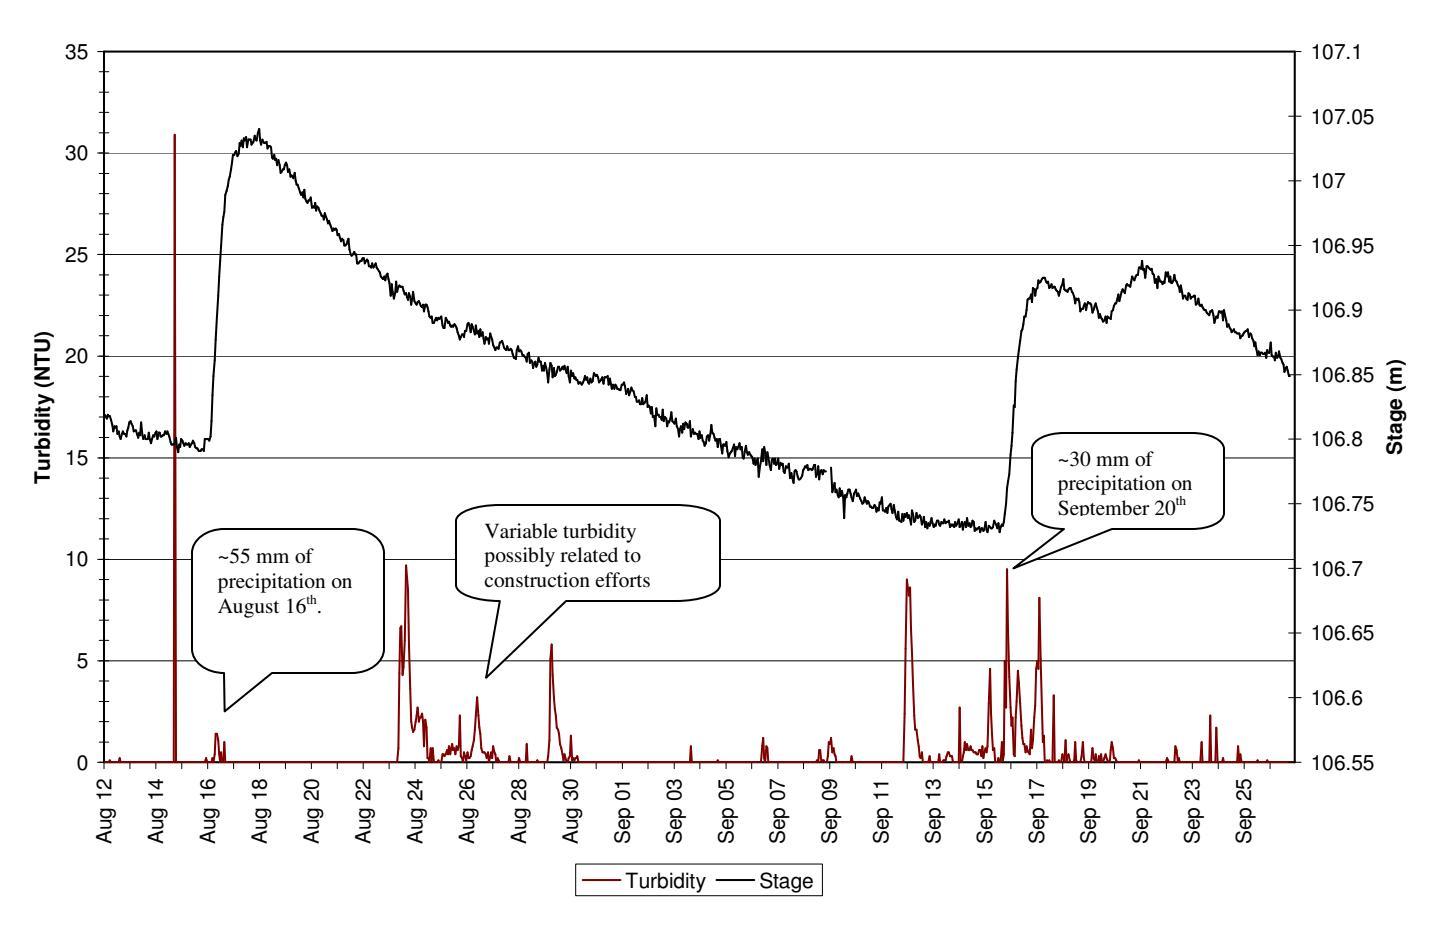
Figure 5: Turbidity at Rattling Brook Big Pond from August 12th to September 27th, 2011

Water Turbidity and Stage Level

- Turbidity values were low during the course of this deployment and fell between 0.0 and a maximum of 36.9 NTU. The median turbidity at this time was found to be 0.2 NTU.
- Construction efforts are ongoing in this area in relation to a water intake structure for the Hydromet facility. From August 24th to 30th, a period of variable turbidity could not be associated with any particular weather event. It is possible that the turbidity encountered is related to construction.

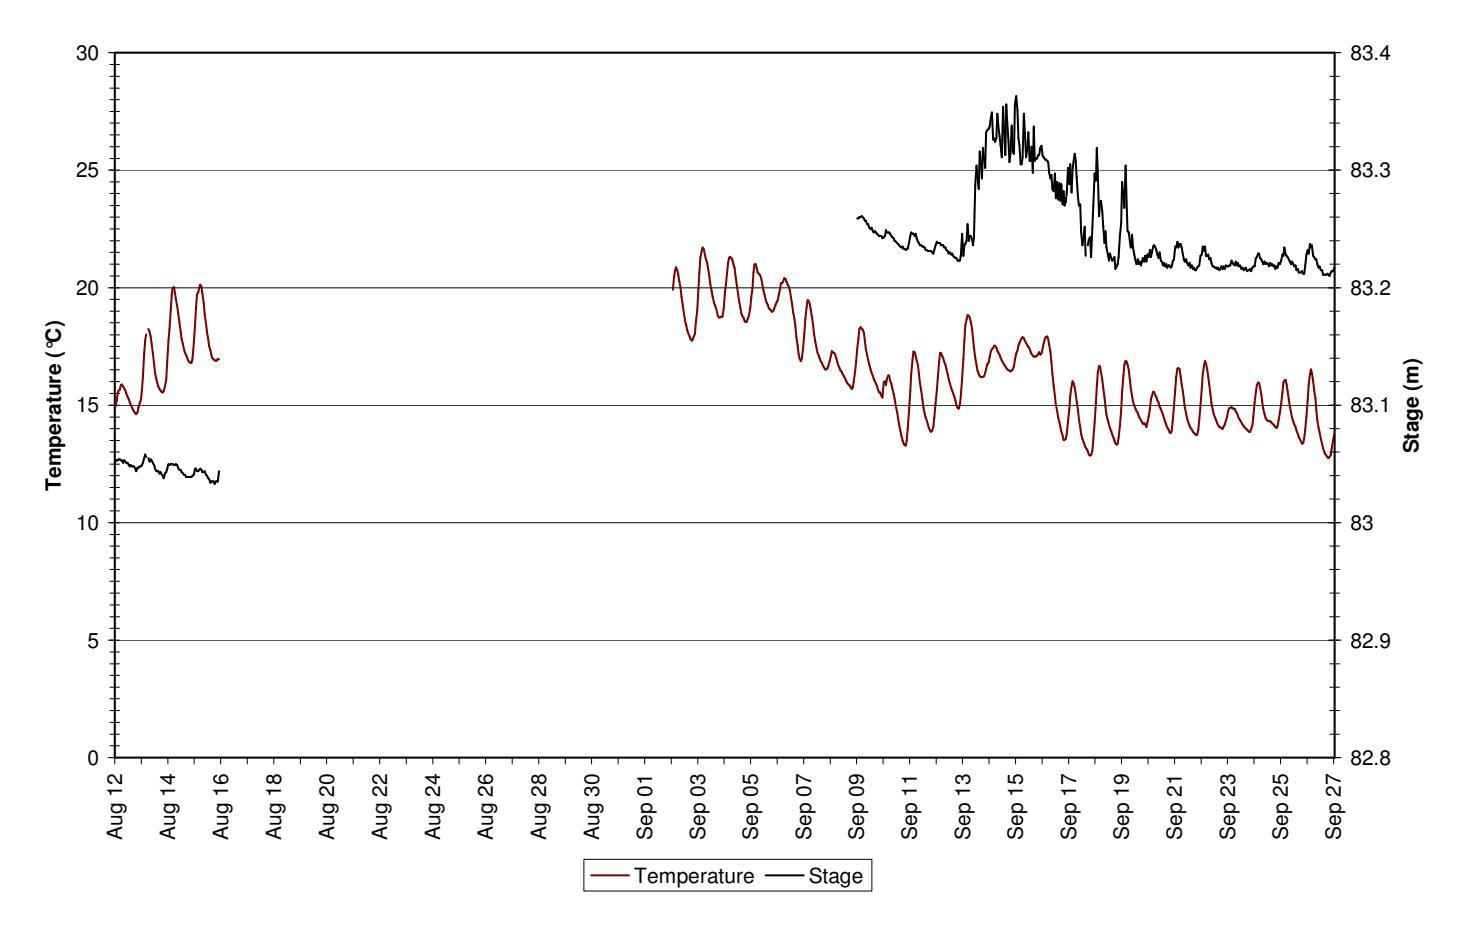
Figure 6: Water Temperature at Rattling Brook below Bridge from August 12th to September 27th, 2011

Water Temperature and Stage Level

Water temperature appears to have peaked around or just before the time Bridge station was brought back online following habitat compensation work. Temperatures fell between 21.71 to 12.75°C (median value: 16.25°C).

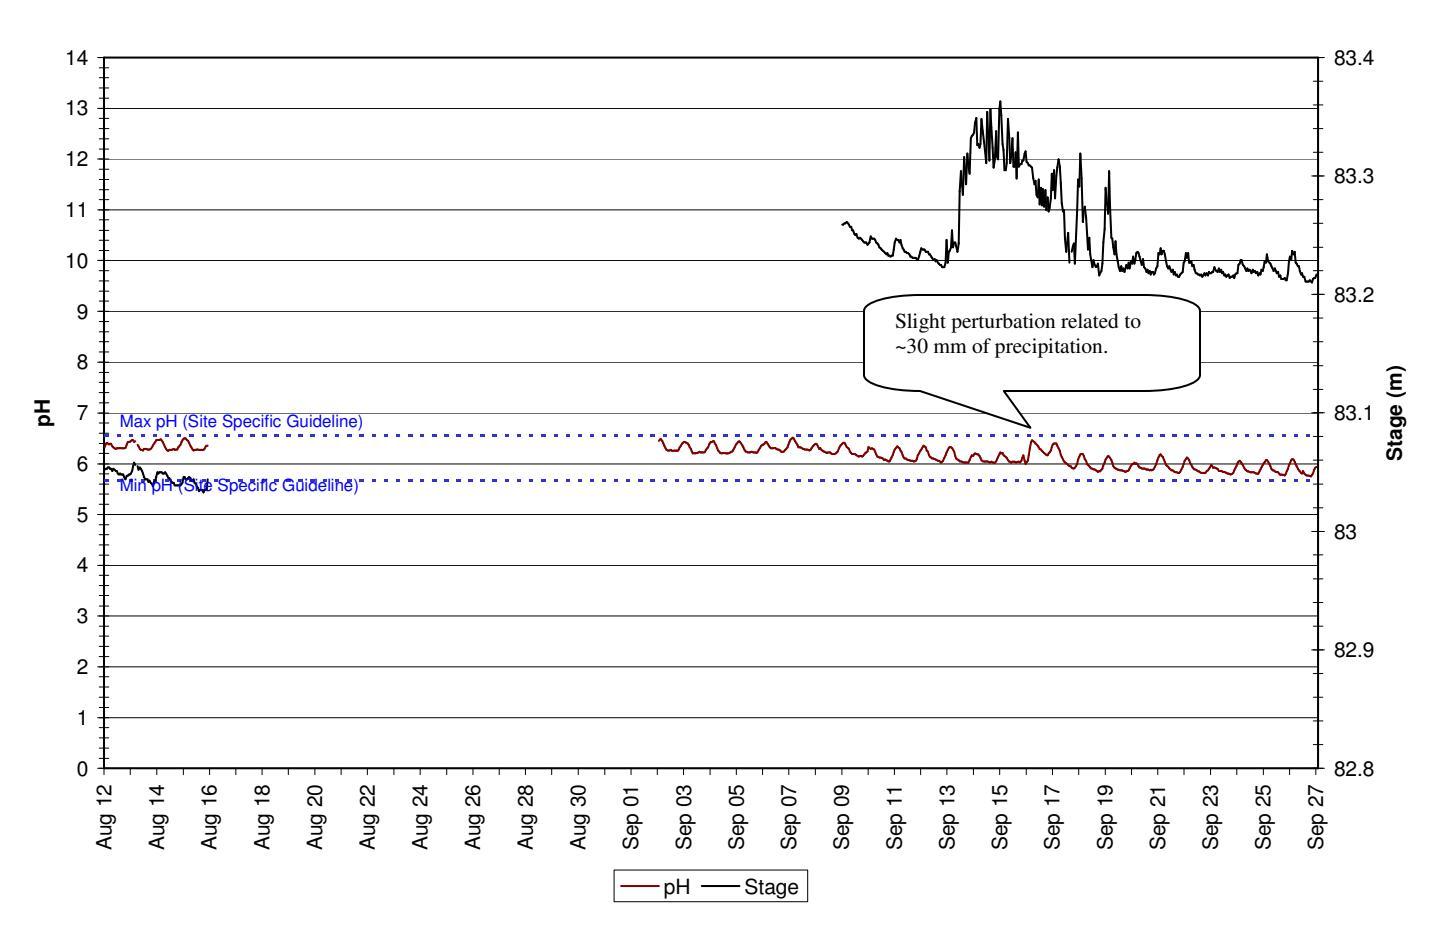
Figure 7: pH at Rattling Brook below Bridge from August 12th to September 27th, 2011

Water pH and Stage Level

- pH values appear to present a declining trend falling from near the upper Site Specific Guideline at deployment to near the lower guideline by removal in late September.
- pH ranged from 5.75 to 6.51 units (entirely within the guidelines) and had a median value of 6.18 pH units. No major fluctuations were recognised during the deployment.

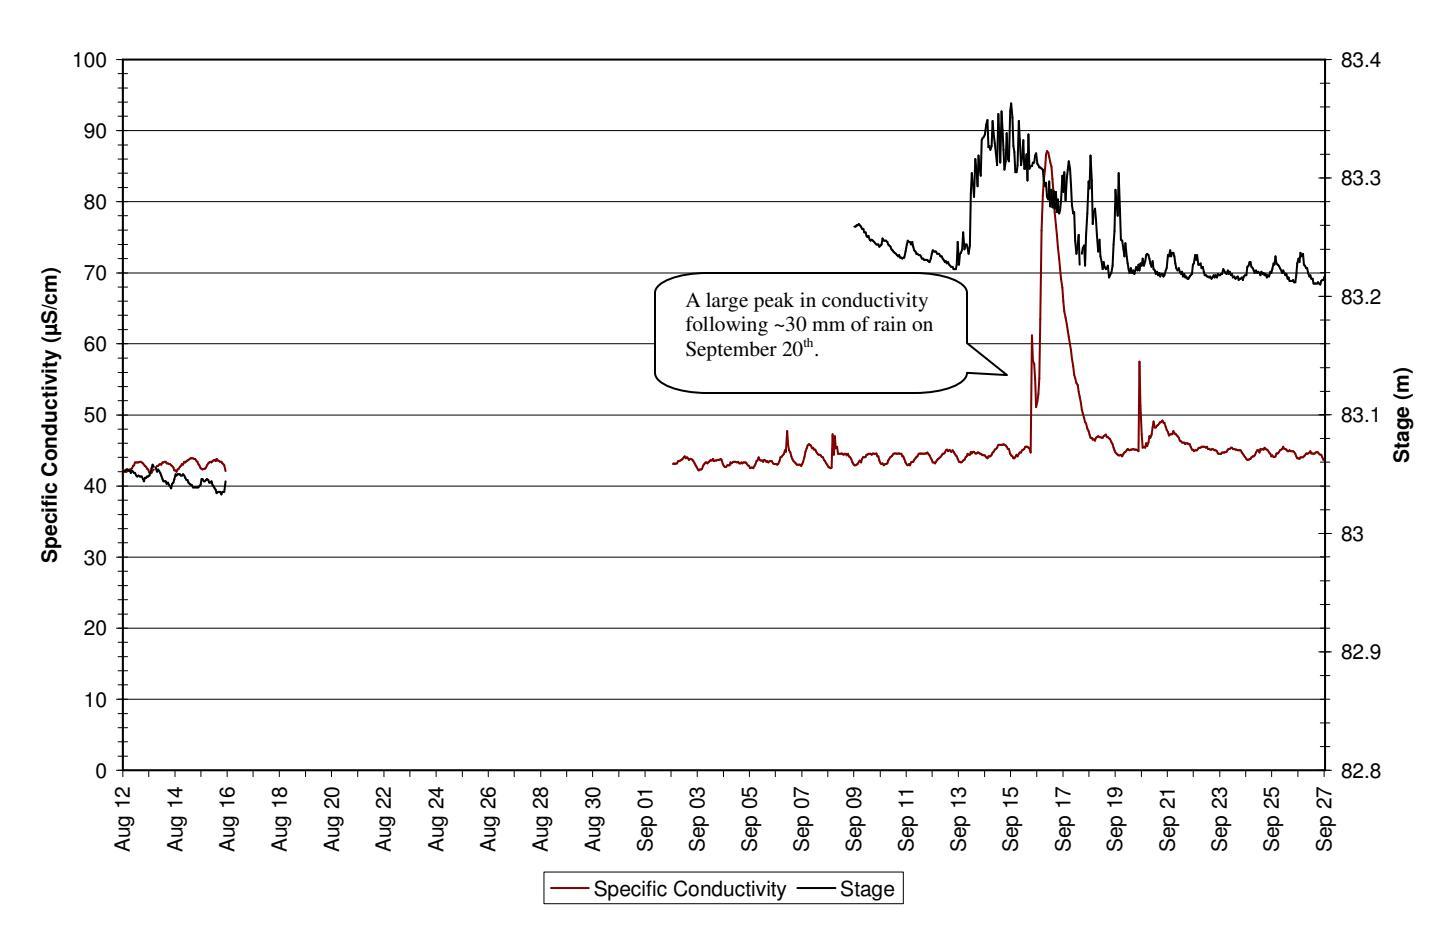
Figure 8: Specific Conductivity at Rattling Brook below Bridge from August 12th to September 27th, 2011

Specific Conductivity of Water and Stage Level

- The latter part of this deployment period follows the addition of large quantities of spawning gravel to the river in the Bridge station area. The addition of gravel will naturally increase the conductivity of the water in the area since gravel will normally carry fine silt and salts.
- During the same time period in 2010, a median conductivity value of 39.0 μ S/cm was found while this year, the median value was found to be 44.4 μ S/cm (Min: 41.9 μ S/cm, Max: 87.1 μ S/cm).
- On September 20th, with the increase in flow through this section of Rattling Brook, a large peak in conductivity was present. It is expected that, as time goes on, settling and washing of the new rock layer will reduce the elevated conductivity.

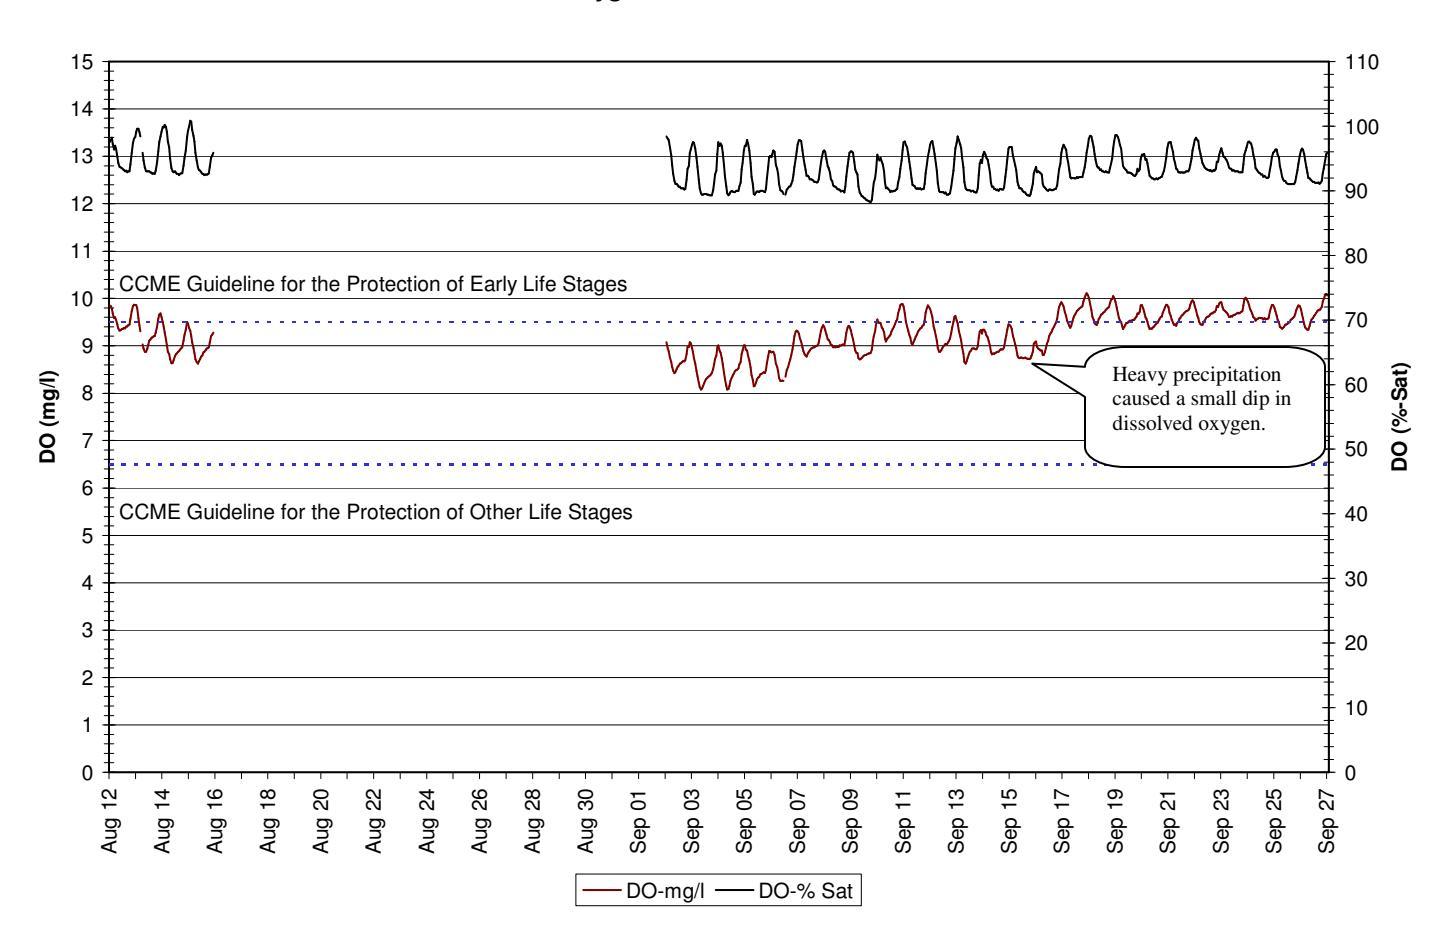
Figure 9: Dissolved Oxygen at Rattling Brook below Bridge from August 12th to September 27th, 2011

Dissolved Oxygen Concentration and Saturation

- An upward trend in dissolved oxygen was observed following the redeployment of Bridge station following the completion of habitat compensation work. A small interruption of the trend occurred in relation to heavy rain on September 20th.
- Dissolved oxygen concentrations ranged from 8.08 to 100.8 mg/l with a median 9.32 mg/l.

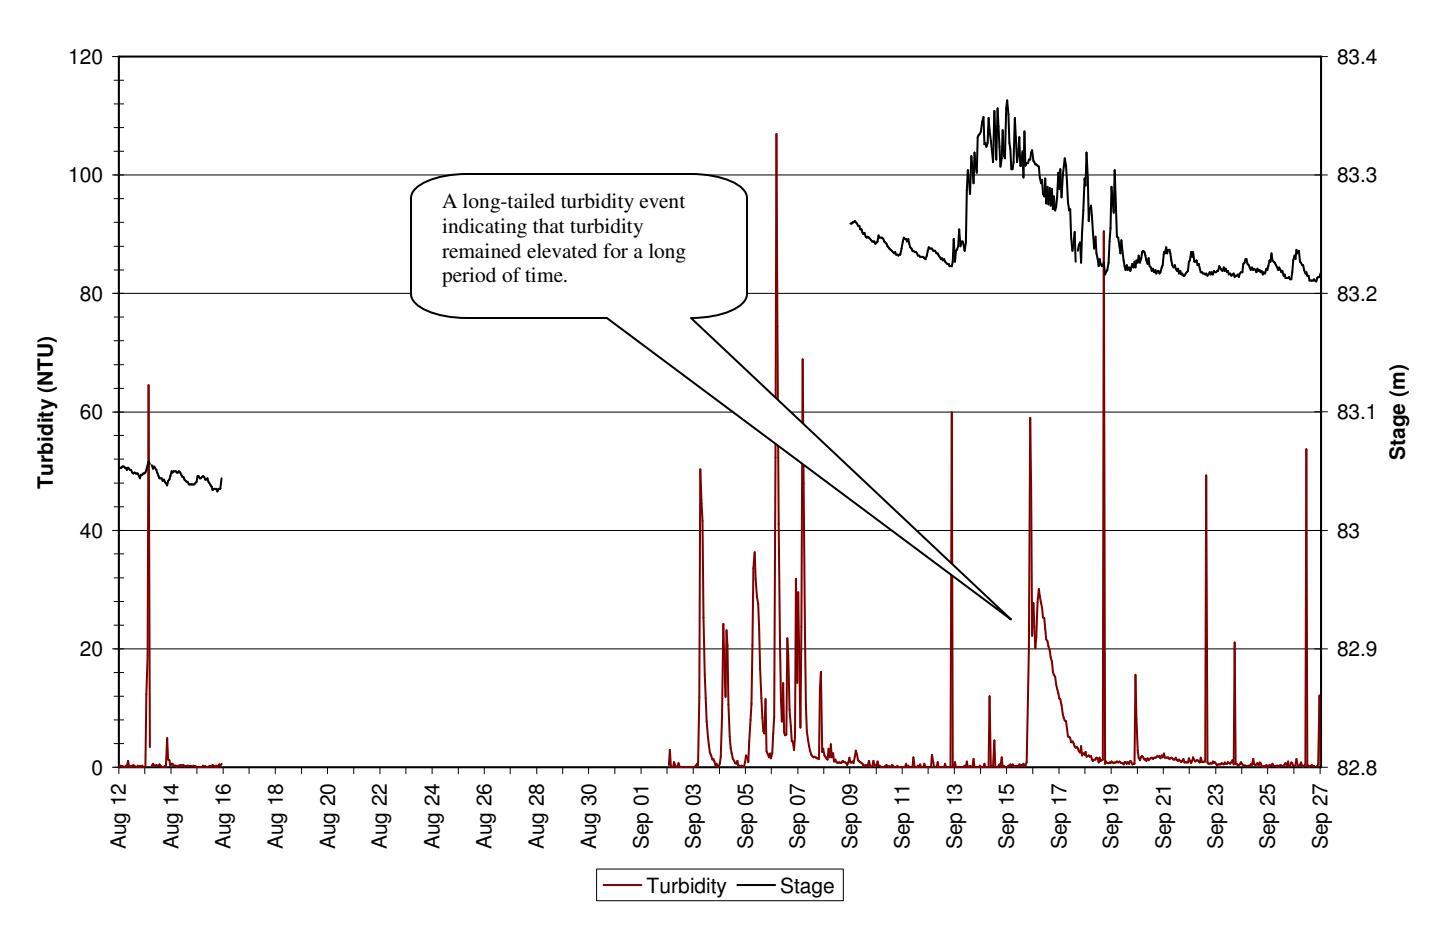
Figure 10: Turbidity at Rattling Brook below Bridge from August 12th to September 27th, 2011

Water Turbidity and Stage Level

- As expected, following major work on the stretch of Rattling Brook where Bridge station resides, turbidity conditions were highly erratic with frequent occurrence. As the spawning gravel that was laid down during the habitat compensation work settles and fines are washed out of the streambed, turbidity events such as this are expected to return to normal.
- Values ranged from 0.0 to 106.9 NTU with a median value of 0.6 NTU. Such a low median value indicates that turbidity events, though high in some cases, quickly return to baseline levels.

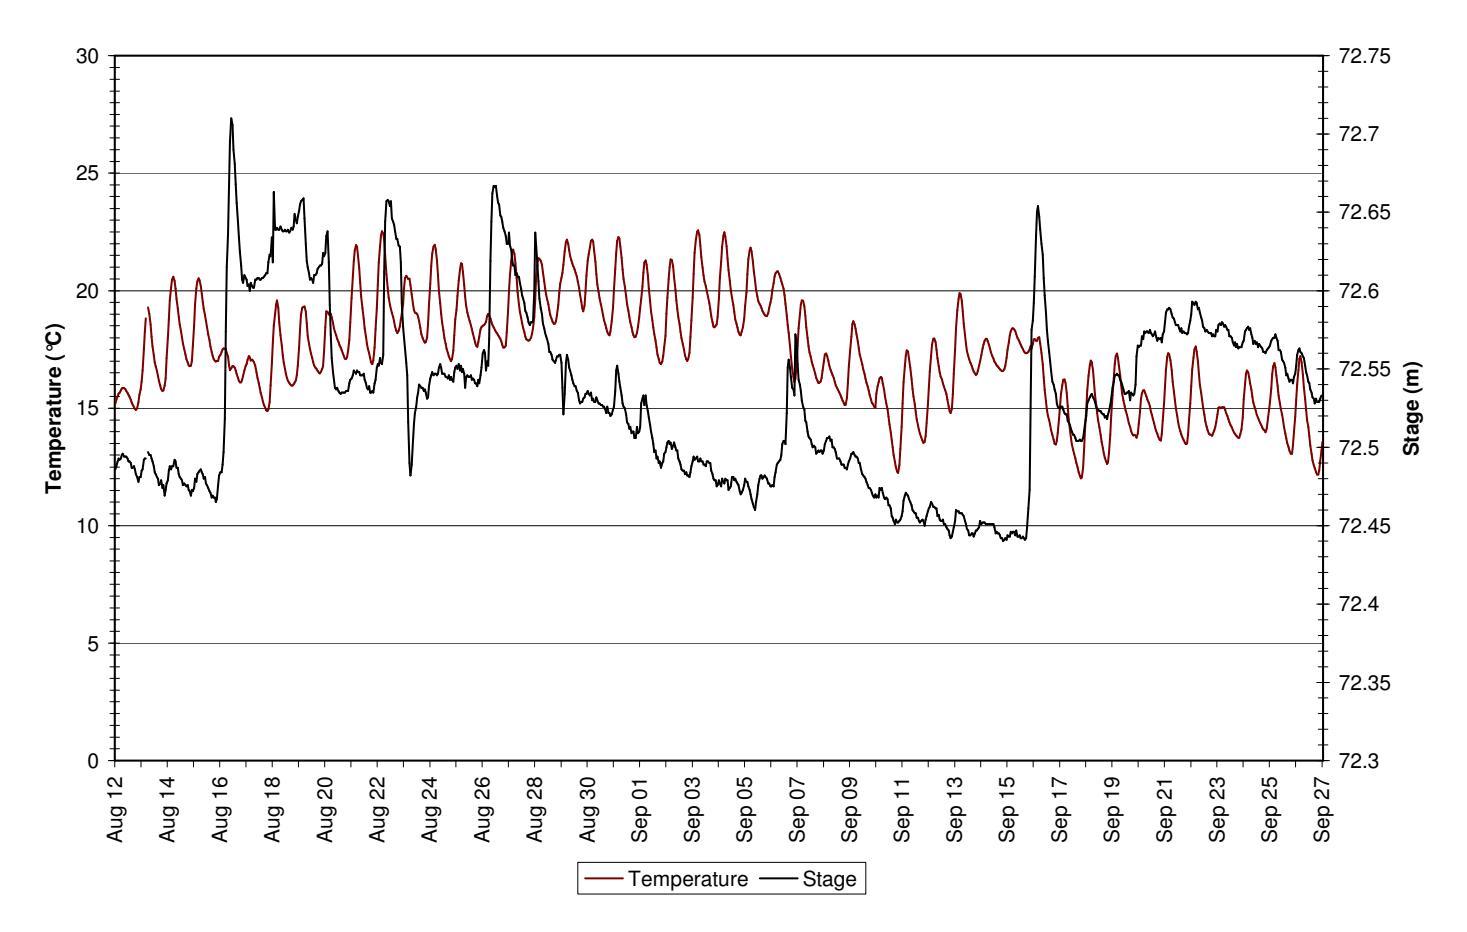
Water Temperature and Stage Level

• Water temperatures ranged from 22.56 to 12.01°C during this deployment period. A downward trend has begun as fall approaches and ambient air temperature decreases.

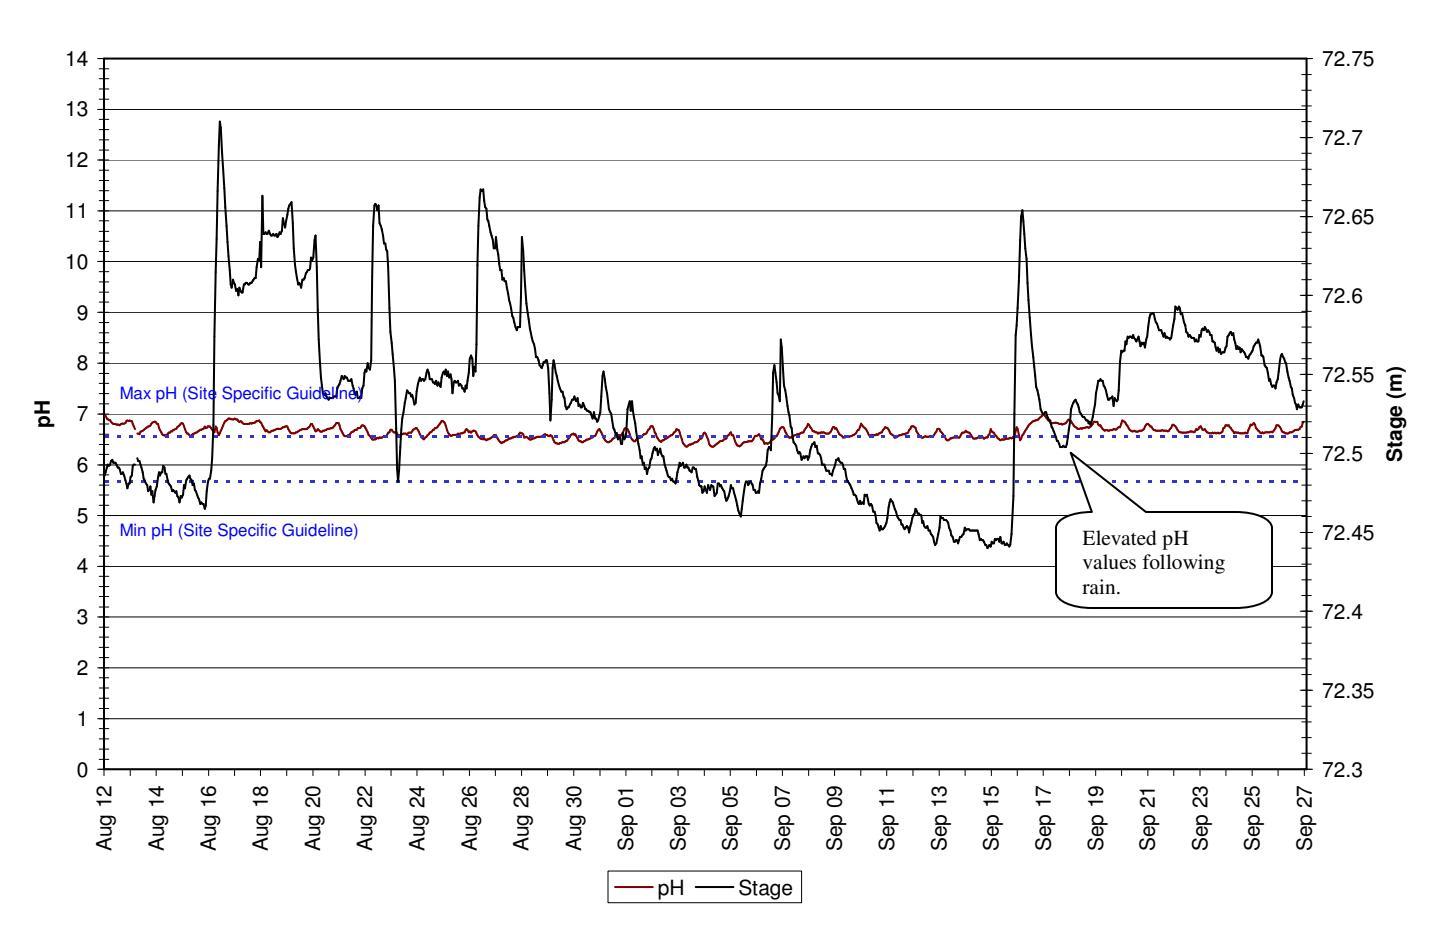
Figure 12: pH at Rattling Brook below Plant Discharge from August 12th to September 27th, 2011

Water pH and Stage Level

- pH at Plant Discharge station hovered at and just above the upper Site Specific Guideline for the Rattling Brook network. Values ranged from 6.35 to 6.99 with a median value of 6.64 units.
- After the large precipitation event on September 20th, pH remained elevated for the remainder of the deployment.

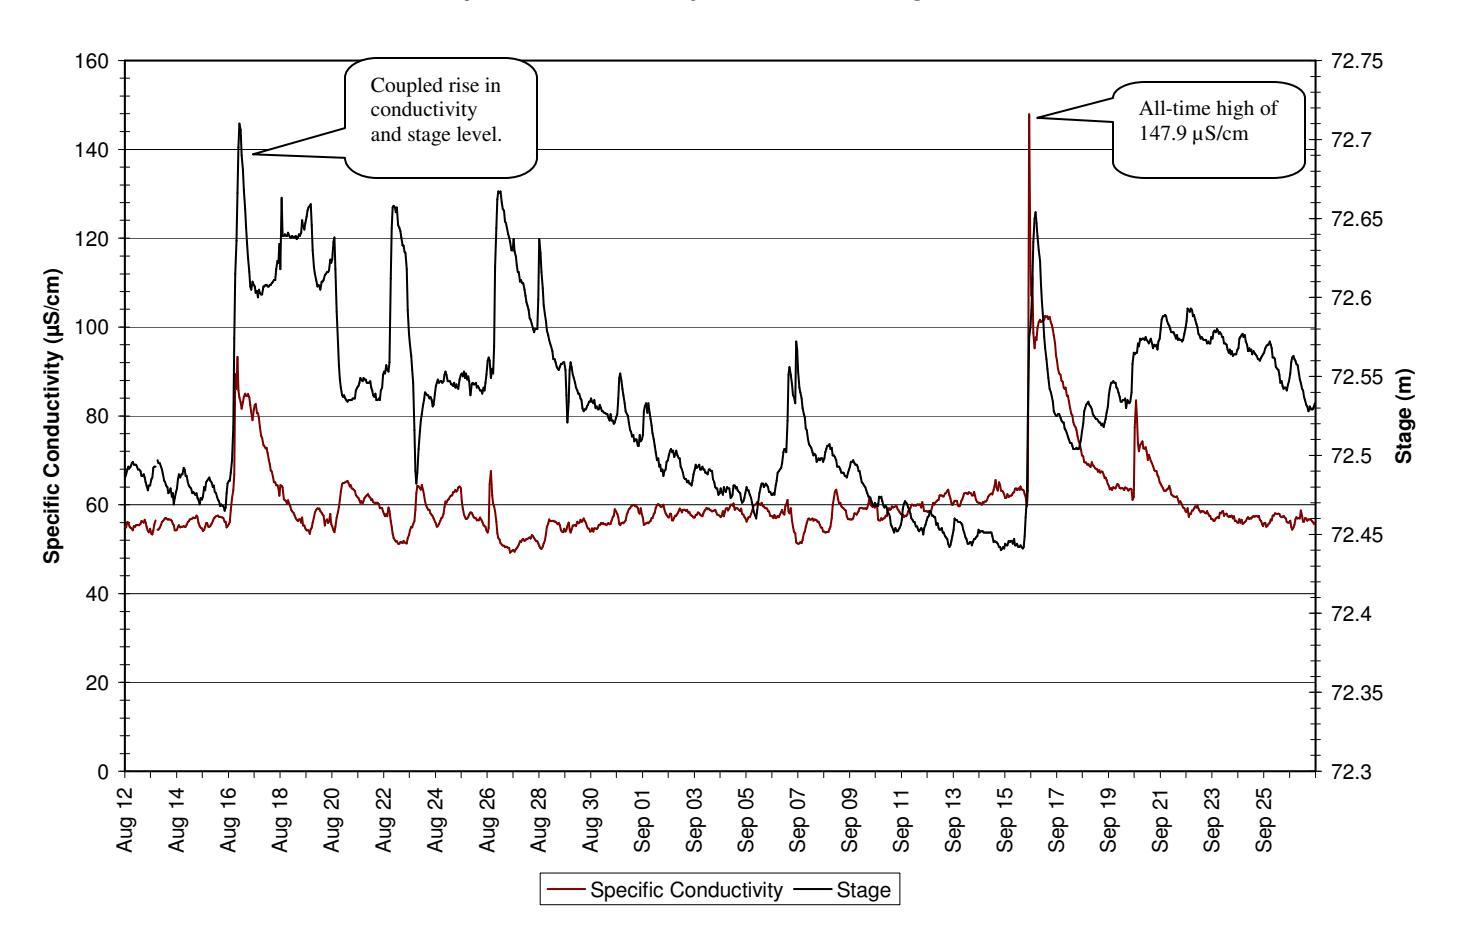
Figure 13: Specific Conductivity at Rattling Brook below Plant Discharge from August 12th to September 27th, 2011

- Aside from peaks in conductivity, a general rise in values over the course of the deployment period is apparent. Two large peaks in conductivity dominate the deployment period and are associated with precipitation on August 16th and September 20th.
- Values ranged from 49.2 to 147.9 μ S/cm with a median of 58.3 μ S/cm. On September 16th at 10:30 am, conductivity reached the highest value ever recorded at this station 147.9 μ S/cm.

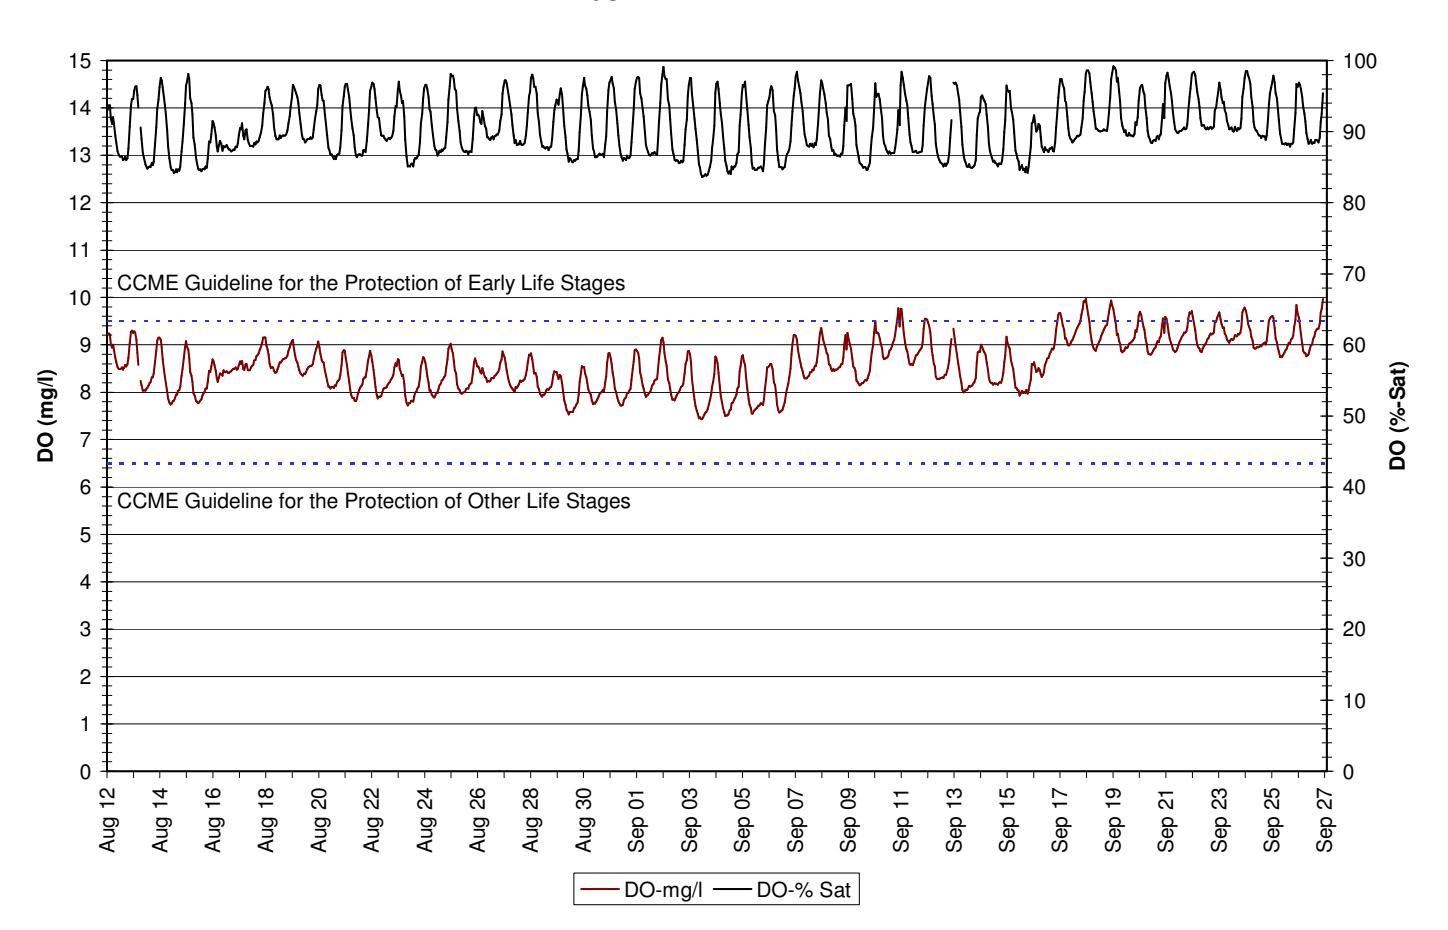
Figure 14: Dissolved Oxygen at Rattling Brook below Plant Discharge from August 12th to September 27th, 2011

Dissolved Oxygen Concentration and Saturation

Dissolved oxygen increased overall during this deployment period and fell between 7.44 and 9.97 mg/l (median: 8.54 mg/l). All values were above the critical CCME Guideline for the Protection of Other Life Stage cold water biota. No particular events occurred regarding DO that is of concern.

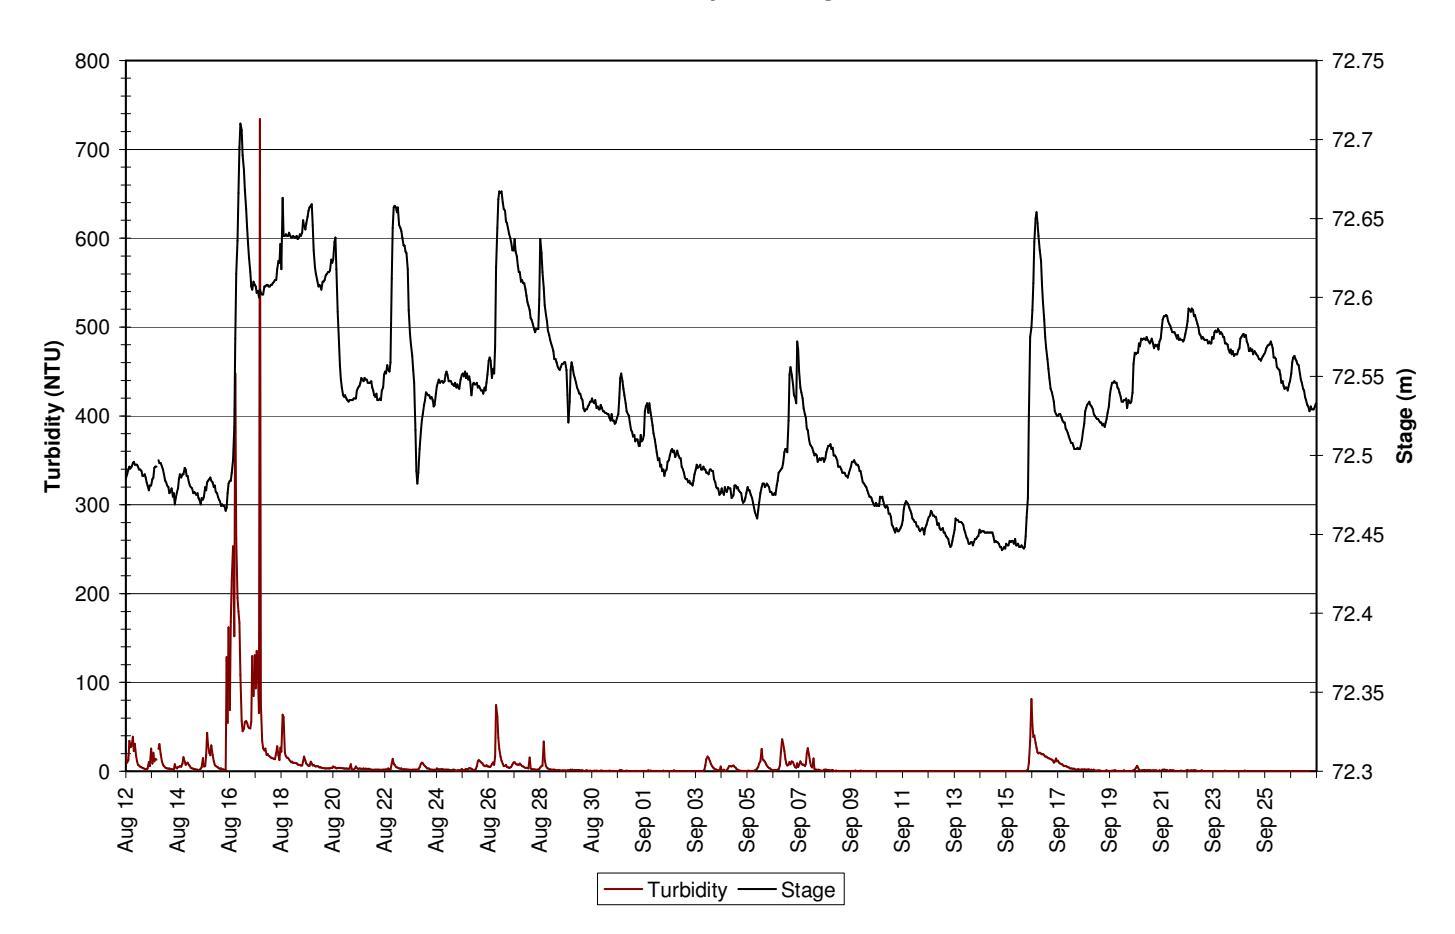
Figure 15: Turbidity at Rattling Brook below Plant Discharge from August 12th to September 27th, 2011

Water Turbidity and Stage Level

- Turbidity values were similar in scope to those found at Bridge station during this deployment period. Values ranged from a low of 0.0 NTU to a maximum of 734.0 NTU (median: 1.4 NTU).
- On August 16th very heavy rainfall caused a series of sustained high-level turbidity periods.
