#### Real Time Water Quality Monthly Report Waterford River - St. John's NL September 2009

# Maintenance and Calibration of Instrumentation

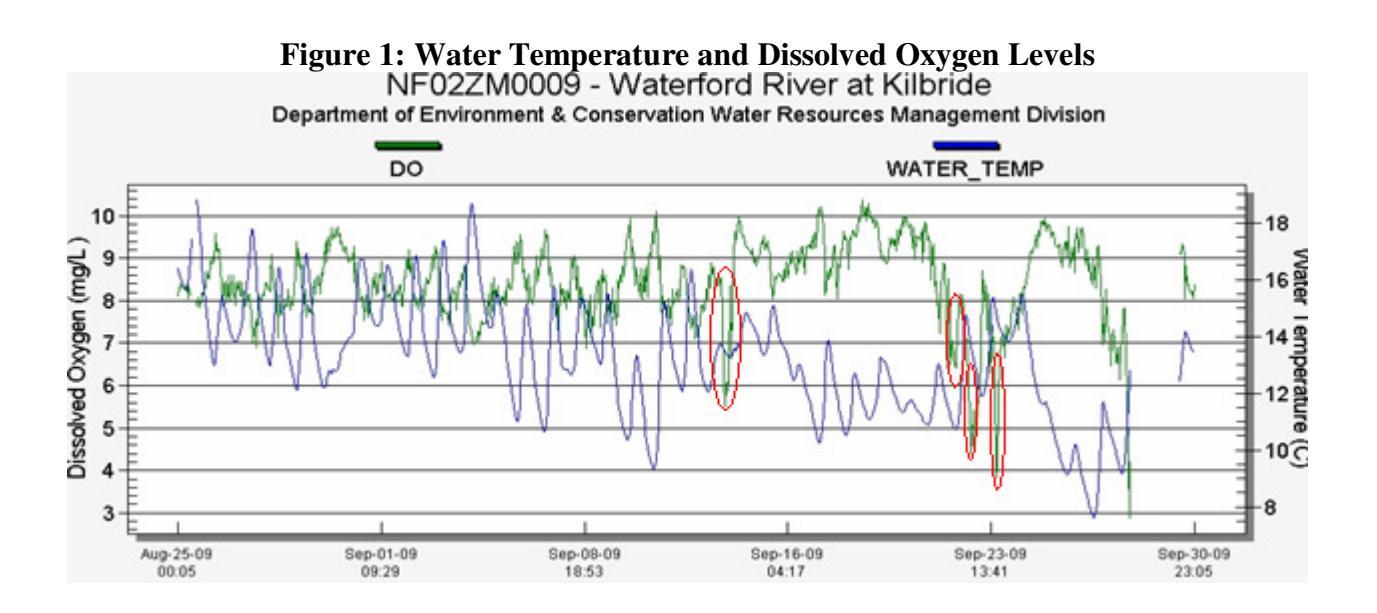
- Water temperature is shown in blue in Figure 1 below. Water temperatures fluctuated in response to daily maximum and minimum air temperatures during this deployment. This is illustrated by comparing the graph in Figure 1 below, to the air temperature data in Appendix 1 at the end of this report. Water temperatures ranged between 7.62 and 18.79°C, which is within the expected range for this station at this time if year.

- The inverse relationship between dissolved oxygen(DO) levels and water temperature is demonstrated in **Figure 1** below (DO levels shown in green). Colder water has a greater capacity to hold DO than warmer water, which is clearly seen in **Figure 1**; when water temperatures (blue) decrease DO(green) increases proportionally. Three areas of the graph are highlighted in red to identify occurrences where DO levels dropped below the minimum guideline value of 6.5, as recommended in the Canadian Water Quality Guidelines for the Protection of Aquatic Life. These low oxygen values can be an indication of an adverse water quality event or debris lodged near the sensor. Both DO and water temperatures appear to bottom out at the end of the graph, but this is representative of the instrument being disconnected at the end of the deployment period.

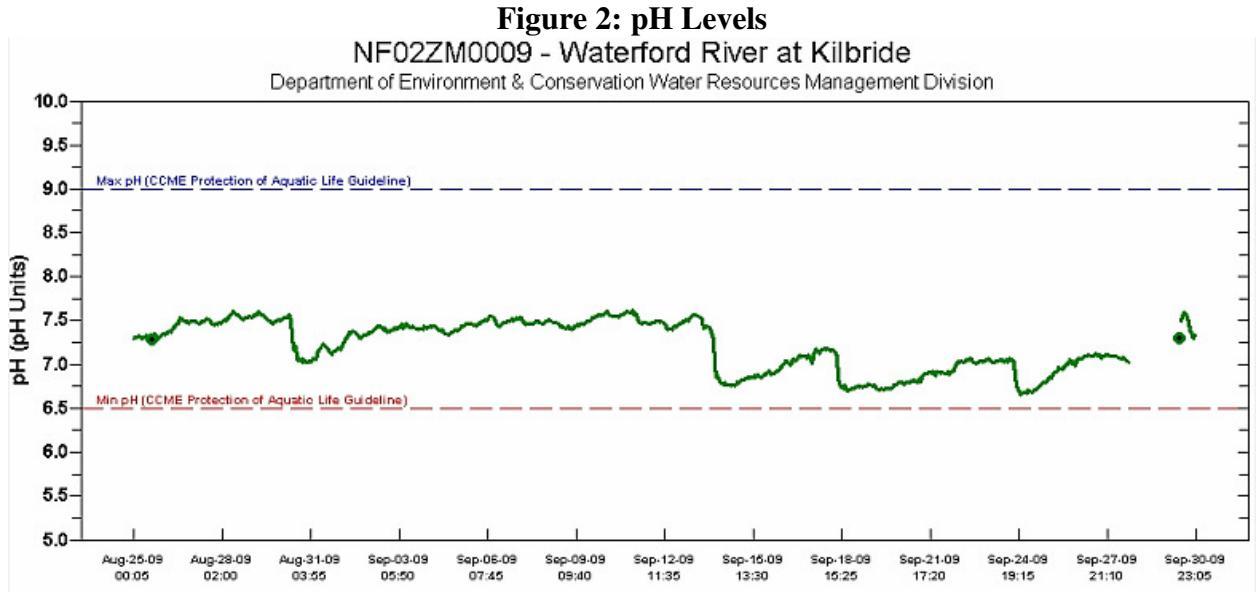
pH levels ranged from 6.65 to 7.62 units, as seen in Figure 2 below. All pH measurements during this deployment period were within the range recommended by the Canadian Water Quality Guidelines for the Protection of Aquatic Life of 6.5 to 9 pH units (Figure 2).

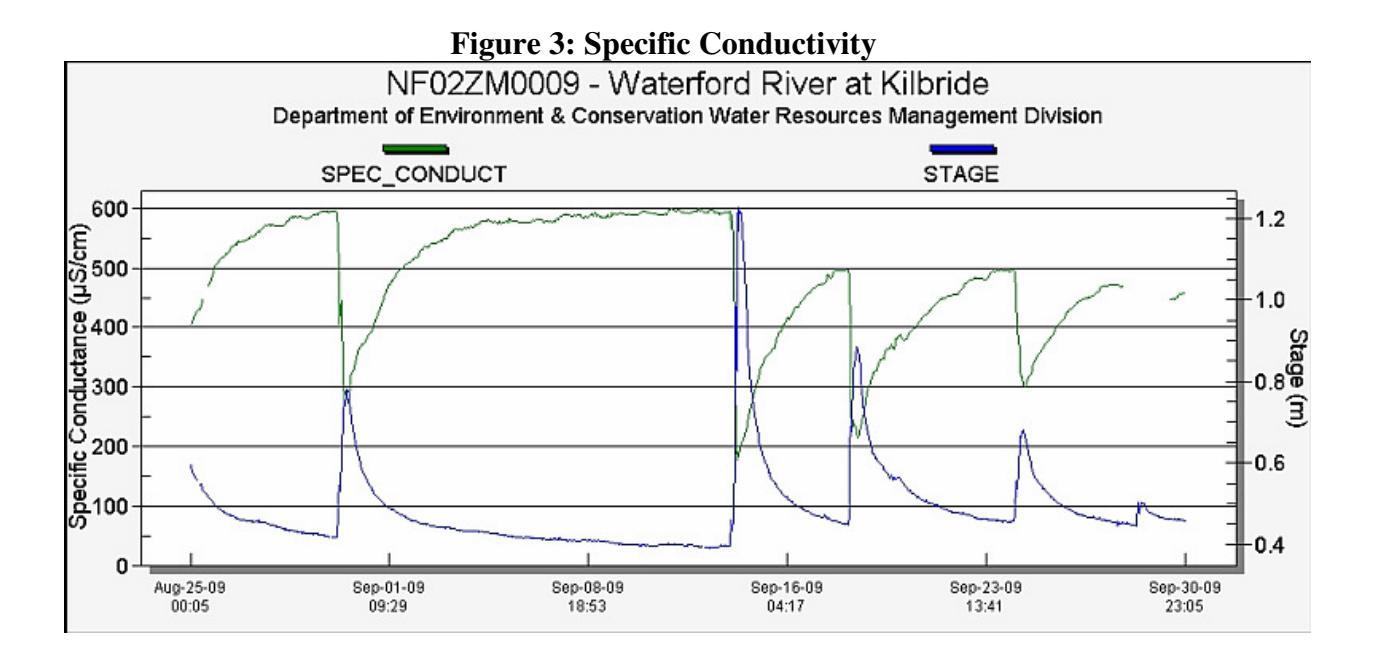
Specific conductivity levels were variable during this deployment, ranging from 176.4 to 600µS/cm, as seen in Figure 3. Sudden drops in conductivity levels generally correspond with rainfall events, with the rainfall having a dilution effect on conductivity, lowering its values. This relationship is clearly seen in Figure 3, as specific conductivity levels (green) change in response to changes in water levels (stage-blue). Stage levels increase as a result of precipitation events, which are shown in Appendix 1 at the end of this report. Specific conductivity values were in the expected range for this station at this time of year.

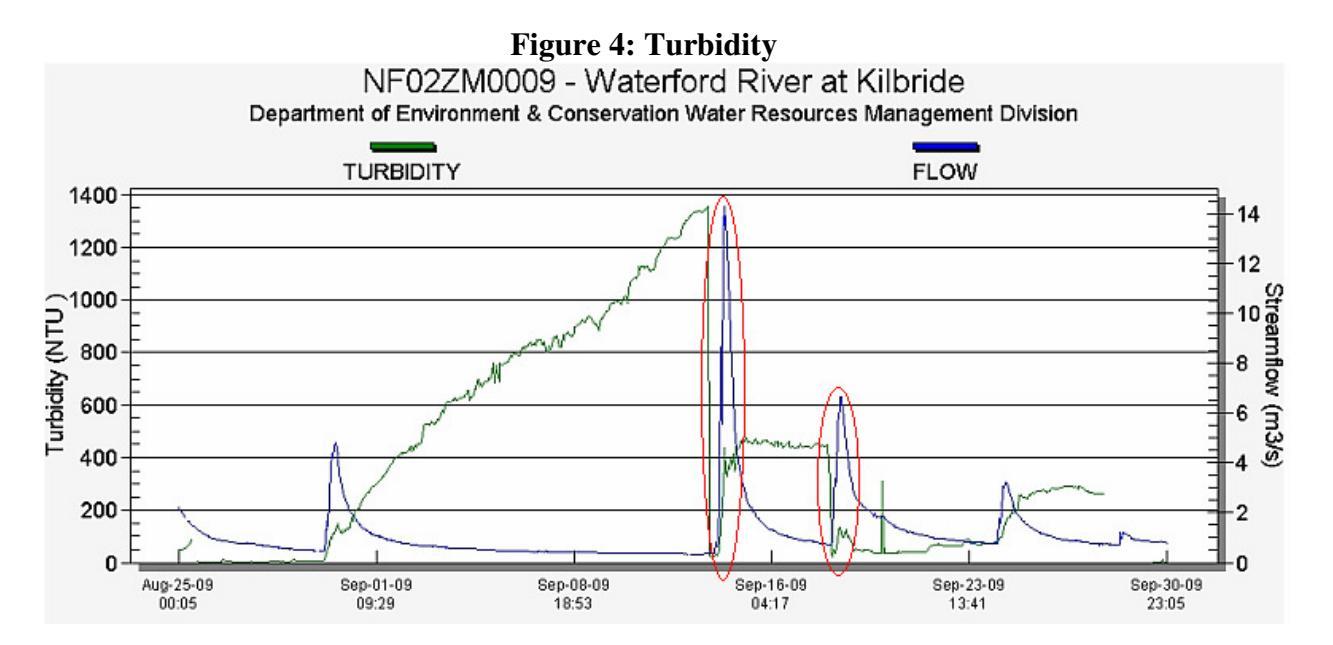
Turbidity values, shown in Figure 4 below, steadily increased from late August until mid-September, as seasonally low water levels and warm water temperatures provided optimum conditions for algal and macrophyte populations to flourish. A significant rainfall of 53mm on September 14 had a settling effect on suspended particles as turbidity values plunged to background levels. Increased flows that followed the heavy rainfall resulted in turbidity levels rising, until another rainfall of 31mm on September 18 triggered a sudden drop in turbidity. Turbidity values fluctuated between 0.7 and 1357 NTU during this deployment period.
