# **Real-Time Water Quality Report**

# **Outer Cove Brook Network**

Deployment Period December 19, 2013 to January 21, 2014

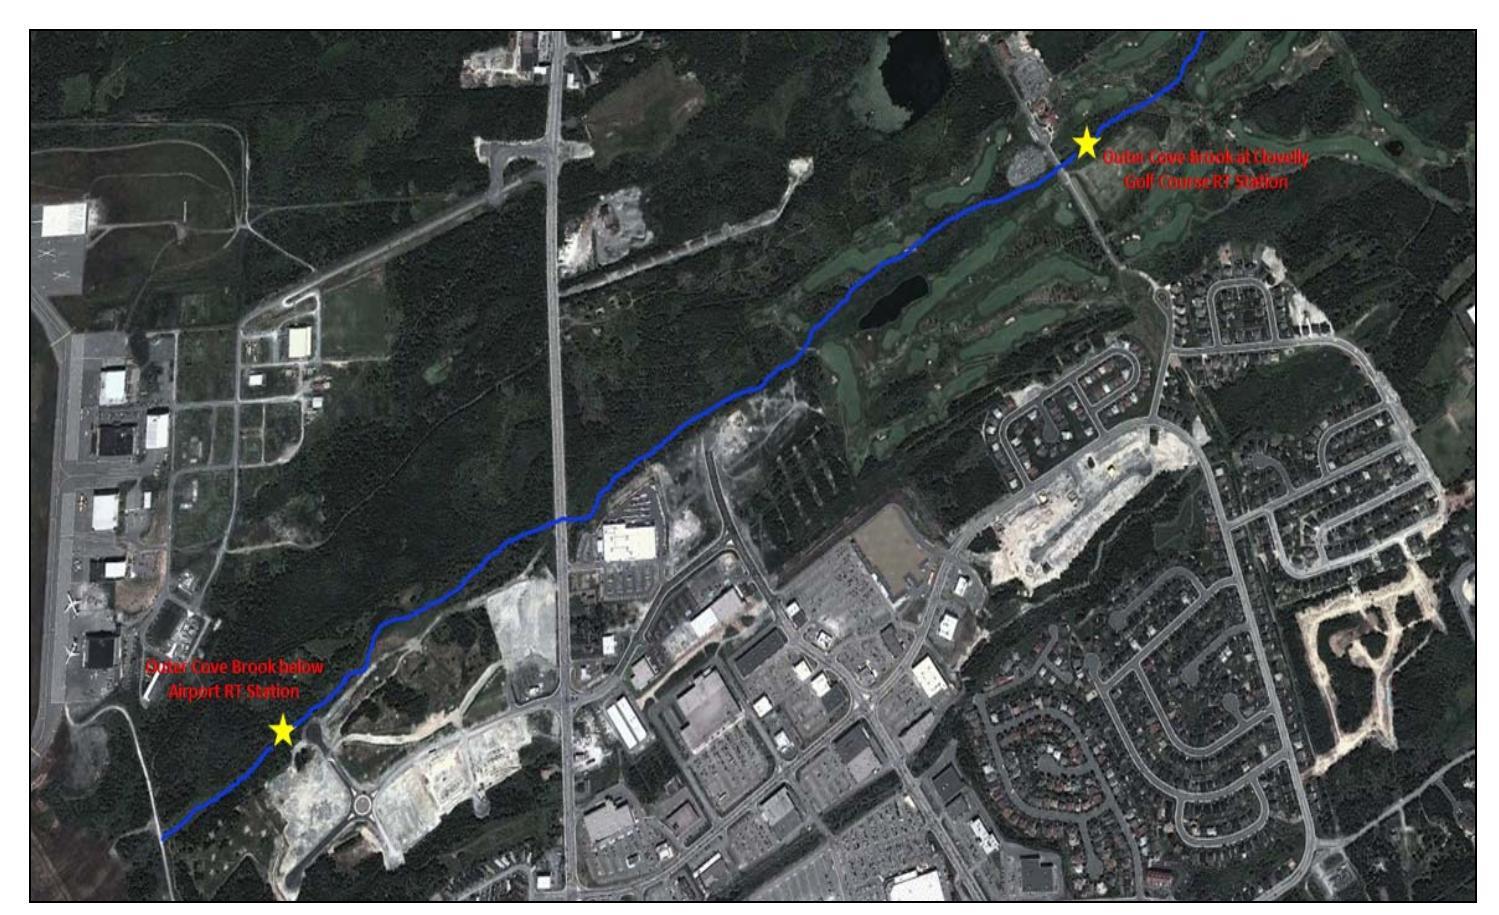
Figure 1: Outer Cove Brook Real-Time Water Quality and Quantity Stations.

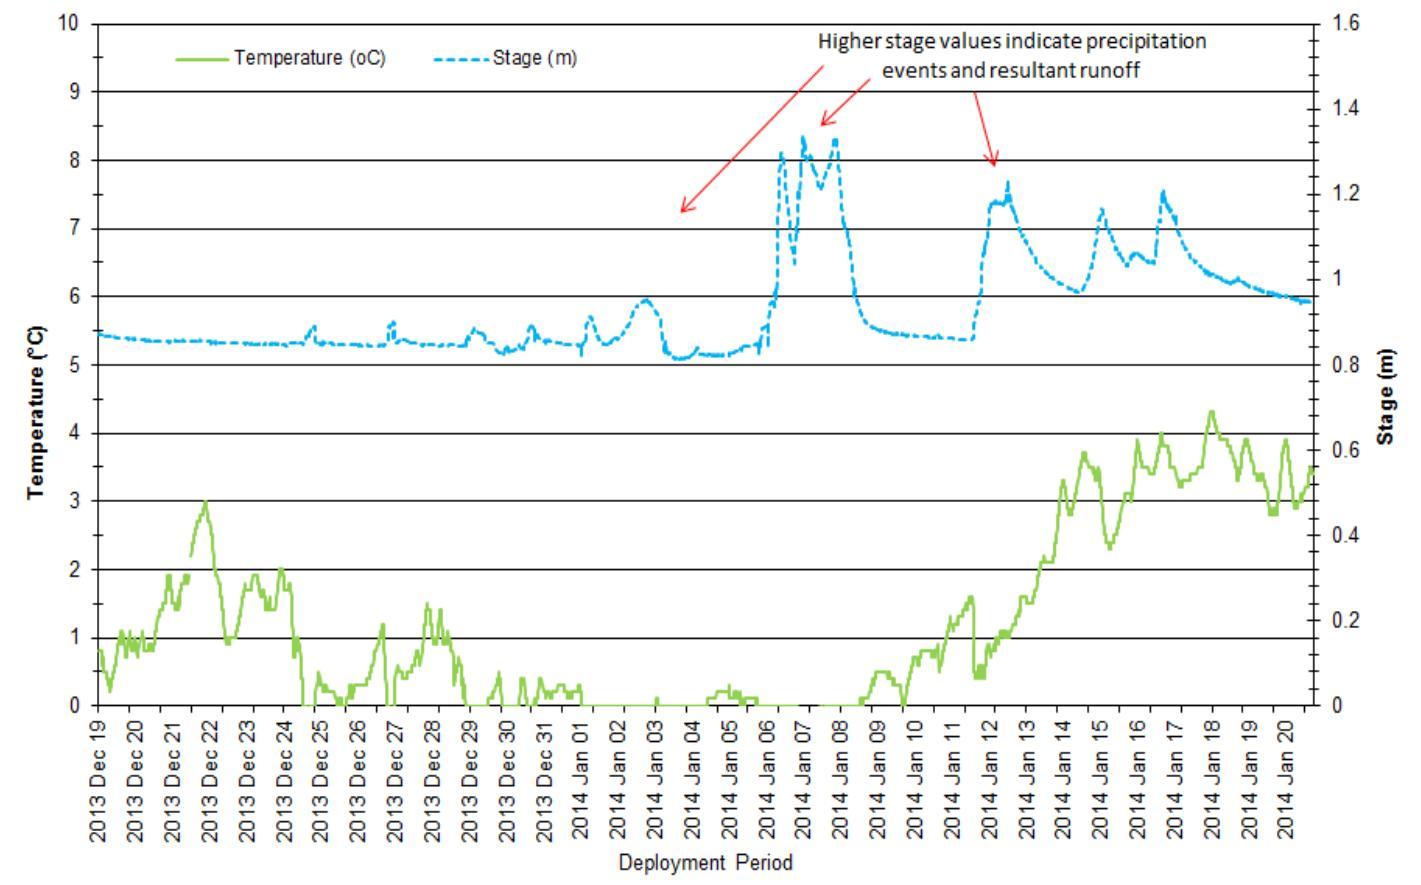
- Water temperature ranged from -0.1°C to 4.30°C during this deployment period (Figure 2).
- There are noticeable increases and decreases in the water temperature during the deployment period. This is consistent with ambient air temperatures over this time period, generally increasing during daylight hours and cooling overnight. During deployment, the temperature decreased to freezing before rising again near the end of deployment due to abnormally warm air temperatures.
- Water temperatures display diurnal variations, typical of shallow streams and ponds which are highly influenced by natural diurnal variations in ambient air temperatures.
- Water temperature is a very important parameter and it has the ability to influence other parameters that are measured by the water quality instrument.

Figure 2: Quarter-hourly water temperature (°C) and stage level (m) values at Outer Cove Brook below Airport for the deployment period December 19, 2013 to January 21, 2014.

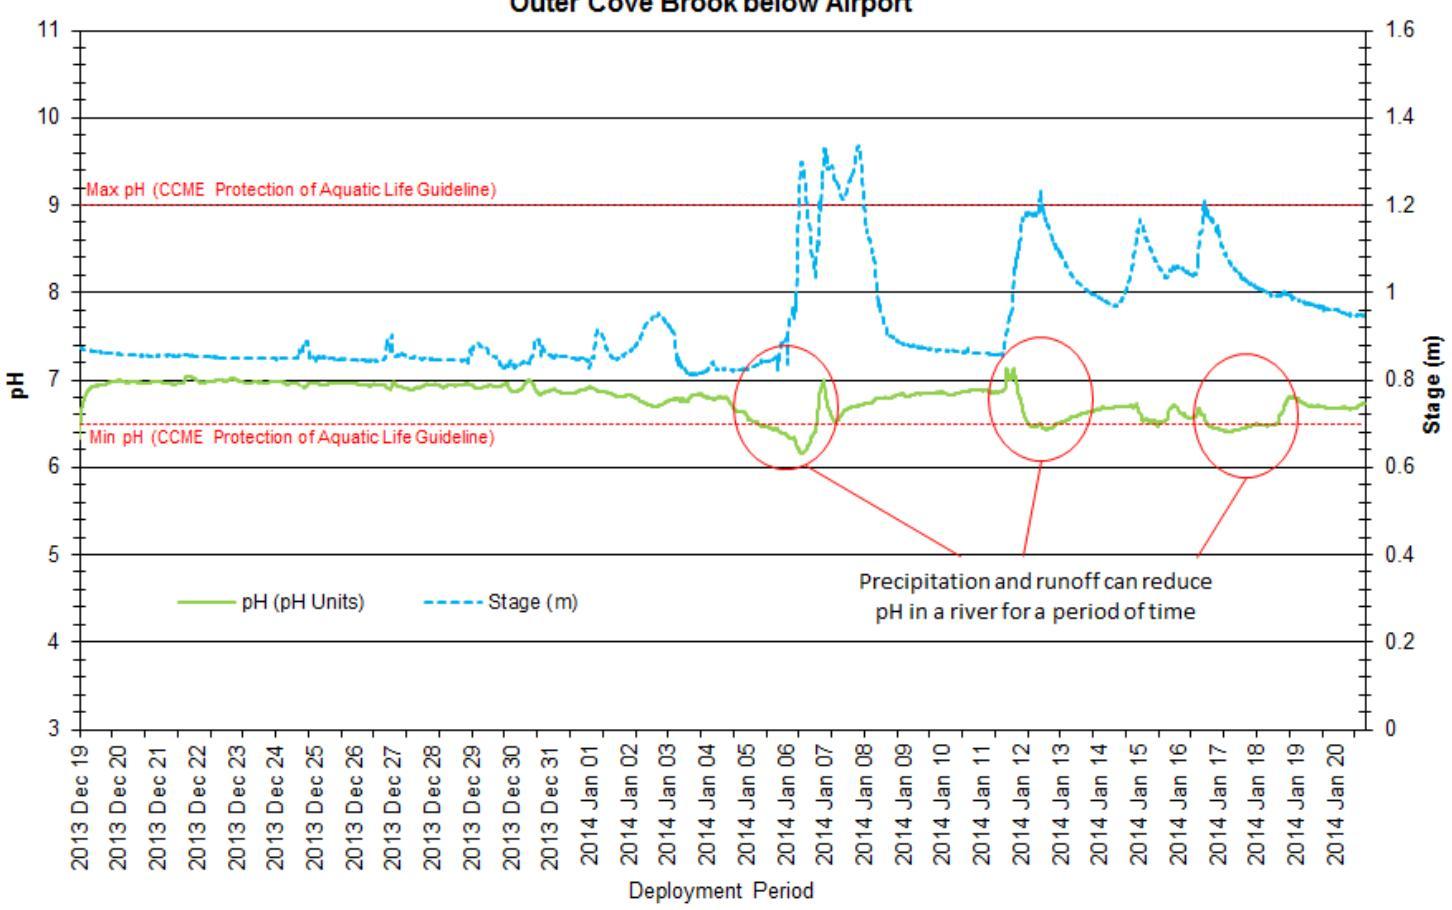
- Throughout this deployment period pH values ranged between 6.16 pH units and 7.14 pH units (Figure 3). The maximum value is notably higher than during previous deployments.

- During the deployment, the pH values at this station are above the minimum CCME Guideline for the Protection of Aquatic Life (between 6.5 and 9 pH units) for the majority of the deployment, dropping below the guideline after precipitation events such as those on January 6<sup>th</sup>, 12<sup>th</sup> and 17<sup>th</sup> (Figure 3). This is a natural occurrence between rainfall and pH levels.

- The CCME guideline provides a basis by which to judge the overall health of the brook. Naturally, all streams and brooks are different. In the case of Outer Cove Brook below Airport, pH during this deployment remained around 7.00 pH units, which is high for this stream, dipping lower during precipitation events, which is normal.

Figure 3: Quarter-hourly pH (pH units) and stage level (m) values at Outer Cove Brook below Airport for the deployment period December 19, 2013 to January 21, 2014.

- A similar high pH trend was noted during March-April 2013, and was suspected to be due to a discharge into the brook upstream of the station. The station will be monitored closely and the possible inputs will be investigated further.

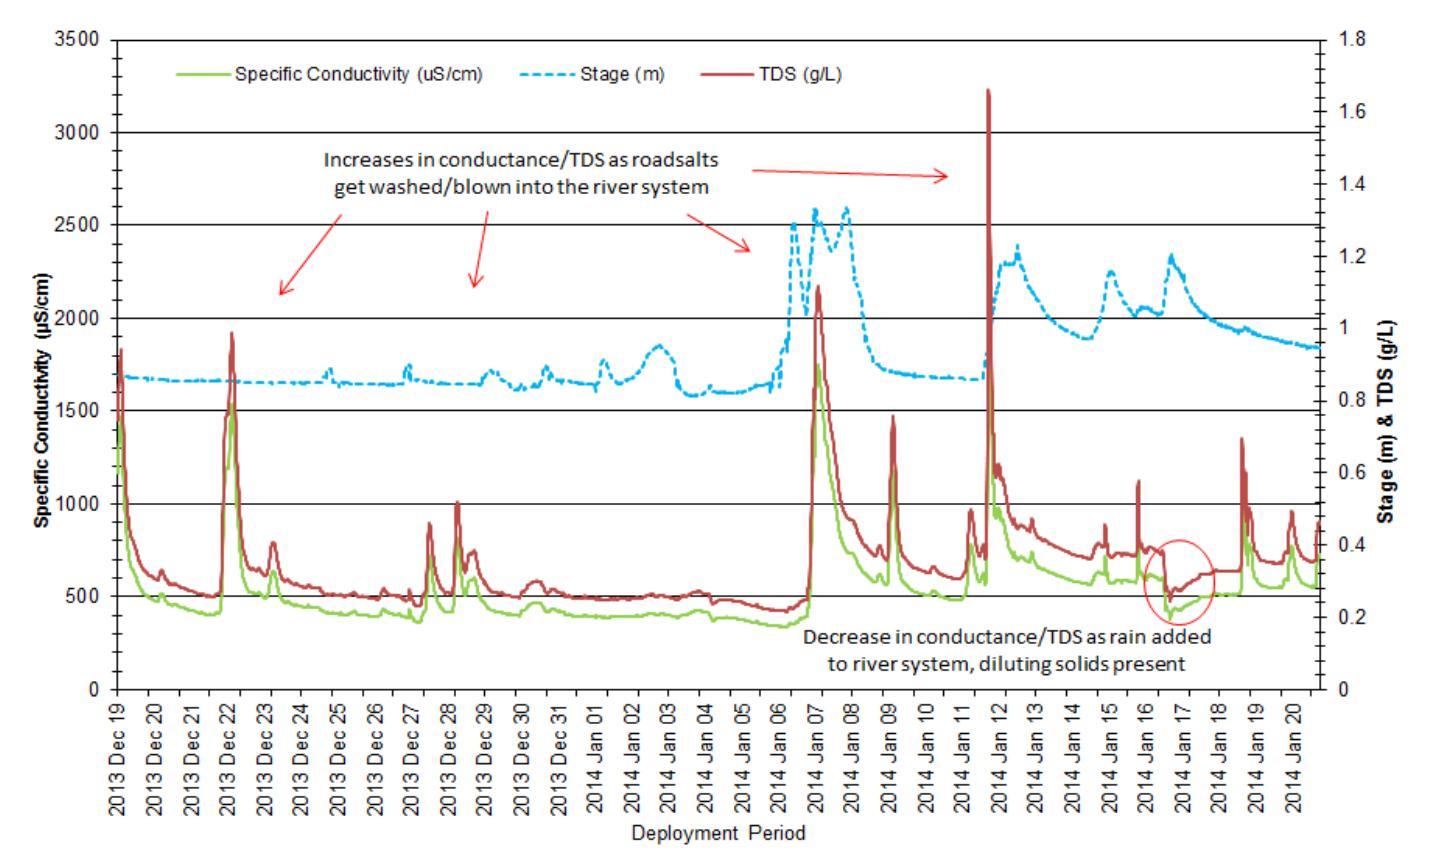
- The conductivity levels were within 337 µS/cm and 2600 µS/cm during this deployment period. TDS ranged from 0.2150 g/L to 1.6600 g/L. These values are notably higher than those of the previous deployment period.

- Generally, rainfall events, such as that which occurred on January 17<sup>th</sup> (Figure 4), can have the effect of diluting and lowering conductance levels. When stage levels rise, the specific conductance levels drop in correlation as the increased amount of water in the river system dilutes the solids present there, thus generally decreasing the specific conductivity readings.

- Cold temperatures and snowfall events during winter months can have the effect of increasing conductance levels due to the addition of salt to roadways. Through wind, snowmelt and rainfall, these salts are carried into the water system, increasing the specific conductance. The increases on December 22<sup>nd</sup> and January 12<sup>th</sup> are in response to cold winter temperatures.

Figure 4: Quarter-hourly specific conductivity (µS/cm), TDS (g/L) and stage (m) values at Outer Cove Brook below Airport for the deployment period December 19, 2013 to January 21, 2014.

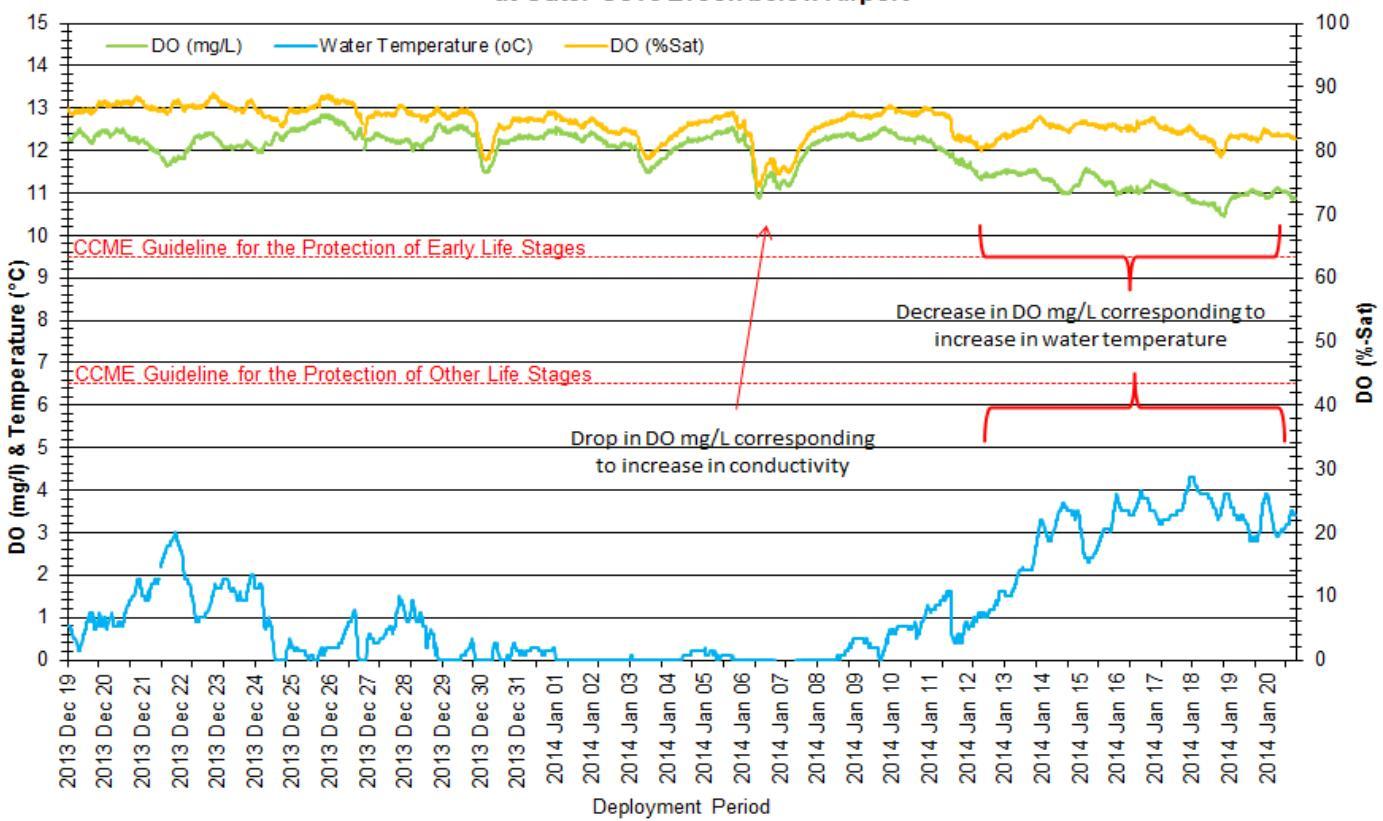
- The instrument measures dissolved oxygen (mg/L) directly then calculates percent saturation (% Sat.).
- The Dissolved Oxygen % Sat levels within this deployment period were within 74.3% Sat–88.9% Sat. Dissolved Oxygen (mg/L) measured 10.46 mg/L to 12.85 mg/L. Water temperatures were cooler during this deployment period, resulting in higher oxygen levels.

- The DO mg/L values are above the minimum DO CCME guideline for early life stages throughout this deployment period (Figure 5), as the colder water during winter months can hold more oxygen. There is a notable decrease in oxygen mg/L values near the end of the deployment when water temperatures were warmer, thus decreasing the oxygen values.

- A drop in dissolved oxygen on January 6-7<sup>th</sup> corresponds to a sharp increase in conductivity at this time. The decrease is likely due to the large amount of salts present in the brook, lowering the amount of oxygen the water can hold.

- Dissolved Oxygen percent saturation remains relatively constant throughout the deployment period. Dissolved oxygen mg/L content fluctuates with the water temperature changes. Small decreases in dissolved oxygen values are inversely related to increases in water temperature as warmer water can hold less oxygen.

Figure 5: Quarter-hourly dissolved oxygen (mg/L & % sat) and water temperature (°C) values at Outer Cove Brook below Airport for the deployment period December 19, 2013 to January 21, 2014.

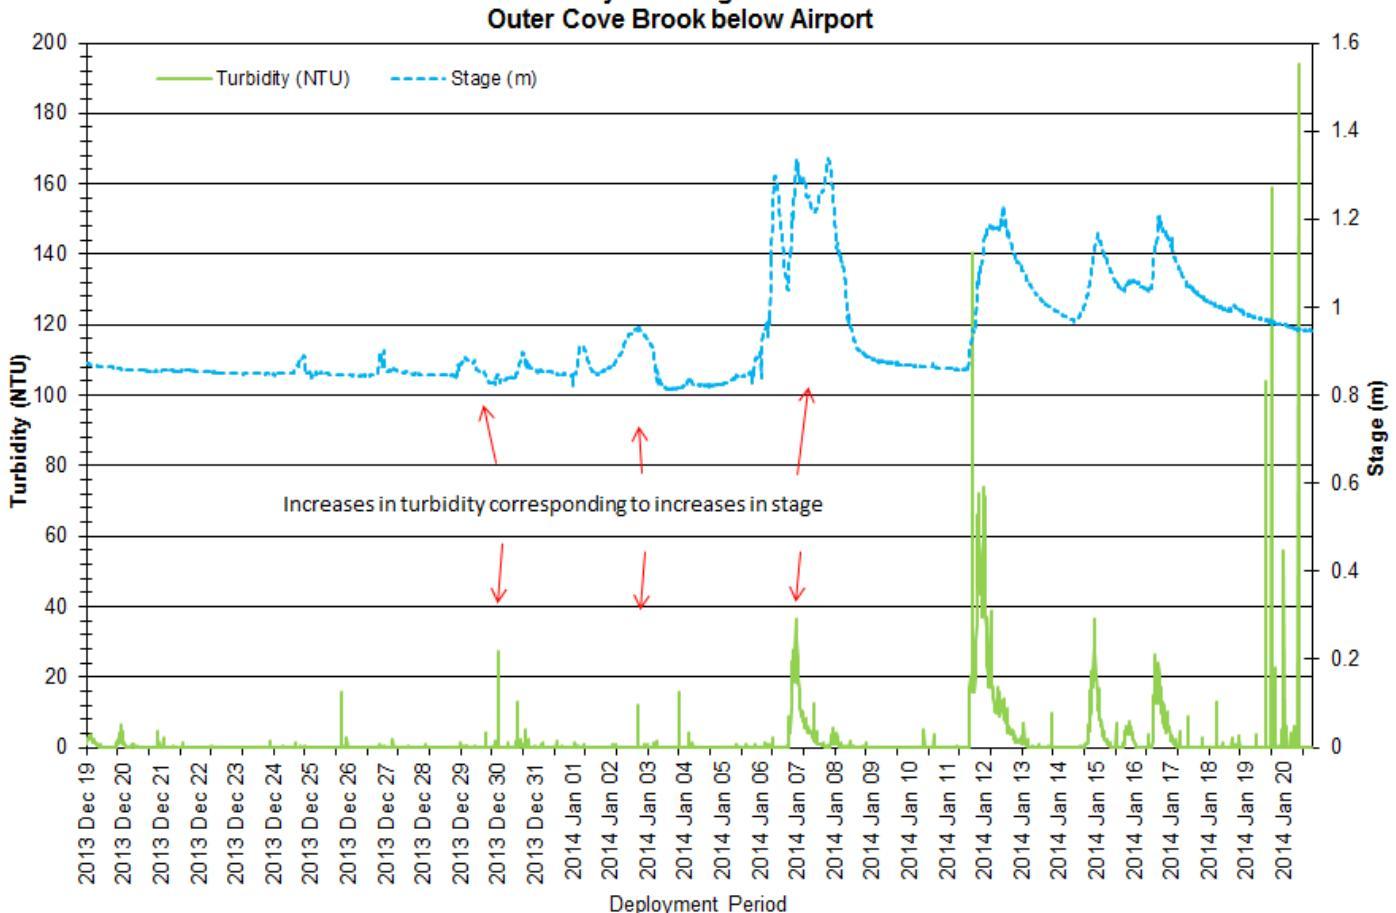
- Outer Cove Brook below Airport contains a significant amount of algae. High algal growth, biofouling, or leaf and grass debris can interfere with turbidity measurements as they block the sensor.
- The turbidity sensor can read a turbidity value between 0 NTU and 3000 NTU. If a reading hits 3000NTU it is identified as an error reading and thus is not a true turbidity value.
- The turbidity readings during this deployment ranged within 0.0 NTU to 194.2 NTU (Figure 6).
- Several precipitation events and corresponding stage increases led to fluctuating turbidity values (see Figure 6) as sediment and debris were resuspended into the water column. Sudden increases in turbidity for single readings may indicate debris is blocking the turbidity sensor.

Figure 6: Quarter-hourly turbidity (NTU) and stage level (m) values at Outer Cove Brook below Airport for the deployment period December 19, 2013 to January 21, 2014.

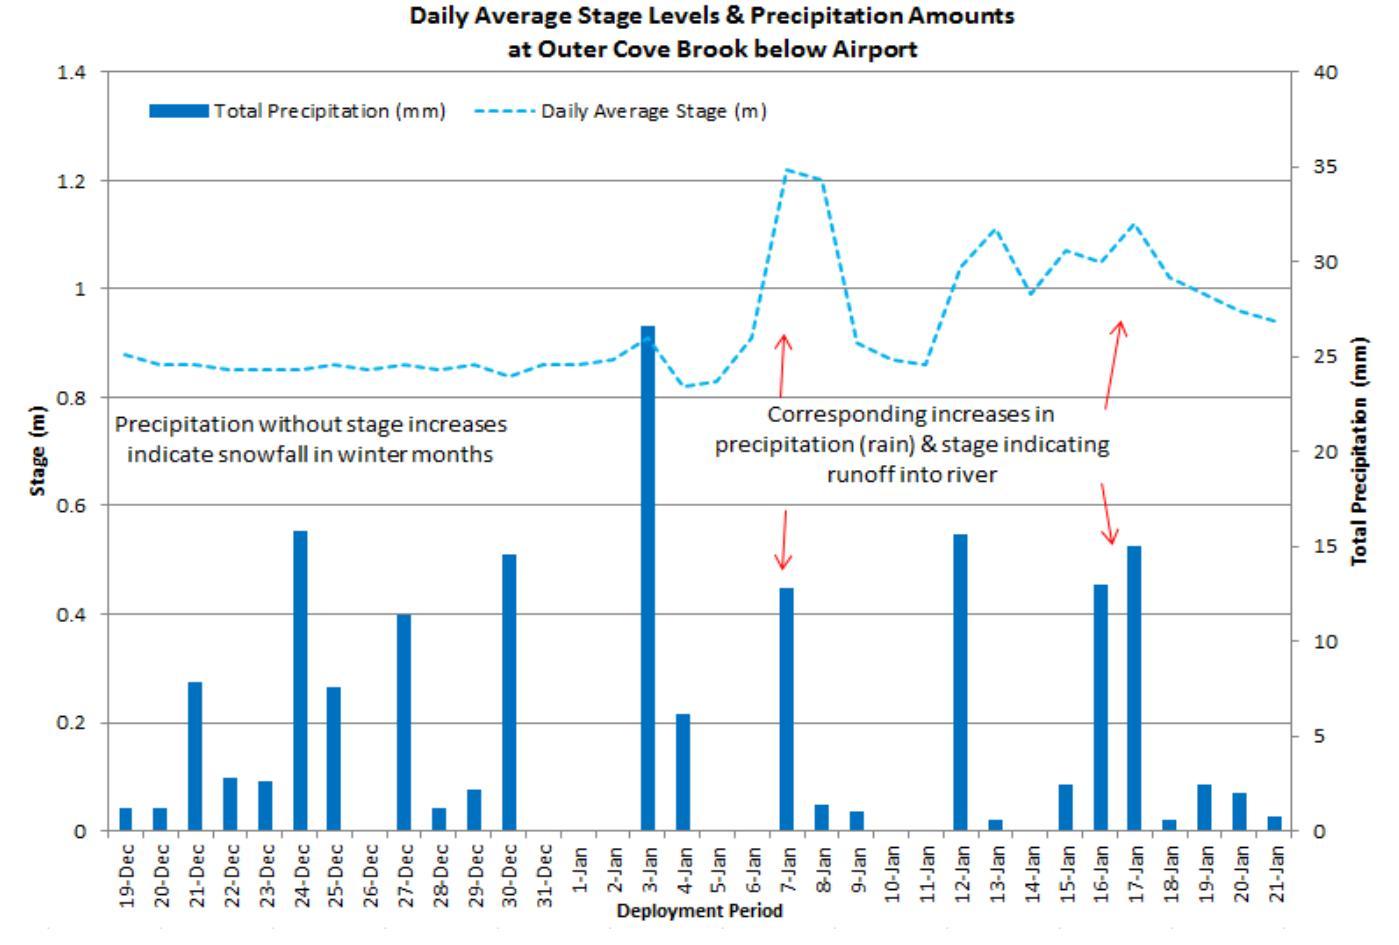
- Stage values are based on a vertical reference that is unique to each station. As a result, absolute
  values of stage are not comparable between stations, but relative changes in stage are.
- Stage provides an estimation of water level at the station and can explain some of the changes that are occurring with other parameters (i.e. Specific Conductivity, DO, turbidity). Stage increases during rain events (Figure 7) due to increased runoff from the surrounding area. However, snowfall will not cause stage to rise significantly as it is not runoff into the river. This is noted in Figure 7, December 19-30<sup>th</sup>, 2013.
- Precipitation data was obtained from Environment Canada's St. John's Airport weather station and supplemented with data from 'The Weather Network' when EC data was unavailable.
- During the deployment period, the stage ranged from 0.81m to 1.34m.

Figure 7: Daily average stage values (m) at Outer Cove Brook below Airport and daily total precipitation values (mm) from Environment Canada's St. John's Airport Station for the deployment period December 19, 2013 to January 21, 2014.

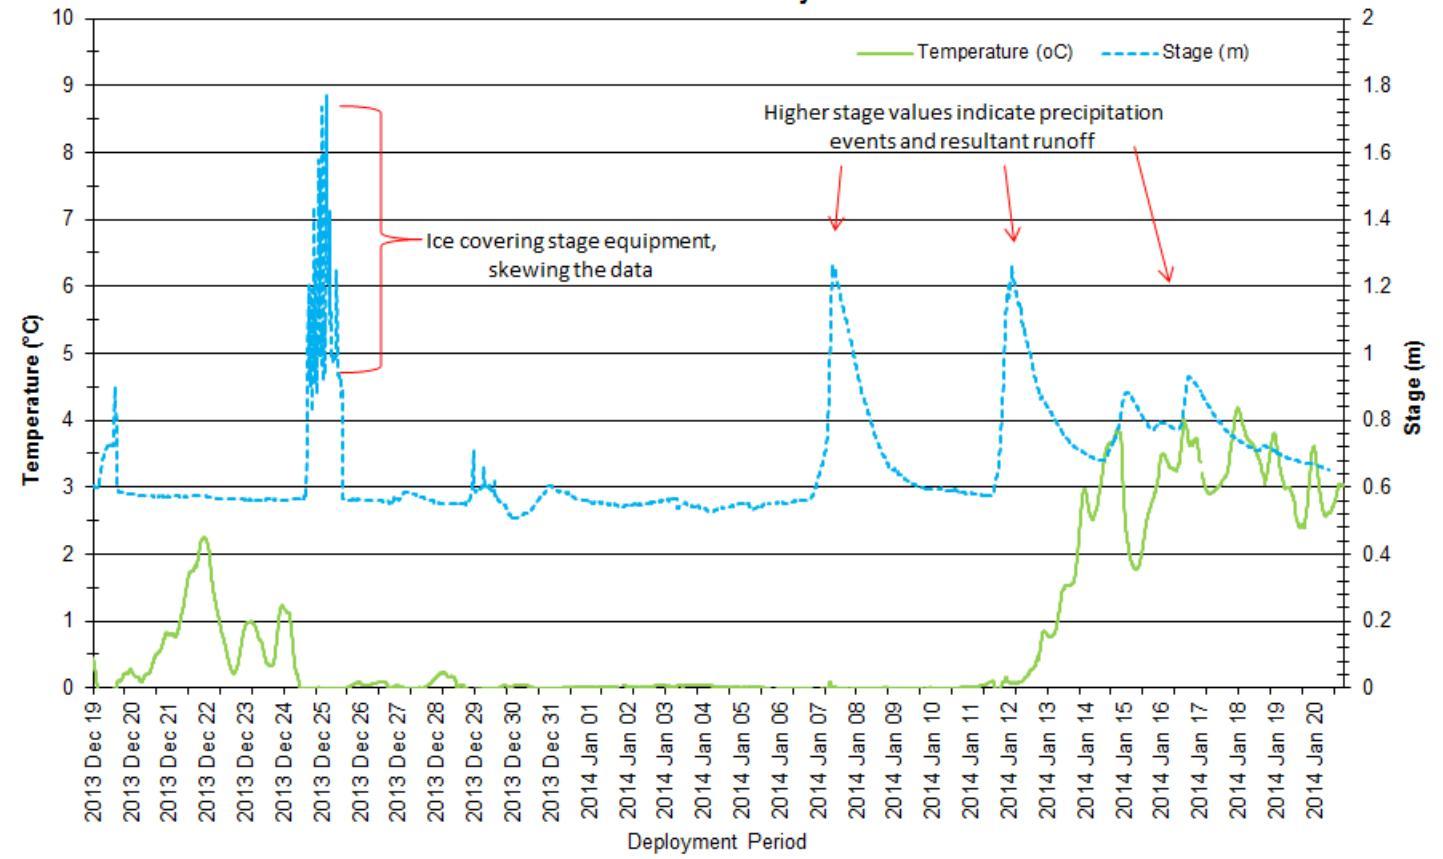
- Water temperature ranged from -0.06°C to 4.18°C during this deployment period (Figure 8). This
  is notably cooler than the previous deployment, and is normal during winter months.
- There are noticeable increases and decreases in the water temperature during the deployment period. This is consistent with ambient air temperatures over this time period, generally increasing during daylight hours and cooling overnight.
- Water temperatures display diurnal variations, typical of shallow streams and ponds which are highly influenced by natural diurnal variations in ambient air temperatures.
- Water temperature is a very important parameter and it has the ability to influence other parameters that are measured by the water quality instrument.

Figure 8: Quarter-hourly water temperature (°C) and stage level (m) values at Outer Cove Brook at Clovelly Golf Course for the deployment period December 19, 2013 to January 21, 2014.

- During the deployment period, the stage values ranged from 0.51m to 1.77m. Ice was an issue at this station December 24-26<sup>th</sup>, as evident in the erratic data recorded during this period (see Figure 8).

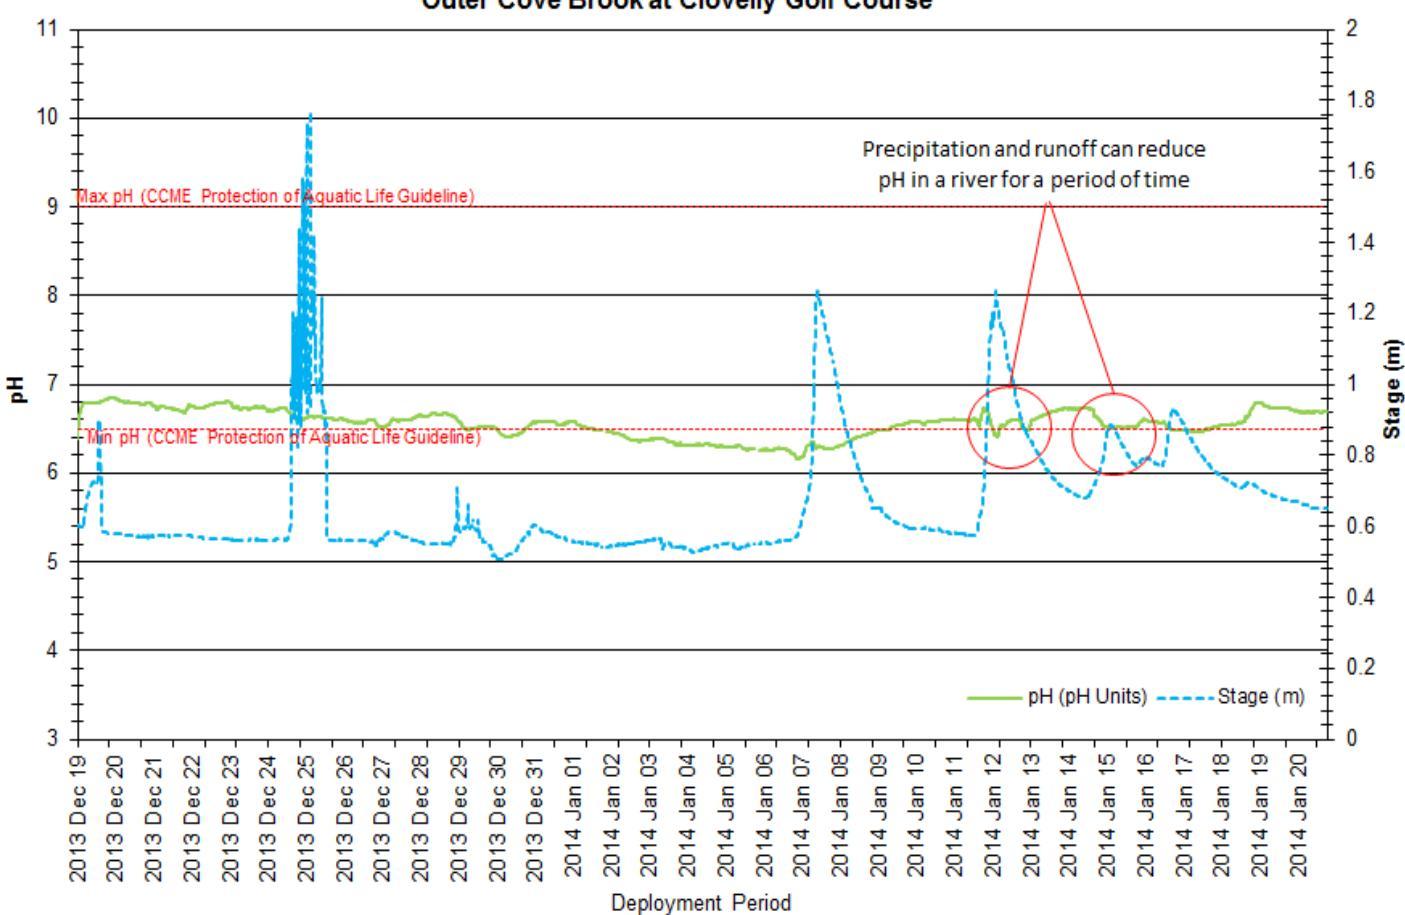
- Throughout this deployment period pH values ranged between 6.16 pH units and 6.84 pH units (Figure 9).
- During the deployment, the pH values at this station are above the minimum CCME Guideline for the Protection of Aquatic Life (between 6.5 and 9 pH units), decreasing at times due to the addition of precipitation. There are notable drops on January 12<sup>th</sup> and 15<sup>th</sup>, related to precipitation events. This is a natural occurrence between rainfall and pH levels.
- The CCME guideline provides a basis by which to judge the overall health of the brook. Naturally, all streams and brooks are different. In the case of Outer Cove Brook at Clovelly Golf Course, pH was higher than normal during this deployment period.

Figure 9: Quarter-hourly pH (pH units) and stage level (m) values at Outer Cove Brook at Clovelly Golf Course for the deployment period December 19, 2013 to January 21, 2014.

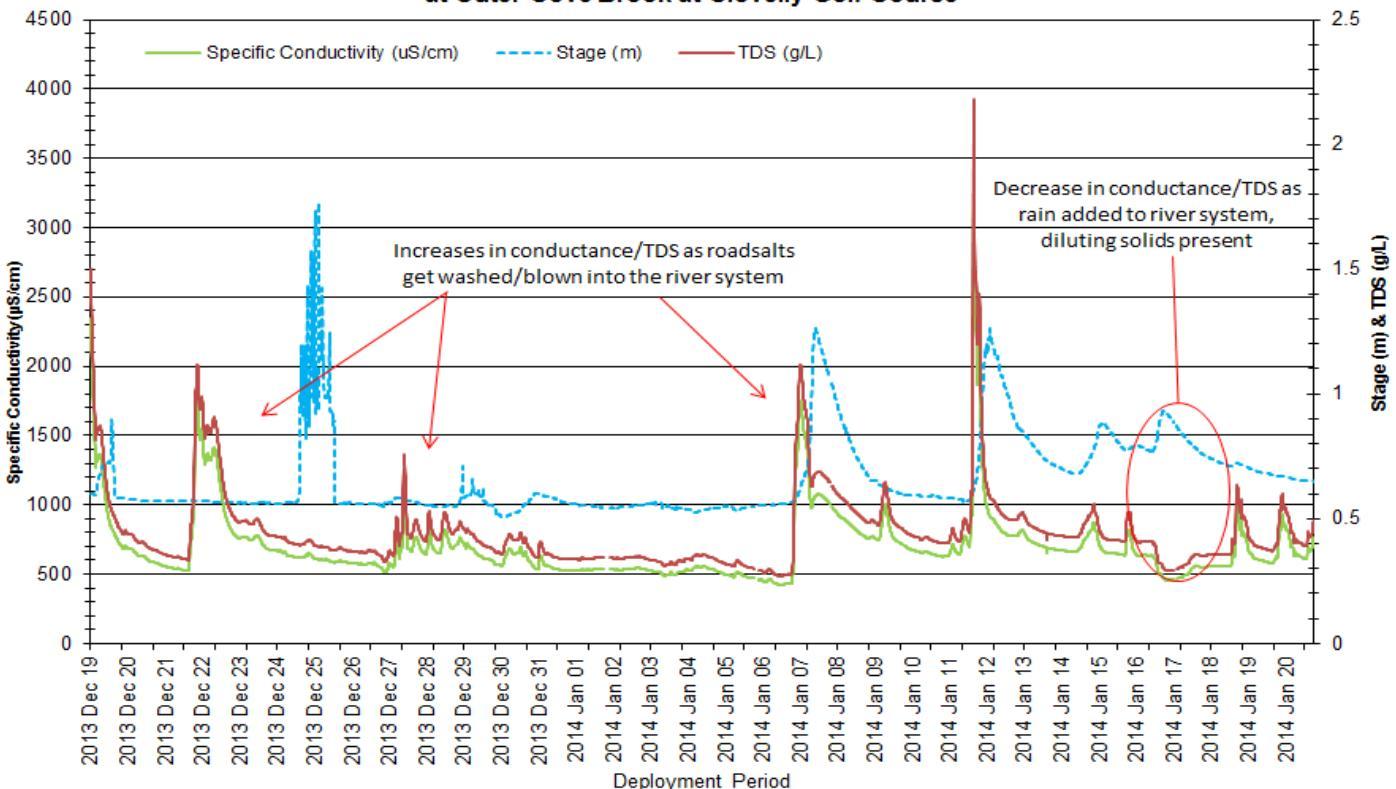
- The conductivity levels were within 423 µS/cm and 3406 µS/cm during this deployment period. TDS ranged from 0.2710 g/L to 2.1800 g/L. This is notably higher than during the previous deployment.

- Cold temperatures and snowfall events during winter months can have the effect of increasing conductance levels due to the addition of salt to roadways. Through wind, snowmelt and rainfall, these salts are carried into the water system, increasing the specific conductance. The increases on December 22<sup>nd</sup> and January 12<sup>th</sup> are in response to winter temperatures and road salt application.

- Generally, rainfall events, such as that which occurred on January 17th (see Figure 10), can have the effect of diluting and lowering conductance levels. When stage levels rise, the specific conductance levels drop in correlation as the increased amount of water in the river system dilutes the solids present there, thus generally decreasing the specific conductivity readings.

Figure 10: Quarter-hourly specific conductivity (uS/cm), TDS (g/L) and stage (m) values at Outer Cove Brook at Clovelly Golf Course for the deployment period December 19, 2013 to January 21, 2014.

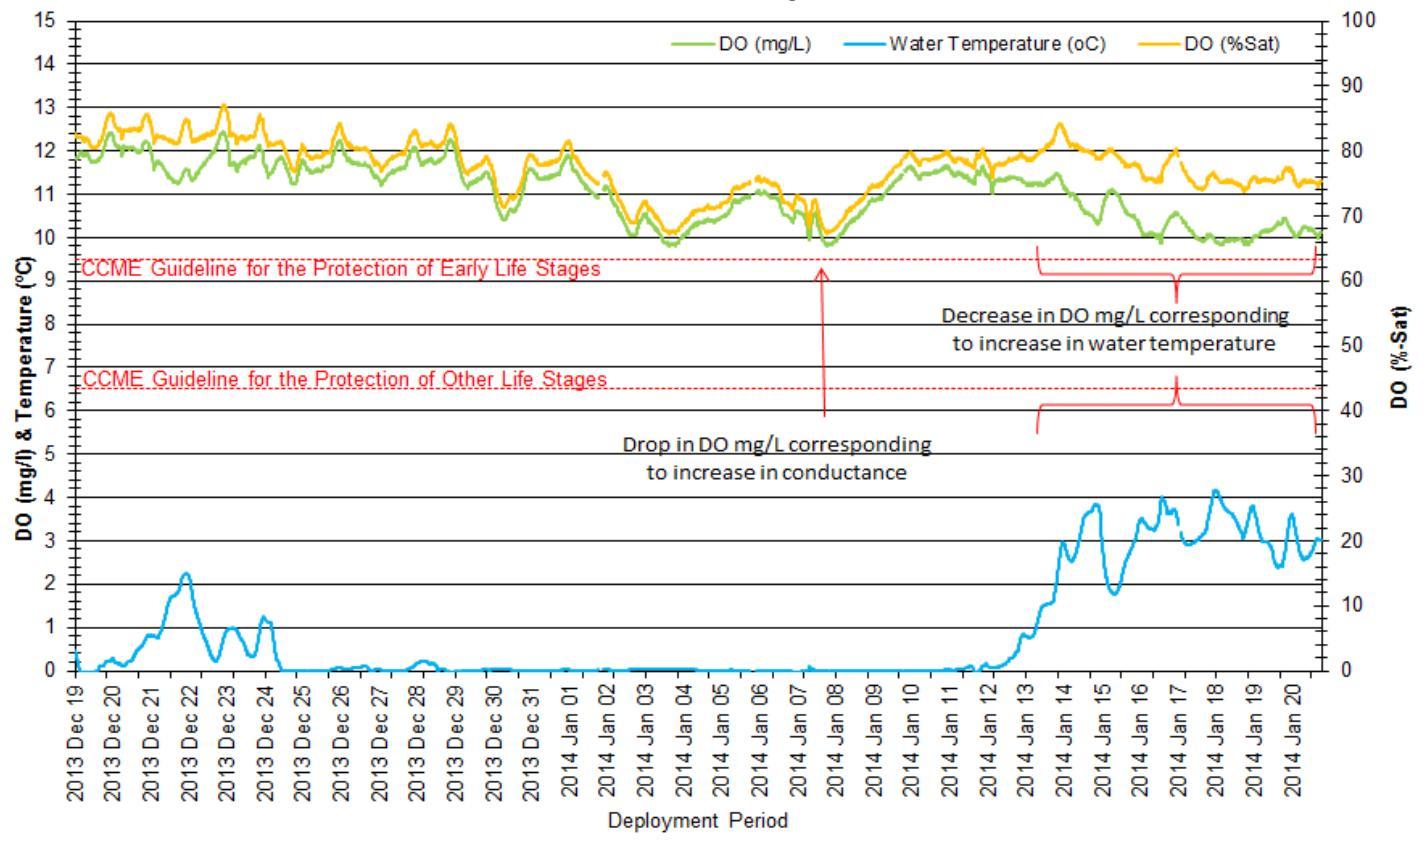
- The instrument measures dissolved oxygen (mg/L) then calculates percent saturation (% Sat).
- The Dissolved Oxygen % Sat levels within this deployment period were within 67.2% Sat–87.2% Sat. Dissolved Oxygen (mg/L) measured 9.80 mg/L to 12.46 mg/L. Water temperatures were cooler during this deployment period, resulting in higher oxygen levels.

- The DO mg/L values are above the minimum DO CCME guideline for early life stages throughout this deployment period (Figure 11), as the colder water during winter months can hold more oxygen. There is a notable decrease in oxygen mg/L values near the end of the deployment when water temperatures were warmer, thus decreasing the oxygen values.

- A drop in dissolved oxygen on January 6-7<sup>th</sup> corresponds to a sharp increase in conductivity at this time. The decrease is likely due to the large amount of salts present in the brook, lowering the amount of oxygen the water can hold.

- Dissolved Oxygen percent saturation remains relatively constant throughout the deployment period, with diurnal fluctuations. Dissolved oxygen mg/L content fluctuates with the water temperature changes. Decreases in dissolved oxygen values are inversely related to increases in water temperature as warmer water can hold less oxygen.

Figure 11: Quarter-hourly dissolved oxygen (mg/L & % sat) and water temperature (°C) values at Outer Cove Brook at Clovelly Golf Course for the deployment period December 19, 2013 to January 21, 2014.

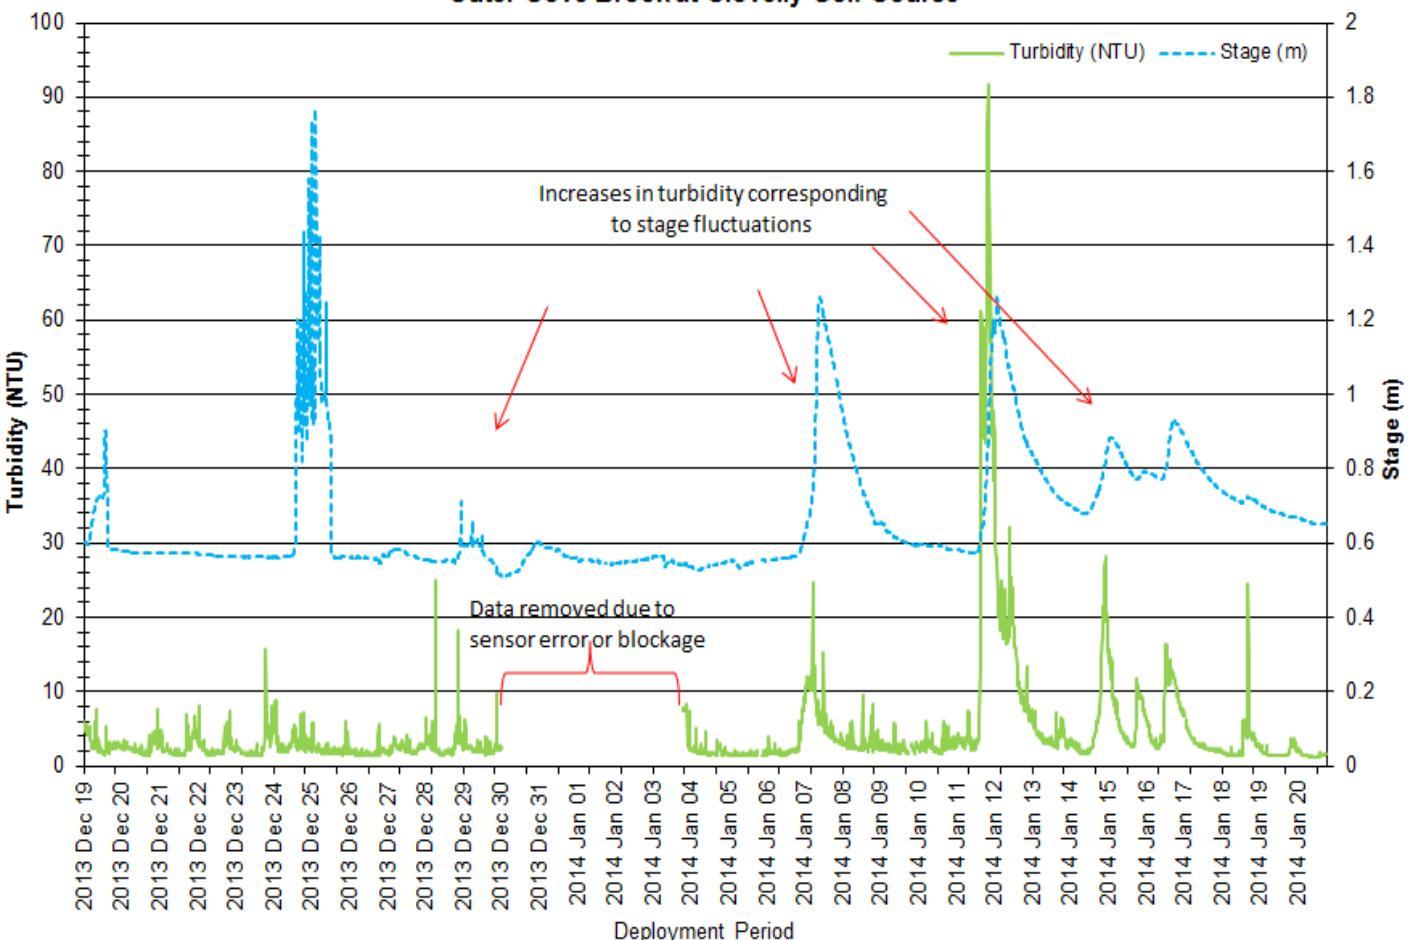
- Outer Cove Brook contains a significant amount of algae. High algal growth in the summer or leaf debris during all seasons can interfere with turbidity measurements as they block the sensor.
- The turbidity sensor can read turbidity values between 0 NTU and 3000 NTU. If a turbidity reading hits 3000NTU it is always identified as an error reading and thus is not a valid turbidity reading.
- The turbidity readings during this deployment ranged within 1.3 NTU to 91.8 NTU (Figure 12). Fluctuations in turbidity values were correlated with increases in stage and thus precipitation events. Data was removed from December 30<sup>th</sup> to January 4<sup>th</sup> due to sensor error or blockage as the data was reading 3000NTU.

Figure 12: Quarter-hourly turbidity (NTU) and stage level (m) values at Outer Cove Brook at Clovelly Golf Course for the deployment period December 19, 2013 to January 21, 2014.

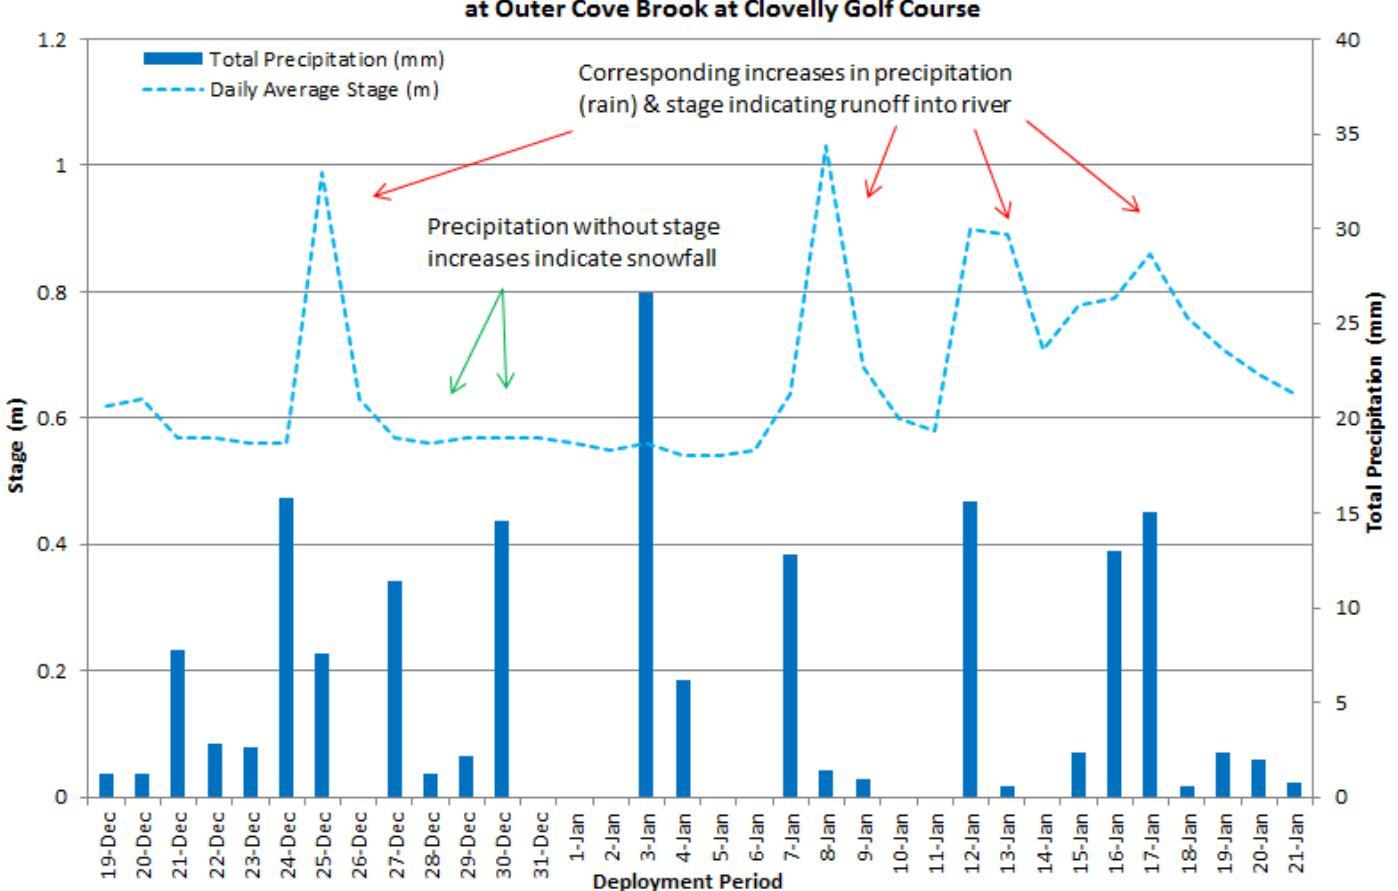
- Stage provides an estimation of water level at the station and can explain some of the changes that are occurring with other parameters (i.e. Specific Conductivity, DO, turbidity). Stage increases during rain events (Figure 13) due to increased runoff from the surrounding area. However, snowfall will not cause stage to rise significantly as it is not runoff into the river. This is noted in Figure 13, December 19-30<sup>th</sup>, 2013.

Figure 13: Daily average stage values (m) at Outer Cove Brook at Clovelly Golf Course and daily total precipitation values (mm) from Environment Canada's St. John's Airport Station for the deployment period December 19, 2013 to January 21, 2014.
