ST. J@HN'S

Structural Lining of Water Mains

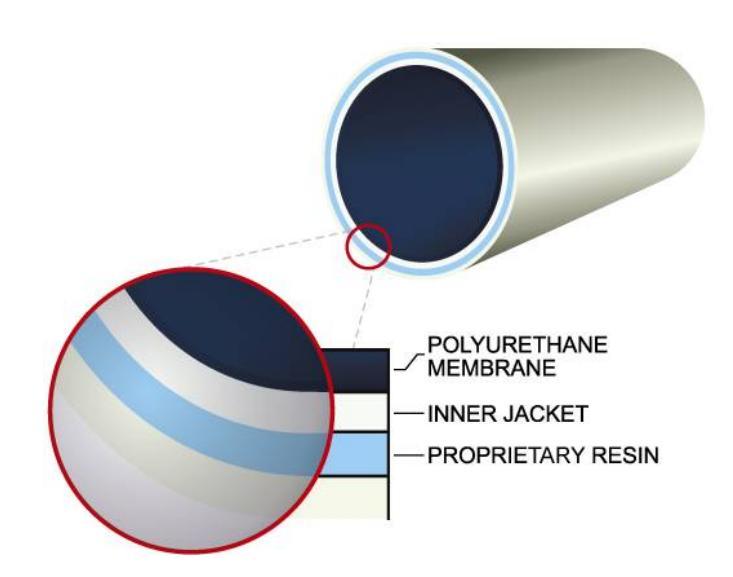
Structural Capacity of Aqua-Pipe

- Class IV fully structural liner in accordance with AWWA M28 Structural Classification.
 - The liner can withstand internal pressures (including a vacuum) without relying on the residual strength of the existing pipe.
 - Maximum operating pressure of 150 psi.
- Certified by NSF/ANSI Standard 61.

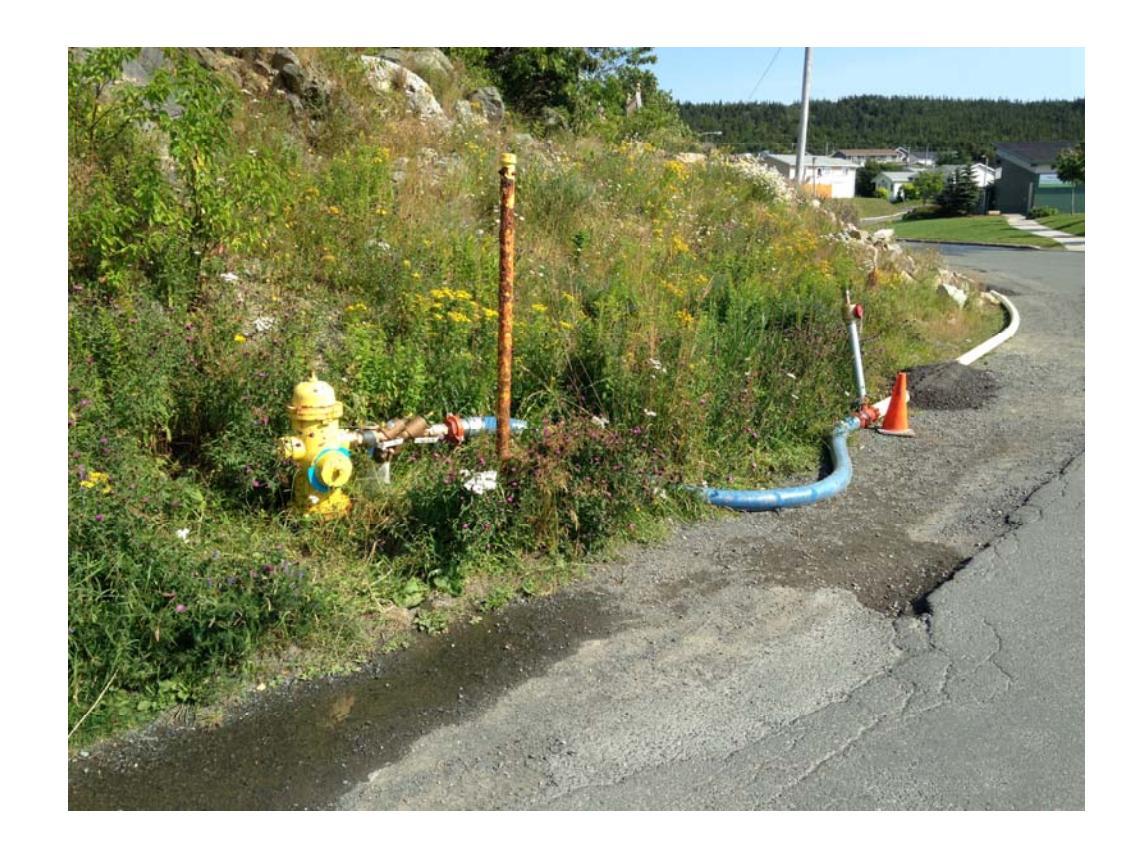
Temporary Water Supply

- Temporary water supply provided to residents prior to starting work.
- Asphalt filings placed on temporary water line at driveway crossings.

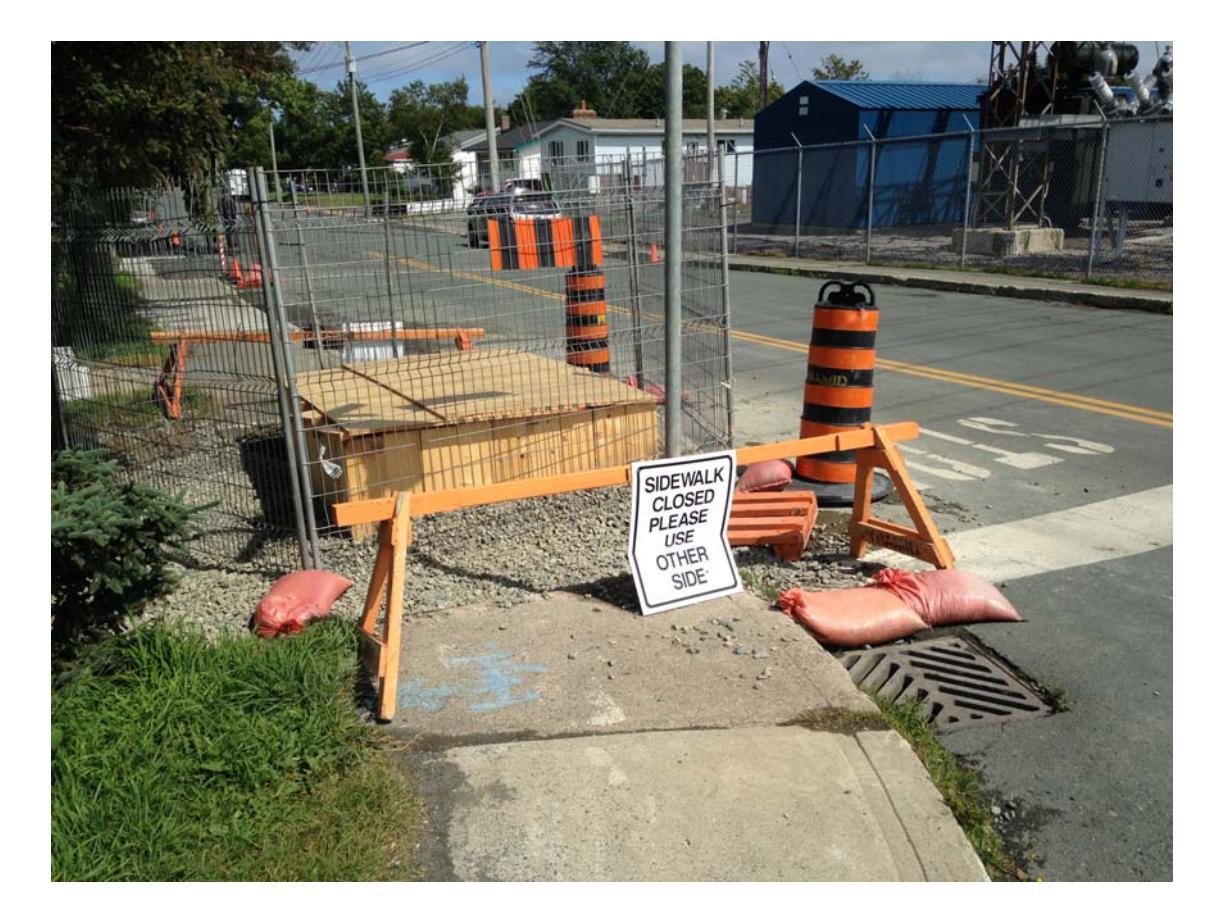
Access Pits Excavated

Access pits are typically located at tees, 90° bends or valves.

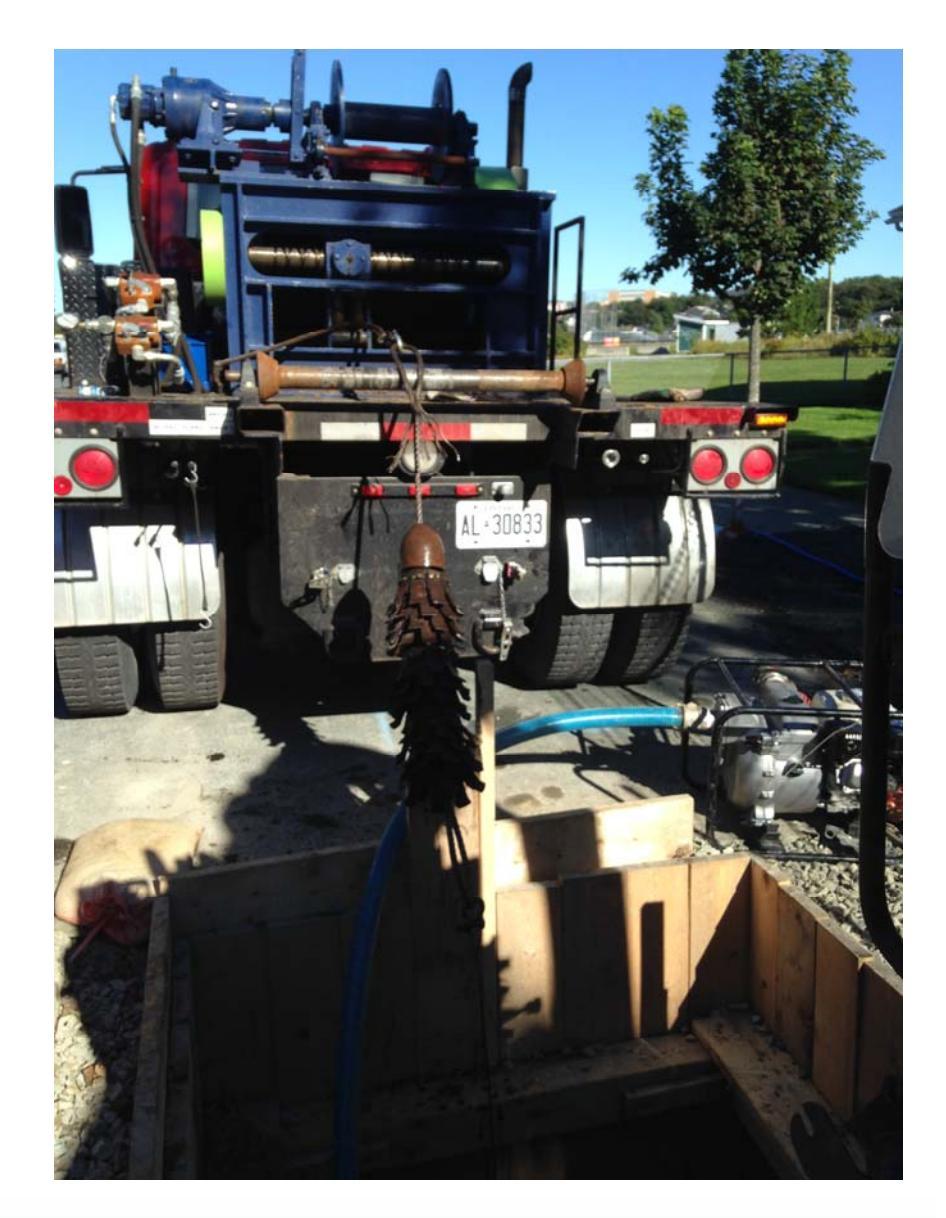
Cleaning Main

- Tuberculation removed and interior of pipe cleaned using a drag scrapper. The main is then flushed.
- Any water services which are protruding significantly into the pipe are cut back near the pipe wall.

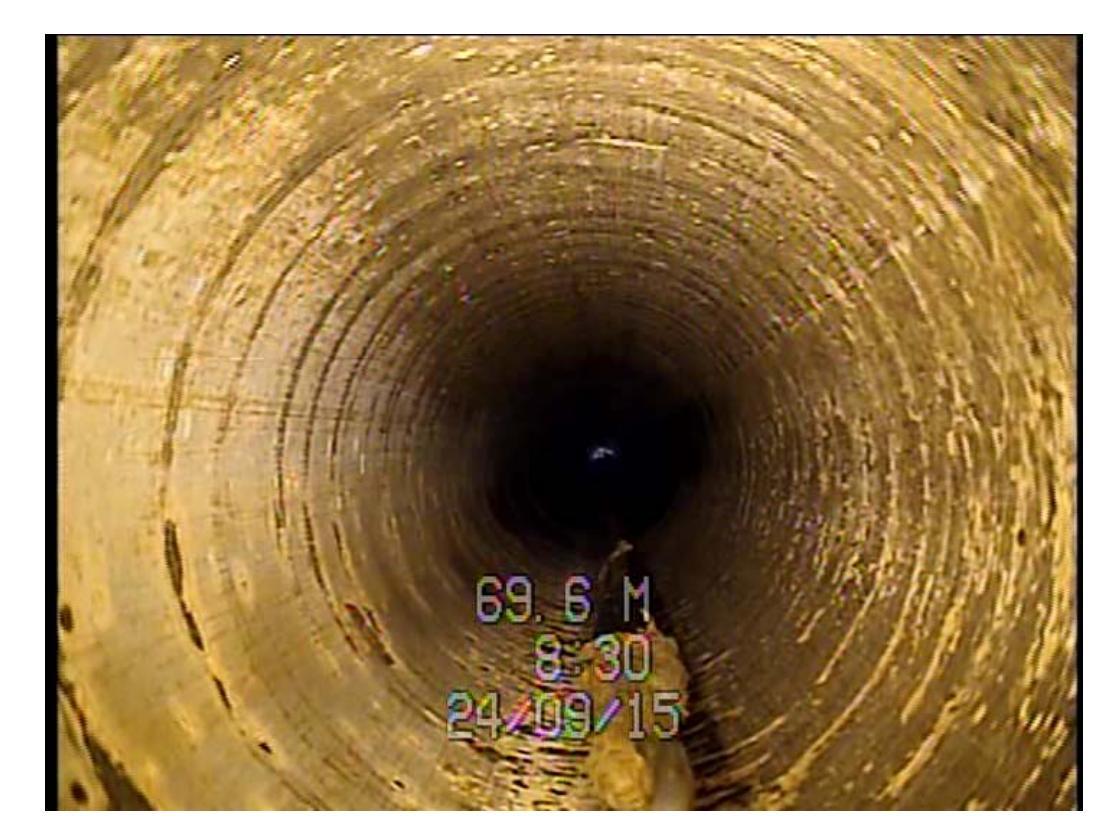
Post Cleaning

- A pre-lining camera inspection is carried out to map the service connections and confirm the pipe is cleaned to satisfaction.
- All standing water must be removed prior to lining.

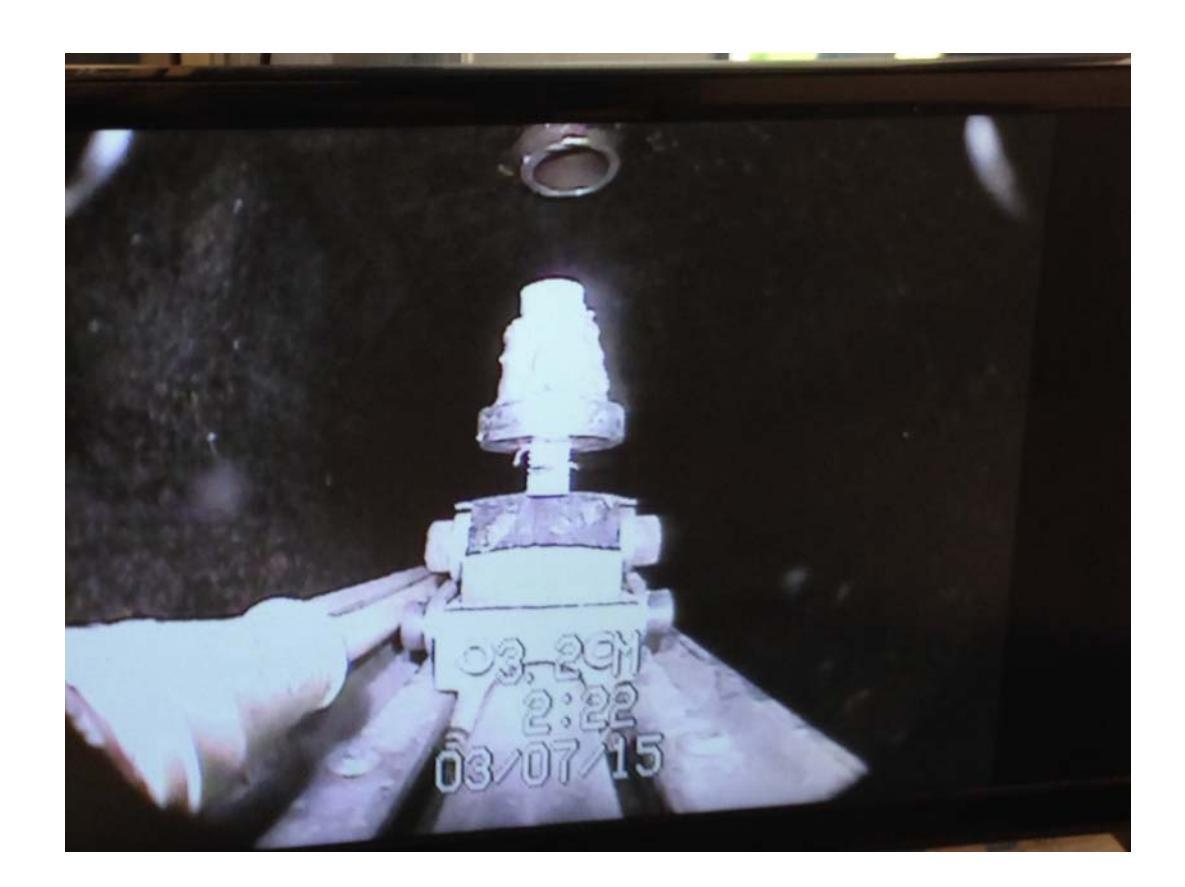
Inserting Plugs into Water Services

Each water service must be plugged inside the pipe using robotic equipment. This prevents epoxy from blocking the service (in most cases).

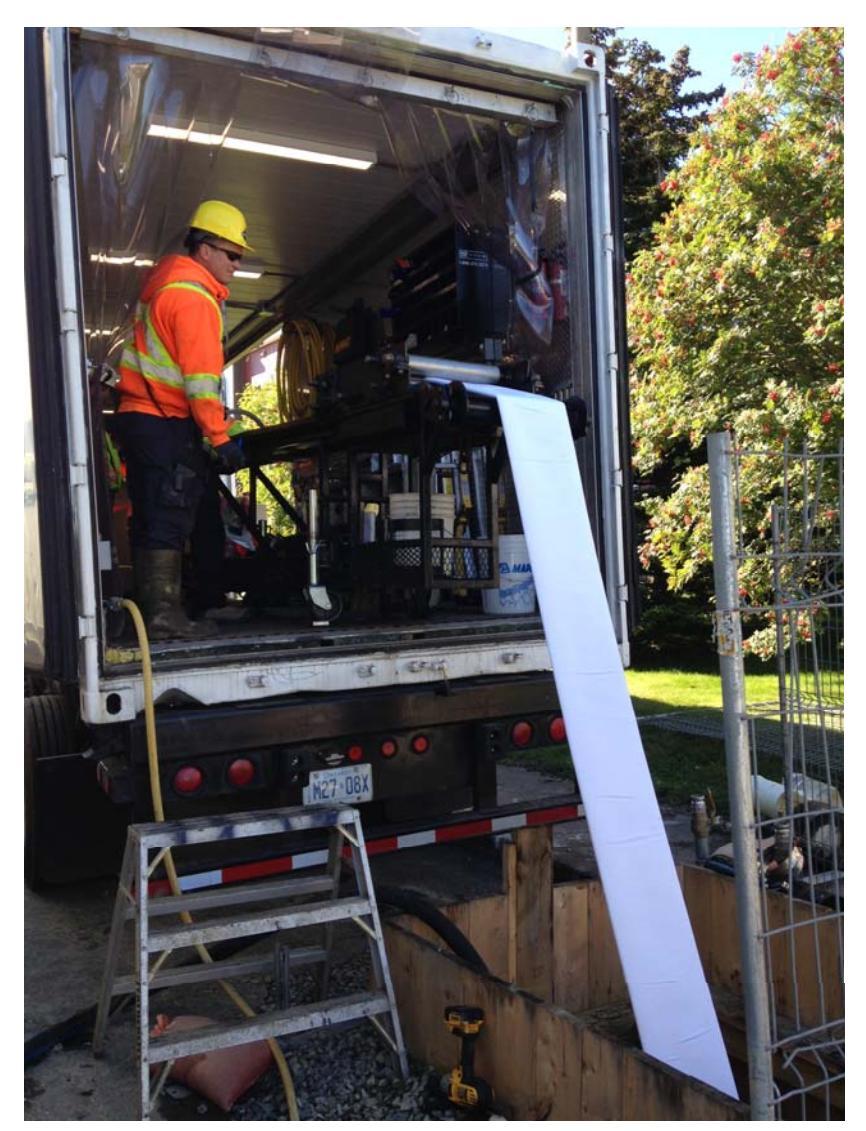
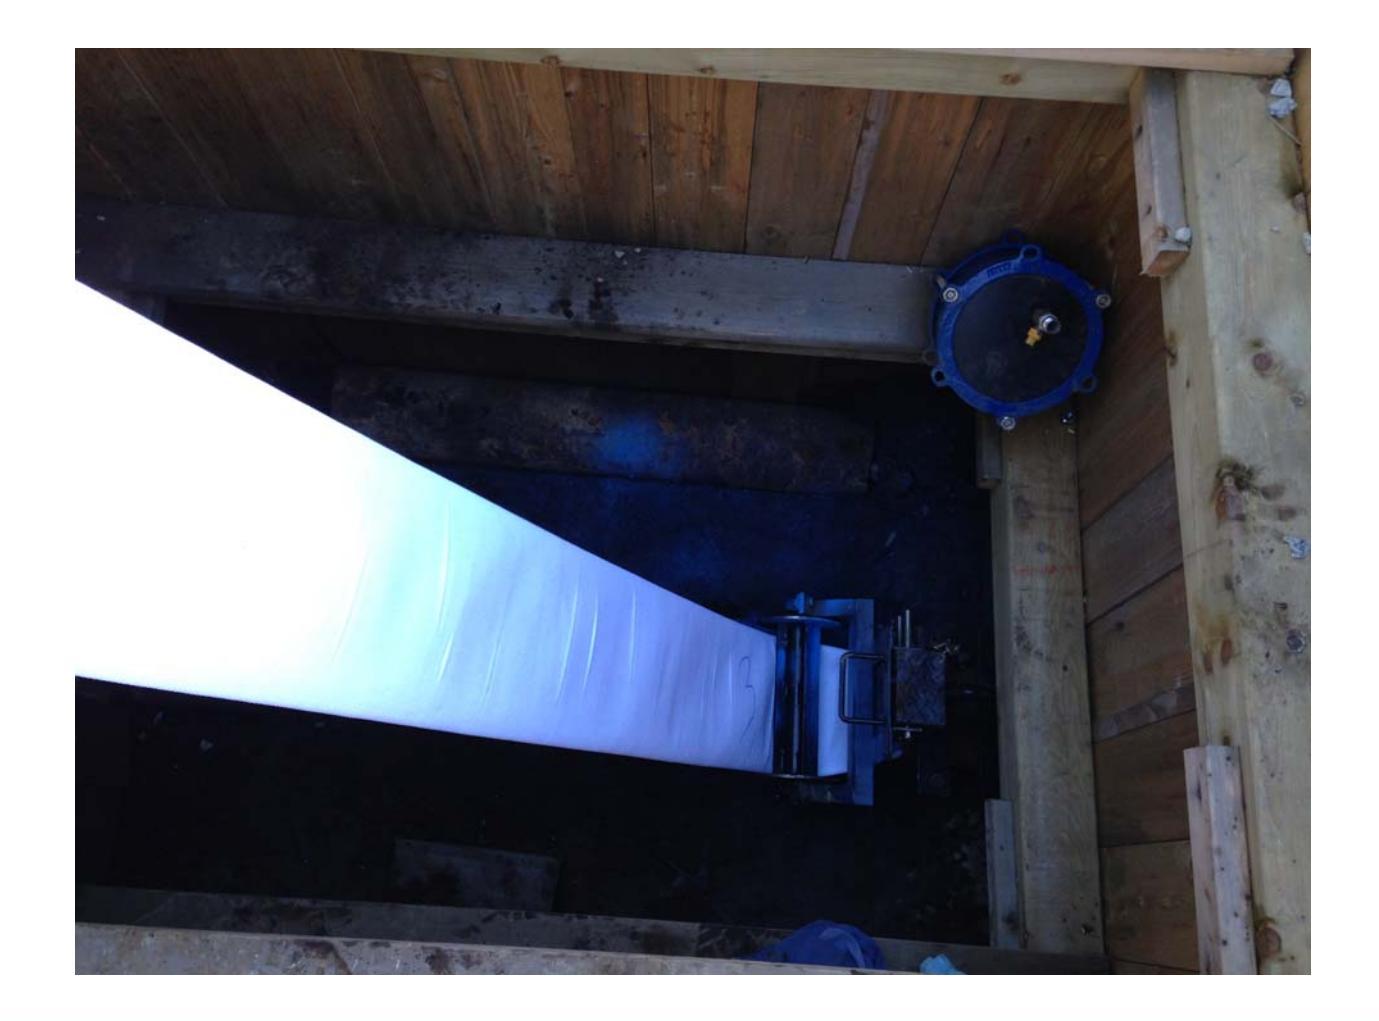
Lining Process (Aqua-Pipe)

- Cured in Place Pipe (CIPP) consists of a woven polyester tube injected with epoxy resin.
- A polymeric membrane is bonded to the interior of the tube to provide water tightness.
- Liner is formed by swabbing the pipe.

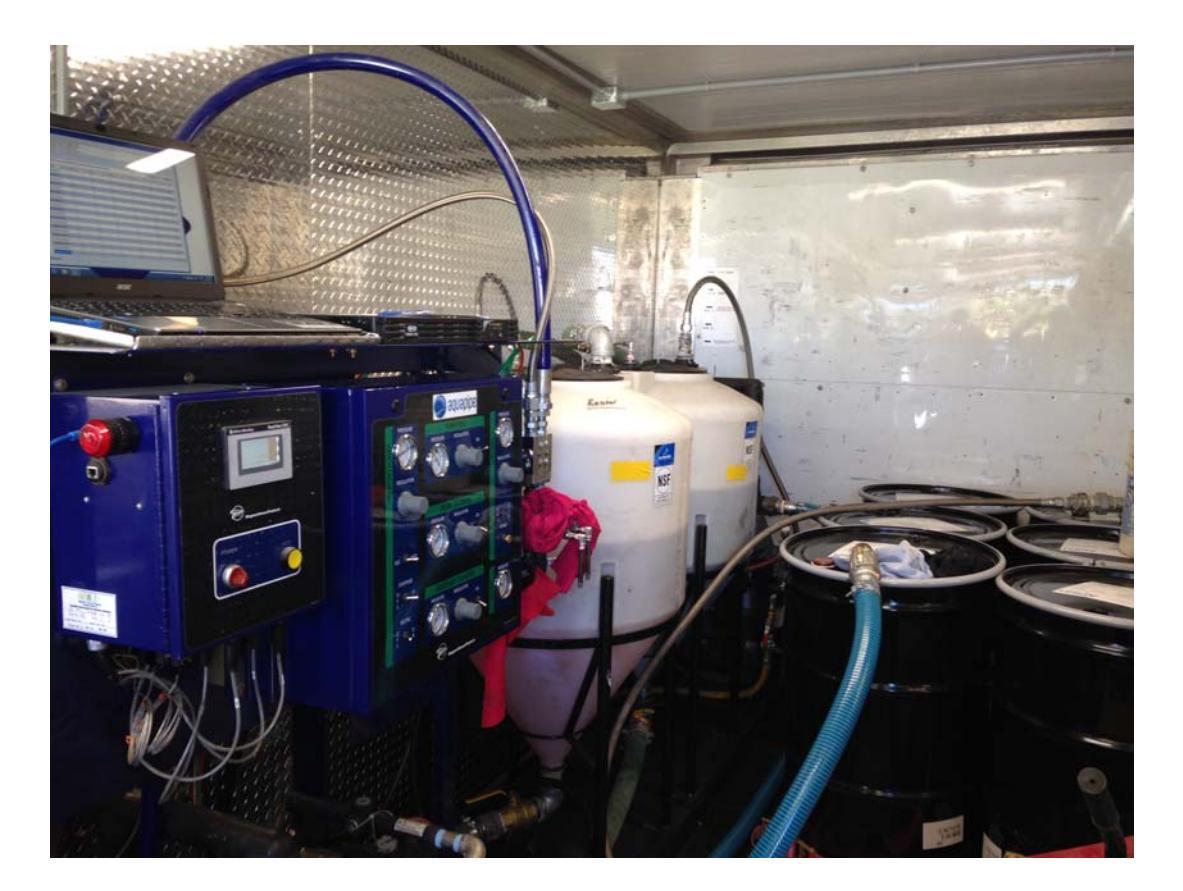
- Required amount of hardener and epoxy resin are mixed on site.
- Epoxy is injected into the liner as it is being pulled into the pipe.

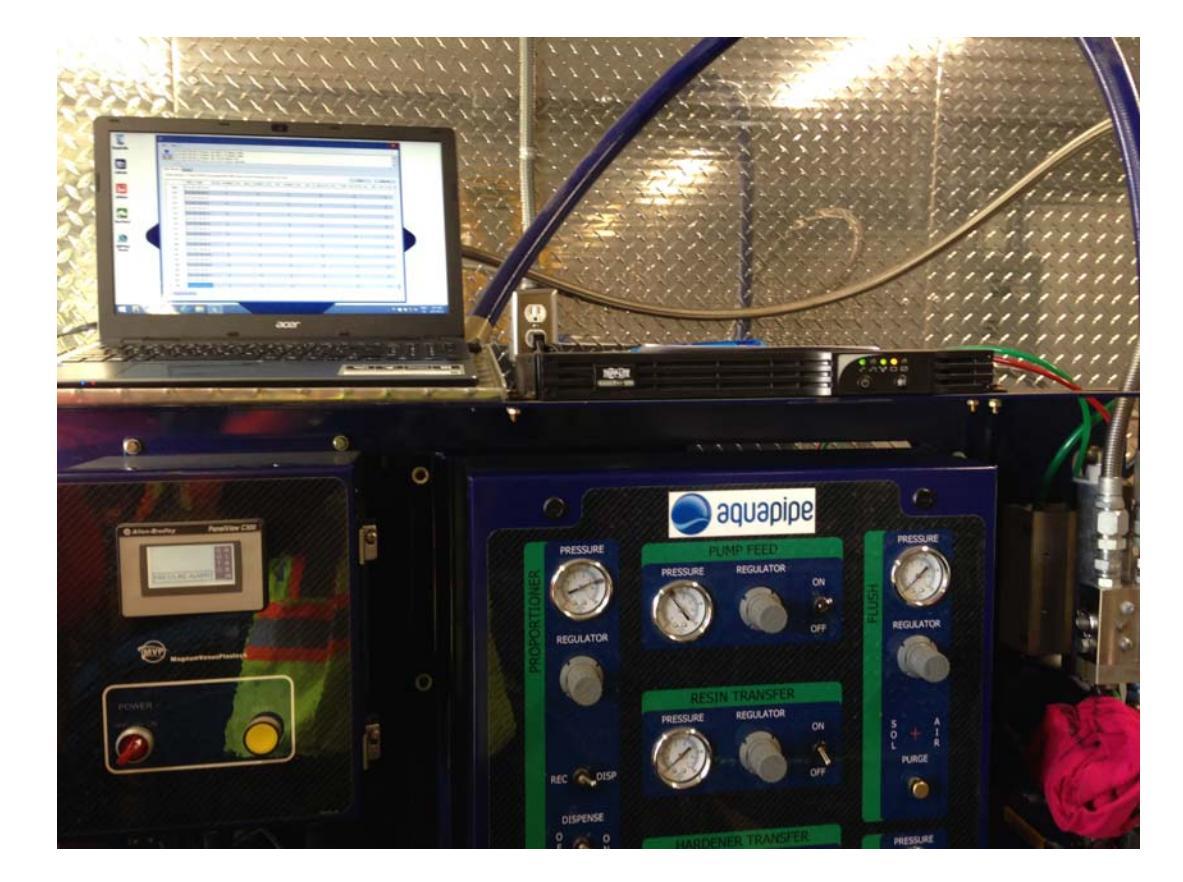
- The lined pipe is pressurized for 30 minutes using cold water to promote a tight fit between the liner and the host pipe.
- Hot water is circulated for 2 hours at 60 degrees Celsius and 50 psi to allow the liner to cure.

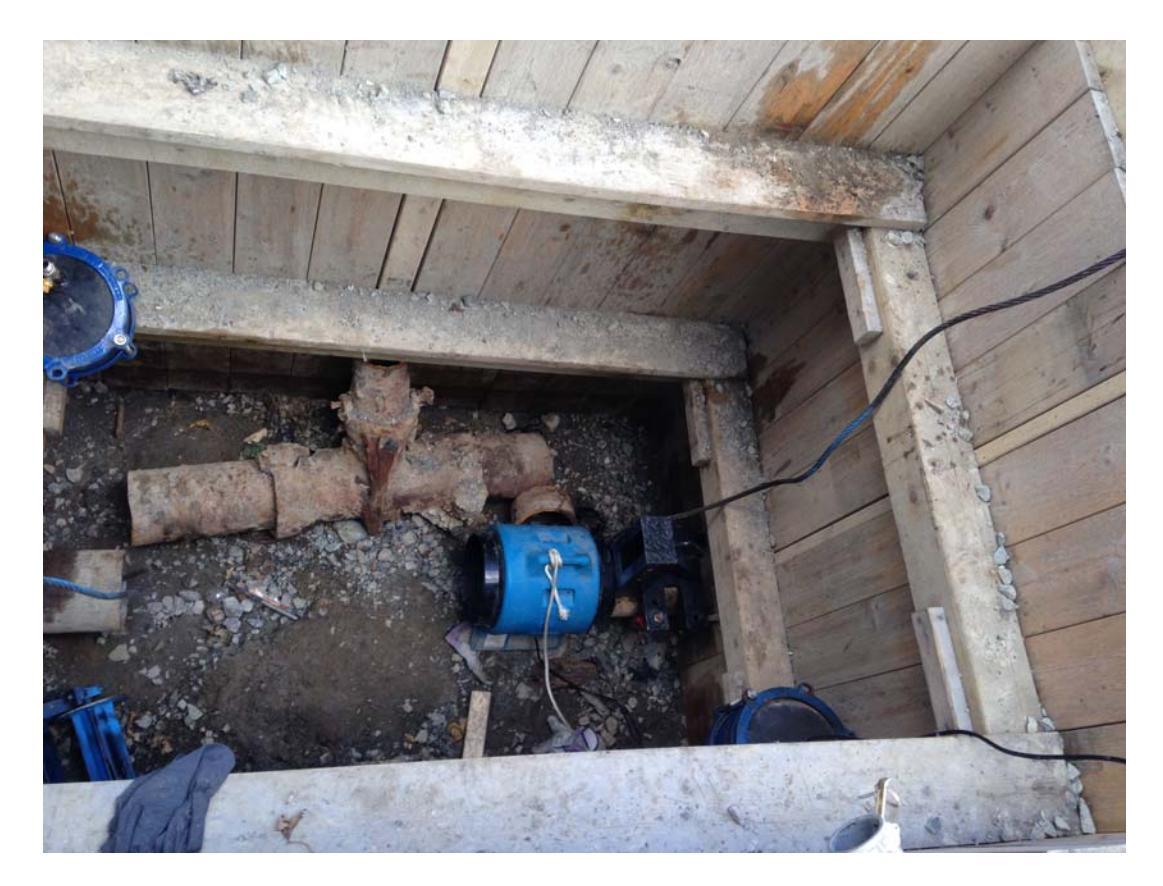
- The lined pipe is kept under pressure during the over night cool down period.
- Perform hydrostatic pressure test as per specifications.

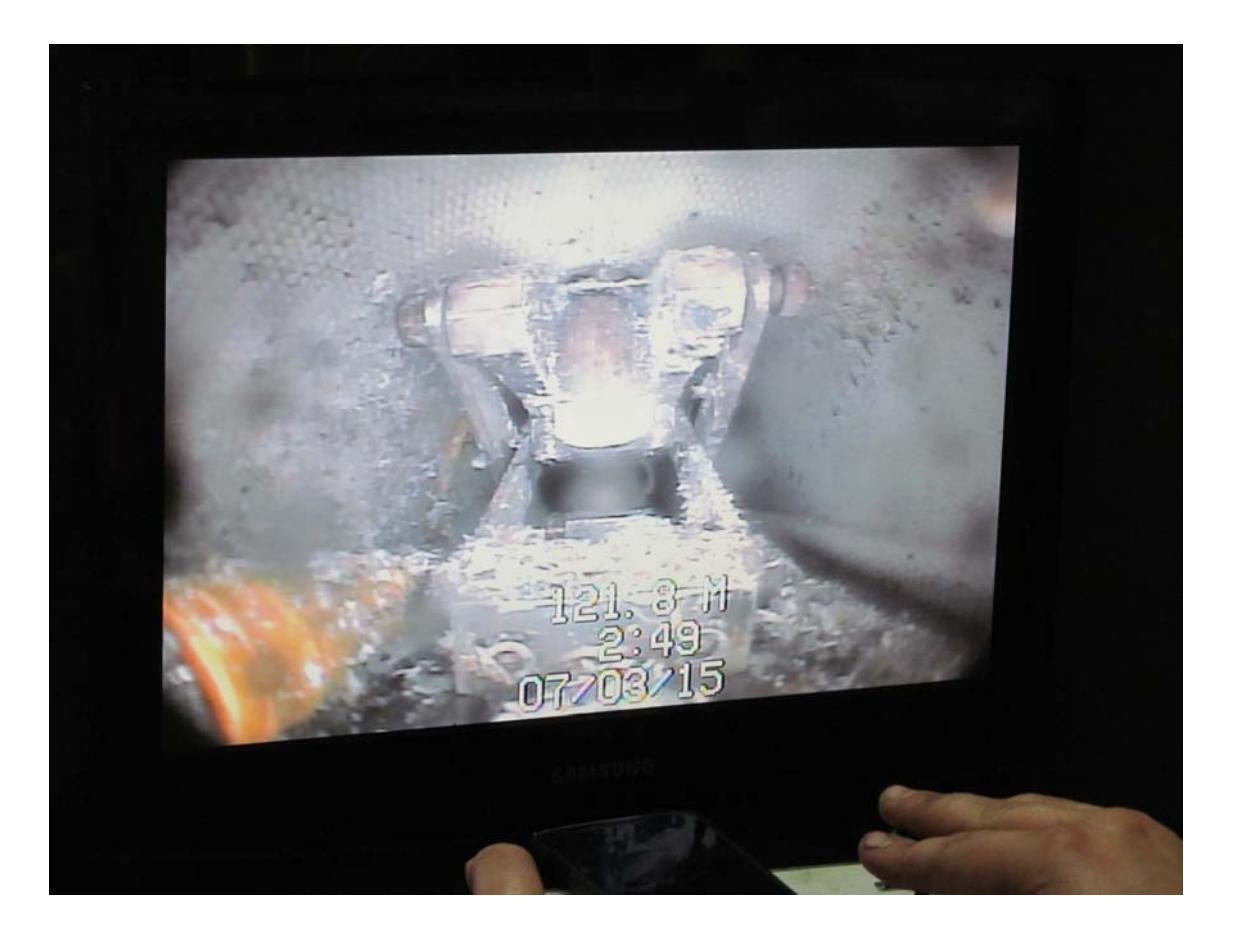
Service Plugs Removed

Service connections are reinstated by drilling out the previously installed plugs using robotic equipment.

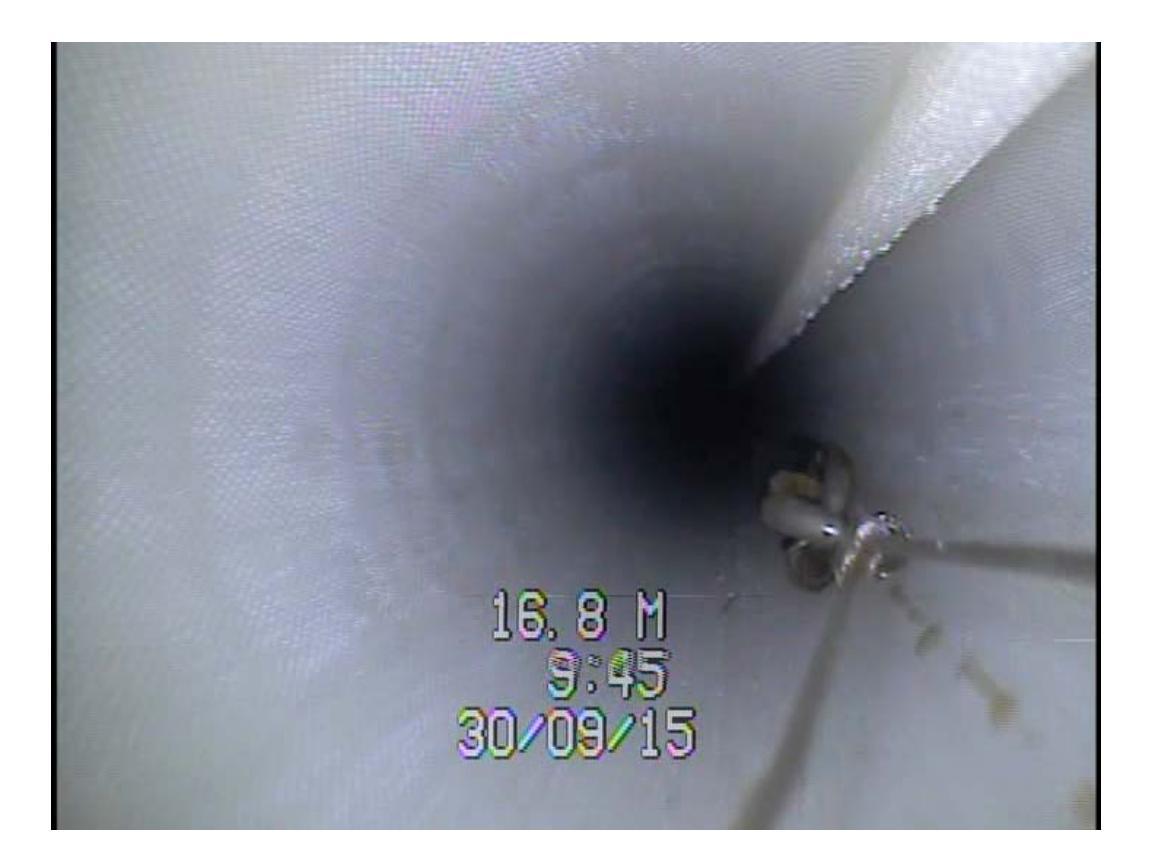
Finished Rehabilitated Product

- A post-lining camera inspection is carried out to confirm service connections have been re-established and to verify that the liner was installed correctly.
- Services located at the liner fold or blocked with resin must be excavated.

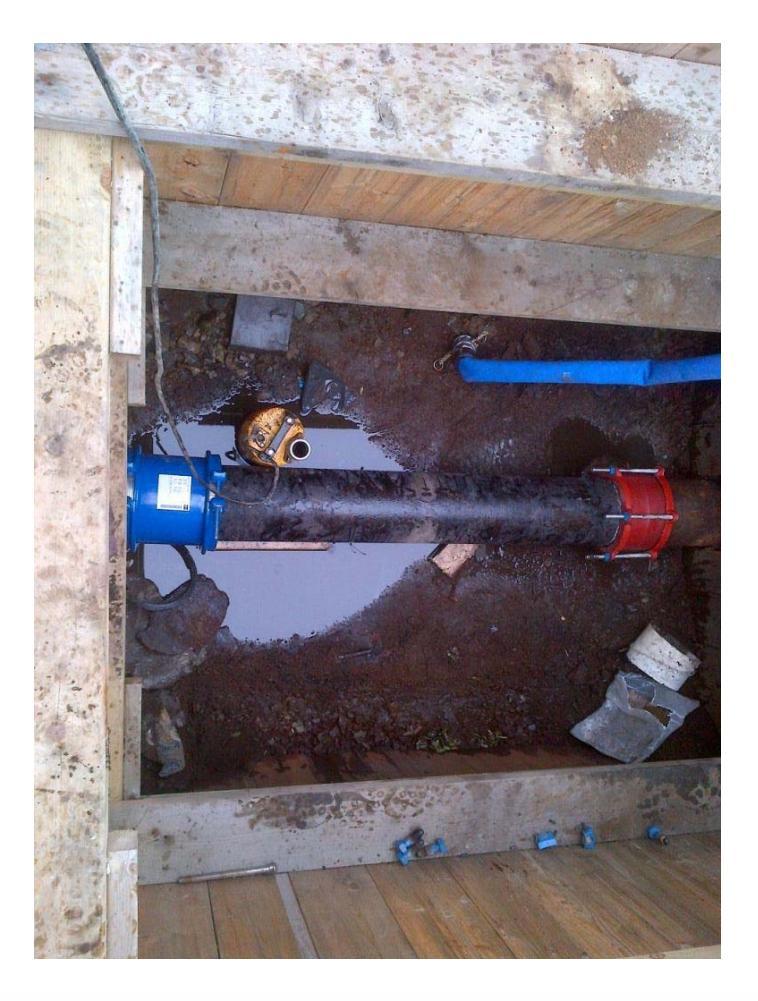
Commissioning of Main

- The rehabilitated pipe is chlorinated as per specifications.
- Typical connections are then made to the distribution system.

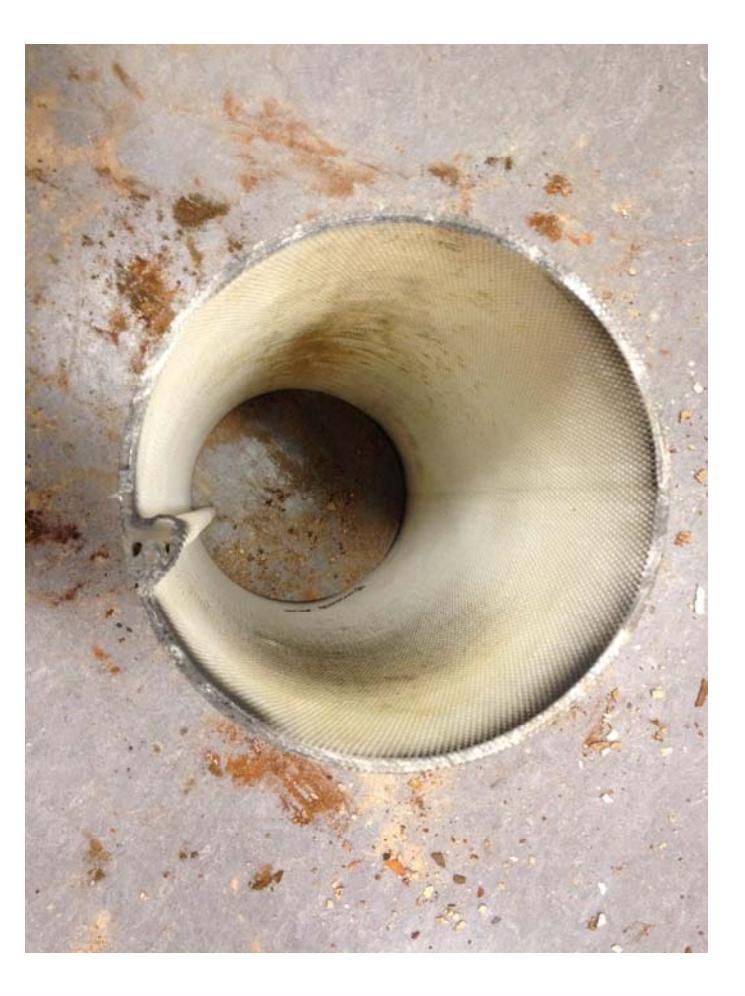
Testing of Liner

- At each access pit, a liner sample is collected and tested for strength and thickness.
- The sample from Rosevelt Avenue is shown on the right.
