THE ASSESSMENT OF GEOLOGICAL HAZARDS AND DISASTERS IN NEWFOUNDLAND: AN UPDATE

M. Batterson, D.G.E. Liverman, J. Ryan¹ and D. Taylor Geochemistry, Geophysics and Terrain Sciences Section

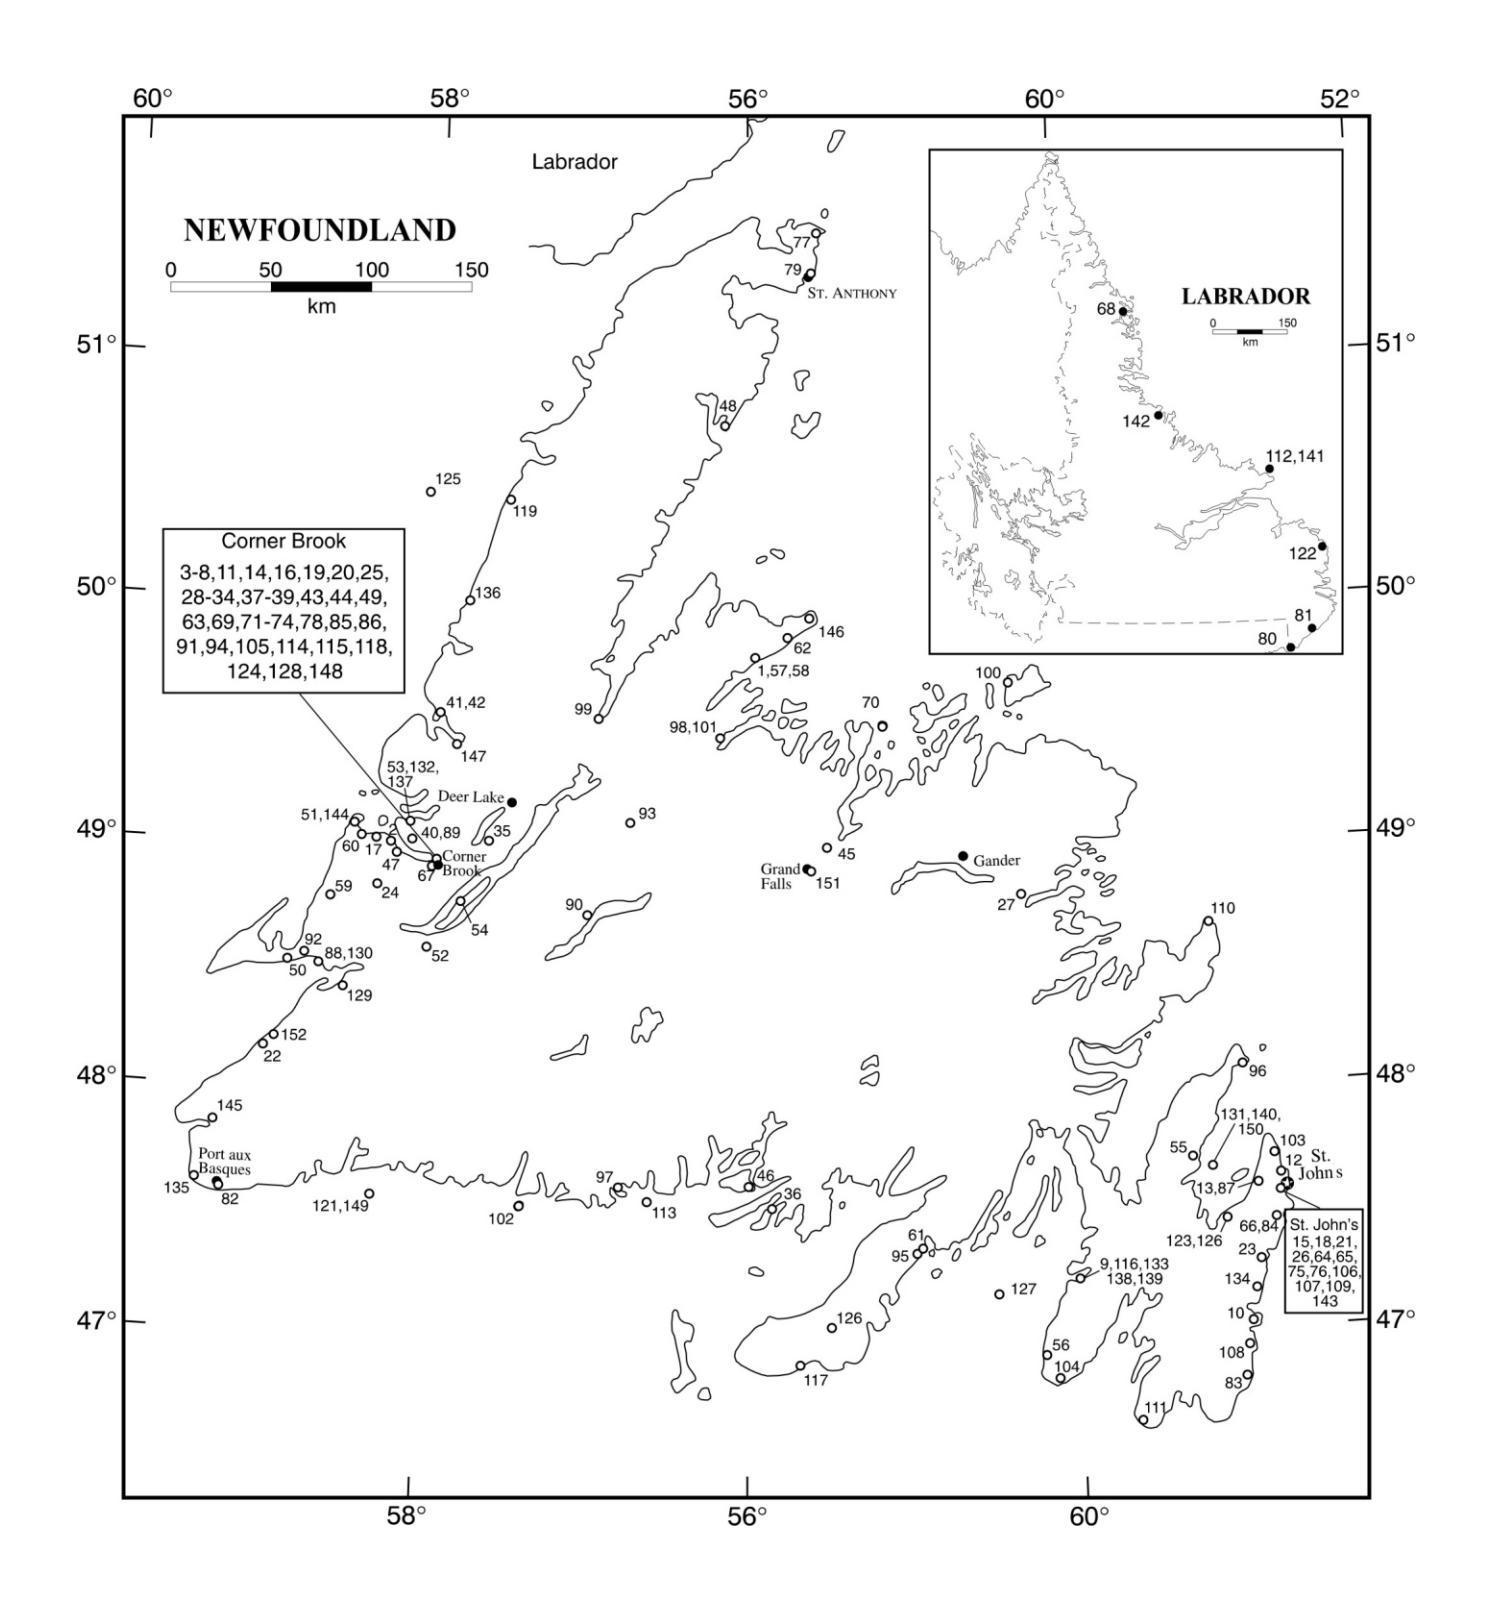
Figure 1. Location of incidents of geological disasters in Newfoundland and Labrador; numbers refer to the location sites shown in Tables 1-5.

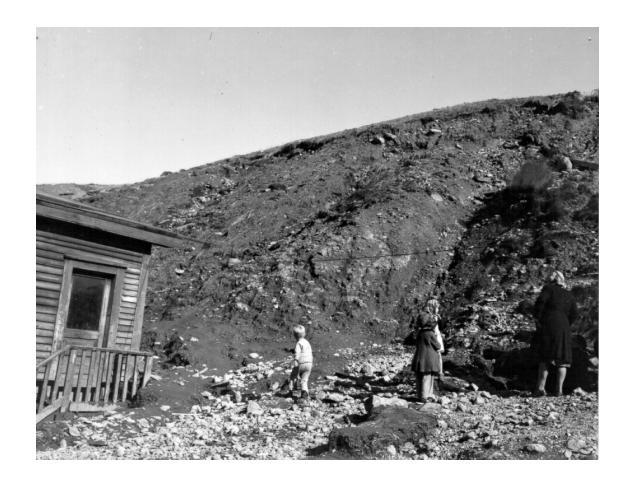
Plate 1. Debris path produced by landslide on Southside Road, St. John's in September 1948. Material washed down a gully, causing considerable damage to the house, and claiming the life of a small child. Photograph courtesy of the City of St. John's archives.

Following a rainstorm that dumped 11.5 cm (4.5") of rain in 18 hours on the St. John's area, a debris torrent on September 15, 1948, damaged a number of houses on Southside Road (Plate 1), and caused a fatality. The site of this tragedy was one of four landslide events reported over a 20-year period at this location. An earlier landslide, on February 23, 1936, killed a young child, and other landslides on October 13, 1934, and in October 1953, damaged property and disrupted transportation routes. The construction of the Pitts Memorial Drive has largely alleviated the landslide threat in this area.

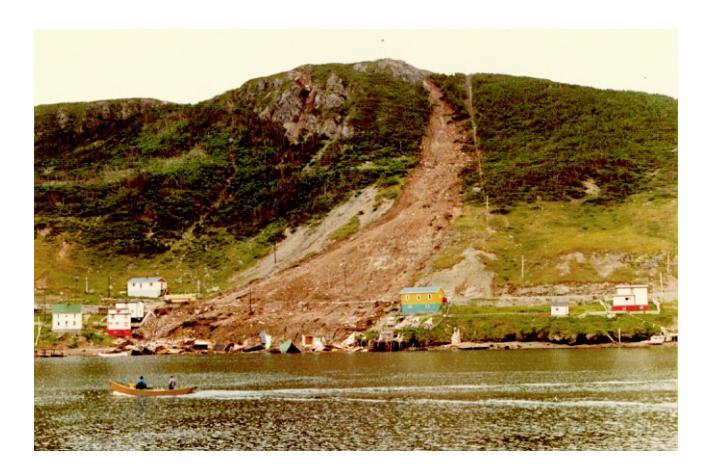
Plate 2. Landslide scar in Harbour Breton generated by a debris torrent in August 1973. Wreckage from the remains of four houses caught in the path of the landslide is seen at the water line.

above the community of Harbour Breton (Plate 2). Four houses were swept into the harbour and destroyed, resulting in the death of four children. Slope movements continued over the days following the disastrous slide. The families who lost their houses during the landslide, and 11 other families whose homes were thought to be at risk from further landslides, were resettled. On at least three subsequent occasions, in November 1982, February 1984, and June 1986, government geologists visited Harbour Breton to examine slope movements. The area in which the tragedy occurred had been the site of a previous landslide, in about 1953; however, there were no houses located in the area, and consequently there was no incidence report filed on which to base future planning decisions.

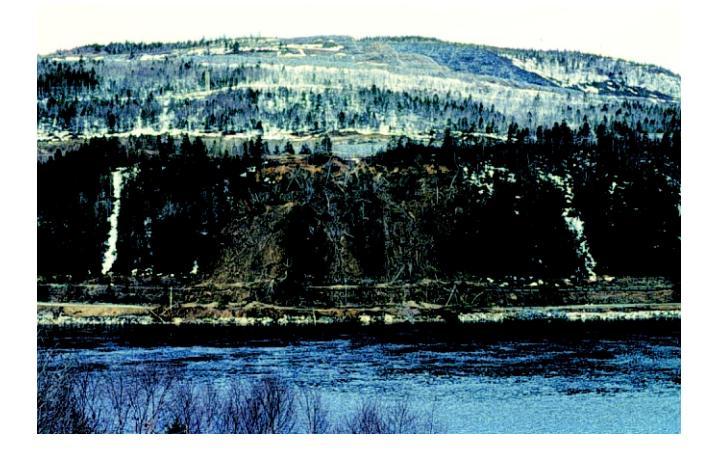
Plate 3. Landslide at Riverside Drive, Corner Brook, April 1994. The three separate scars were the result of landslides within several hours of each other. Debris from the landslide was observed on the telephone wires. The road was not re-opened until mid-summer 1994.

On April 19, 1994, a series of landslides blocked Riverside Drive in Corner Brook (Plate 3). The slides originated on a north-facing slope having a stratigraphy consisting of bedrock overlain by a compact glacial diamicton, and fluvial sand and gravel. The failure occurred along the interface between the fluvial sediments and the till in the upper part of the slope, whereas the lower slope was frozen. The cause of the slides was determined to be related to inadequate drainage from the newly constructed Trans-Canada Highway in the area (Newfoundland Geosciences, 1994). During construction, a major drainage ditch was cut by the new highway. Following a period of intense snowmelt, water normally carried by this ditch was redirected through the subsurface to the adjacent slopes above Riverside Drive,

triggering the landslides. No injuries resulted from the slides, although Riverside Drive was closed until mid-summer. Remedial measures included the construction of sealed ditches to direct water from slopes susceptible to failure. The Department of Works, Services and Transportation assumed responsibility for the slide and absorbed the \$63 000 estimated cost of remedial measures.

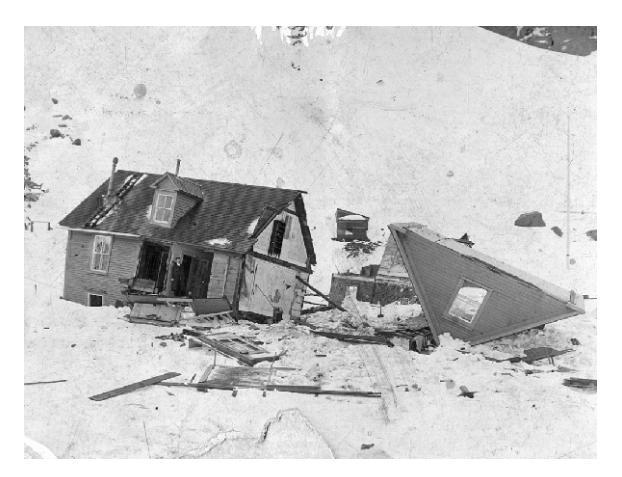
Plate 5. Remains of the Williams house following an avalanche at Tilt Cove in March 1912. The avalanche killed 4 persons in the house, including the mine manager and his son. The adjacent house was also damaged. A servant in this house was also killed. Photograph courtesy of the MacKinnon family.

heavy snow fall had followed freezing rain the previous day². Both houses were smashed by the avalanche, and Mr. Williams and his 13-year-old son were killed instantly. Two servants in the Williams household were also killed. Mrs. Williams and her two daughters were rescued after three and a half hours of burial, without serious injury. In the Cunningham household, most survived with minor injuries, but Edward Cunningham, aged 3, and a servant, Emily were buried, and crushed against the wood stove. They were rescued after two hours of digging. Edward survived with minor burns thanks to the efforts of Emily to keep him safe. Emily, however, was severely burned and died later.

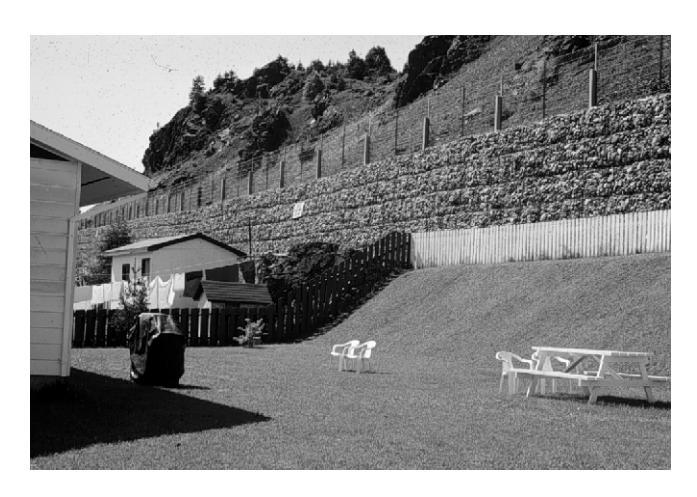
Plate 6. Retaining wall constructed in Taylor's sub-division, Springdale at a cost of \$286 000. The sub-division was built at the base of a highly fractured basalt cliff.

Expansion of the town of Springdale led to the 1972 development of a new subdivision adjacent to a highly fractured basalt cliff. Several incidents of rockfalls from this cliff over the next few years resulted in property damage when boulders struck houses and vehicles. A youth was killed in April 1984, while climbing on the slope, when a large boulder toppled and crushed him. In response to these incidents, extensive engineering works were undertaken by the Department of Municipal Affairs to stabilize parts of the cliff face. In 1986, a retaining wall (Plate 6) was constructed at a cost of \$286 000 to protect 11 houses that were built along the foot slope (Boyd, 1991).

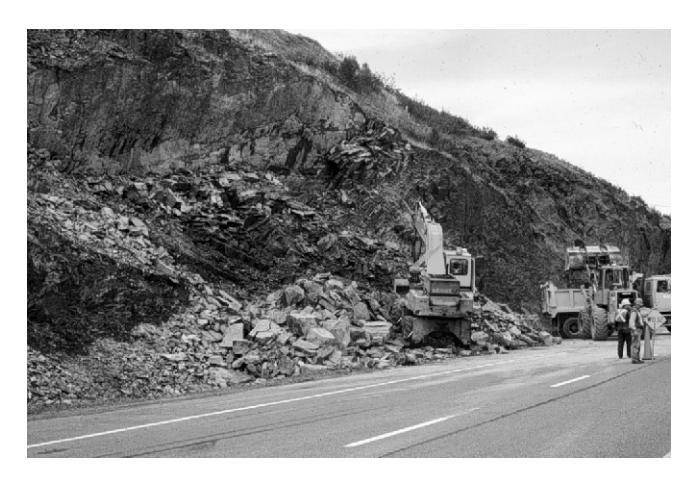
Plate 7. Clean-up efforts following a rockfall along the Pitts Memorial Drive, St. John's in April 1997. Debris closed the road for several hours, but there were no serious injuries.

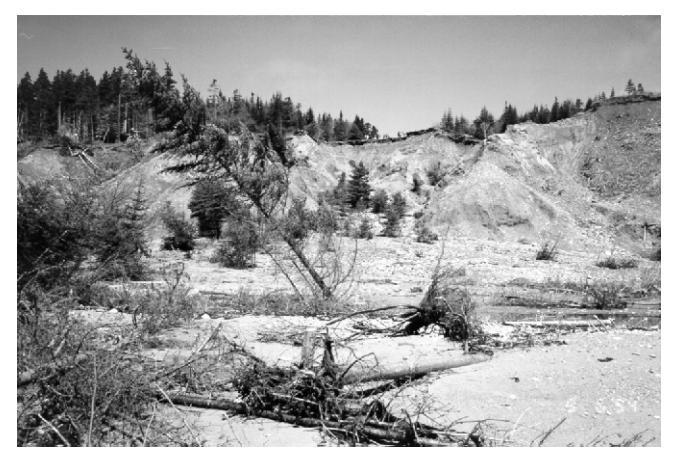
Plate 8. Landslide in coastal cliffs at Port au Port East that occurred in May 1994. Note the alluvial fan that developed on the beach as debris was washed from the gully. This fan had largely been removed by marine action within two years.

The stretch of coast lying between Stephenville and the Port au Port Peninsula has seen increased development in the last few years. The coastline in this area consists of steep (up to 30 m) cliffs of sand and gravel that are retreating at an unknown rate. Encroachment of house construction into the cliff edge area has resulted in increasing concerns regarding property loss in this area. The provincial Geological Survey has visited the site in recent years at the request of the local council. The Atlantic Geoscience Centre of the Geological Survey of Canada contracted a detailed photogrammetric survey of this area to evaluate erosion rates (Forbes *et al.*, 1995). Following a period of heavy rain in May 1994 rapid headward expansion of a gully occurred at Port au Port East (Plate 8). The slide area measured about 150 by 200 by 30 m, and ended about 50 m from the nearest structure (C. McCarthy, Department of Municipal Affairs, personal communication, November 1994). A large debris fan was formed on the beach. Two smaller failures also occurred during the same storm, 500 m and 1300 m west of the main failure.

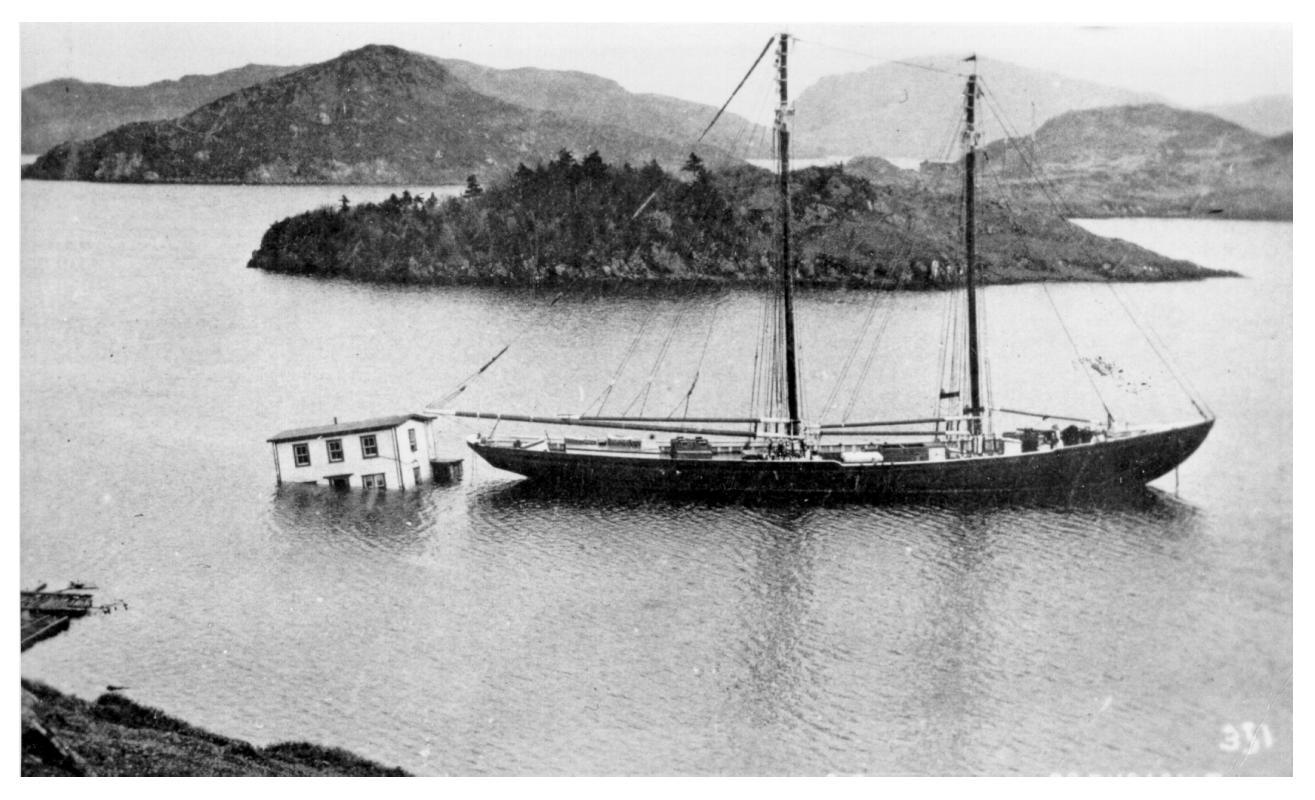
Plate 9. Schooner moored to a house that had been washed out to sea during the Burin Tsunami, November 1929. The tsunami caused 28 deaths in Newfoundland and was the worst earthquake-related disaster in Canadian history. Photograph courtesy of Provincial archives.

The vulnerability to flooding was emphasized by the disaster associated with the 1929 tsunami (Plate 9). The tsunami was produced by an earthquake on the Grand Banks that measured 7.2 on the Richter scale. The earthquake triggered a turbidity current that displayed about 200 km³ of material down the continental slope. The effect on the ocean surface was a tsunami that radiated out from the epicentre. The tsunami was recorded in Nova Scotia and New York in the west, and Portugal in the east (Ruffman, 1994), but impacted most severely on the Burin Peninsula. The tsunami traveled at speeds up to about 500 km/hr through deep water, and about 140 km/hr over the continental shelf (Ruffman, 1994), but had slowed to about 40 km/hr upon impact with the coast (A. Ruffman, Geomarine Associates, personal communication, November 1994). The tsunami arrived as three main pulses, causing local sea levels to rise between 3 and 7 m. Twenty-eight lives were lost on the Burin Peninsula as a result. Total damage to property was estimated at about \$1 million (1929 dollars).

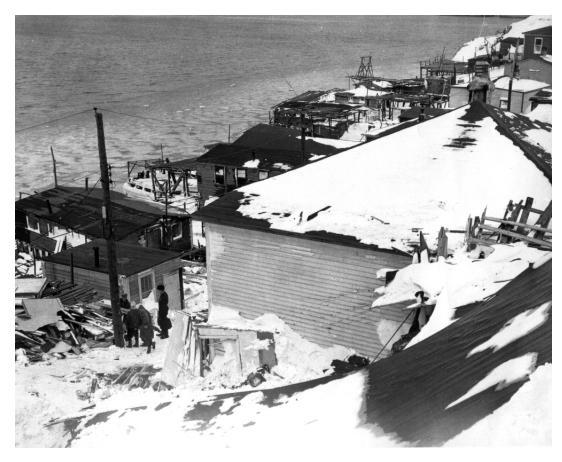
Plate 10. View of The Battery following the avalanche of February 1959. This was the second major avalanche to have affected The Battery in 40 years. Several other smaller incidents have been reported subsequently. Photograph courtesy of Shirley Eales.

winds reported up to 220 kph, dumping 55 cm of snow. At 1:05 a.m., residents in the Outer Battery heard a sound described as louder than a clap of thunder. An avalanche struck two houses sweeping them downslope (Plate 10). The two houses, belonging to the families of Clarence Wells, and Jim Piercey, contained 14 people. Five people were killed and several injured, including Shirley Noseworthy, rescued after being buried for 10 hours. Elsewhere in the Outer Battery, 11 members of the Garland family were buried by what was apparently an earlier avalanche, and they were trapped until dug out by rescuers. Fortunately, the house was able to withstand the weight of snow, and no injuries occurred.

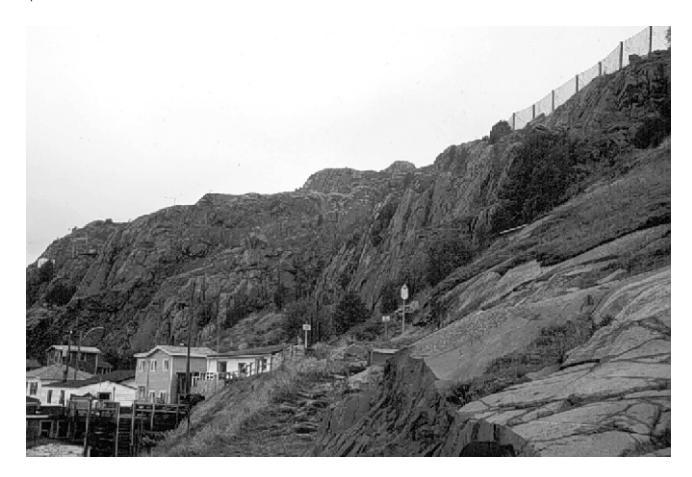
Plate 11. Fencing constructed above the Outer Battery in 1998. The initiative for this protection came from work by the Geological Survey that highlighted the history of avalanche and rockfall in this area. This demonstrates the impact that baseline data can have on planning decisions within municipalities.

A preliminary inspection of the slopes was made in 1995, and a recommendation made that the rockfall hazard should be investigated in detail. Subsequently, consulting reports have confirmed that a rockfall hazard does exist (Newfoundland Geosciences, 1996). The provincial Geological Survey was able to involve Dr. Bruce Jamieson of the Canadian Avalanche Association in further assessments of the slopes with regard to avalanche hazard. Based on the results of his work, and that of the consulting efforts with regard to rockfall (e.g., Golder Associates, 1980, 1992), the City of St. John's constructed safety fences to provide protection from rockfall and avalanche in the Outer Battery (Plate 11) with estimated costs in excess of \$300 000.
