**Long Pond Weir
Environmental Preview Report**

Sensitivity Analysis
Pre- and Post-Weir Construction
Floodplain Delineation

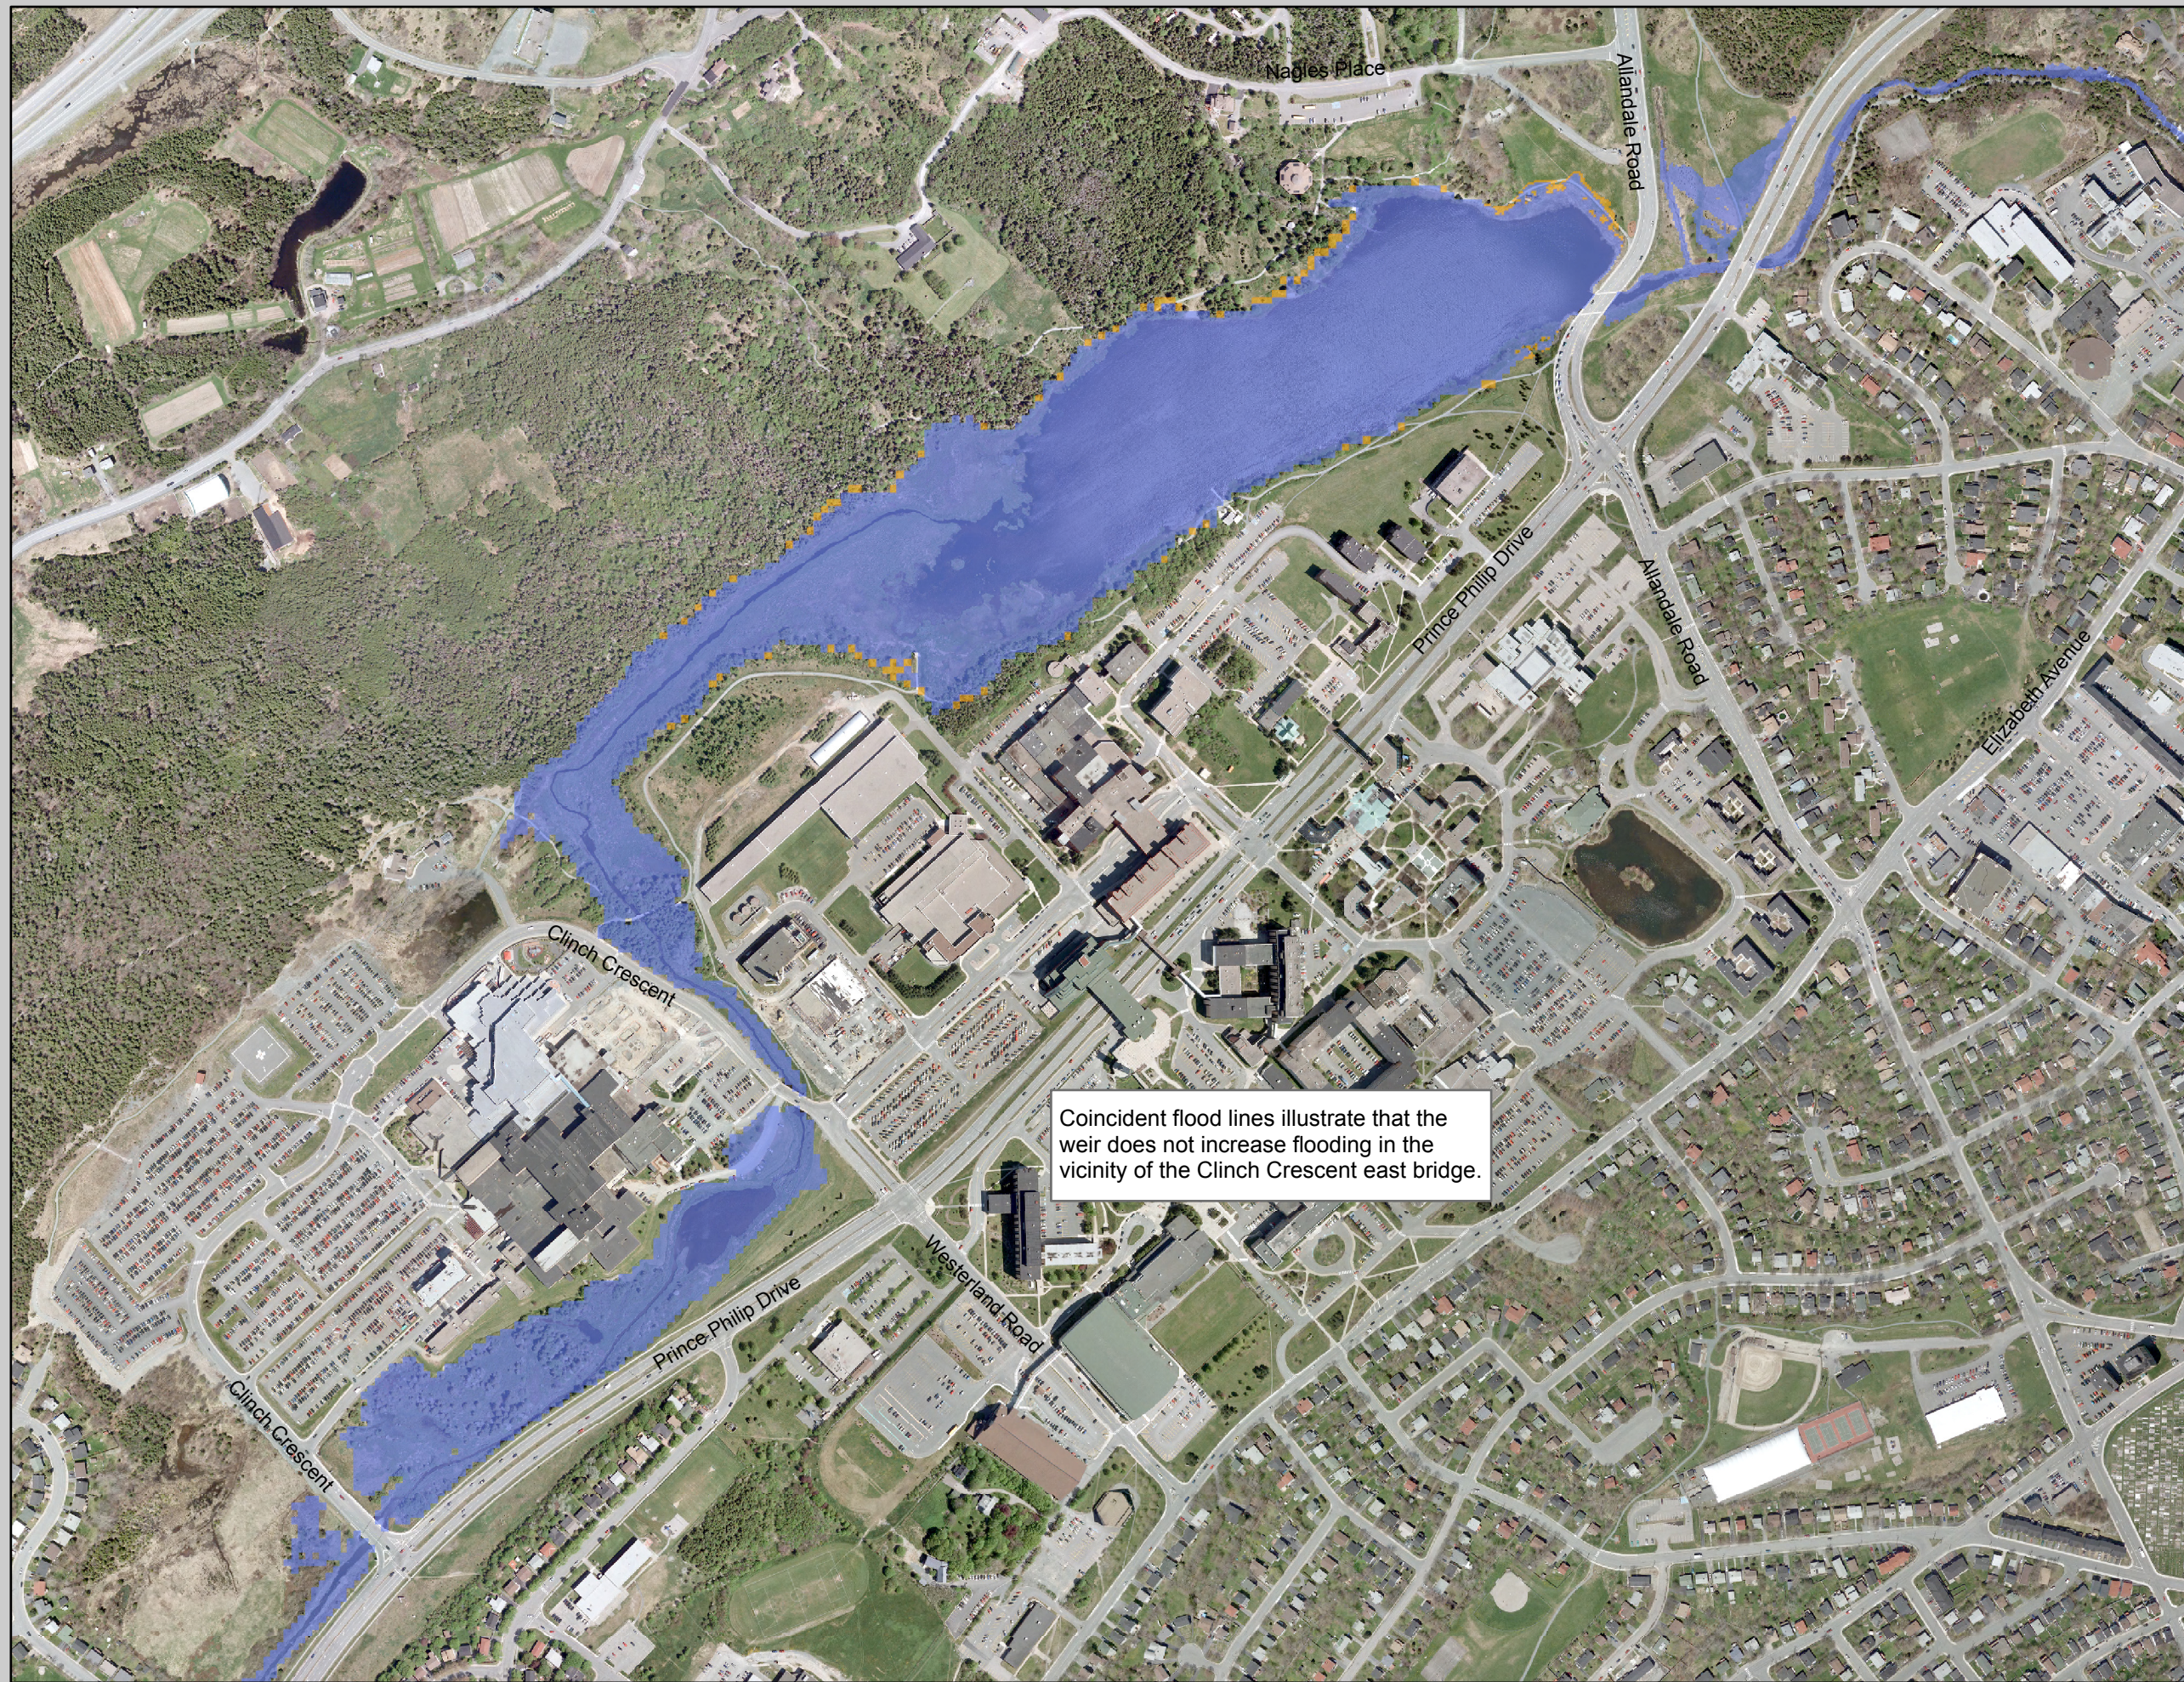
1:5 AEP + 30%
Pre-Construction
-

1:5 AEP + 30%
Post-Construction

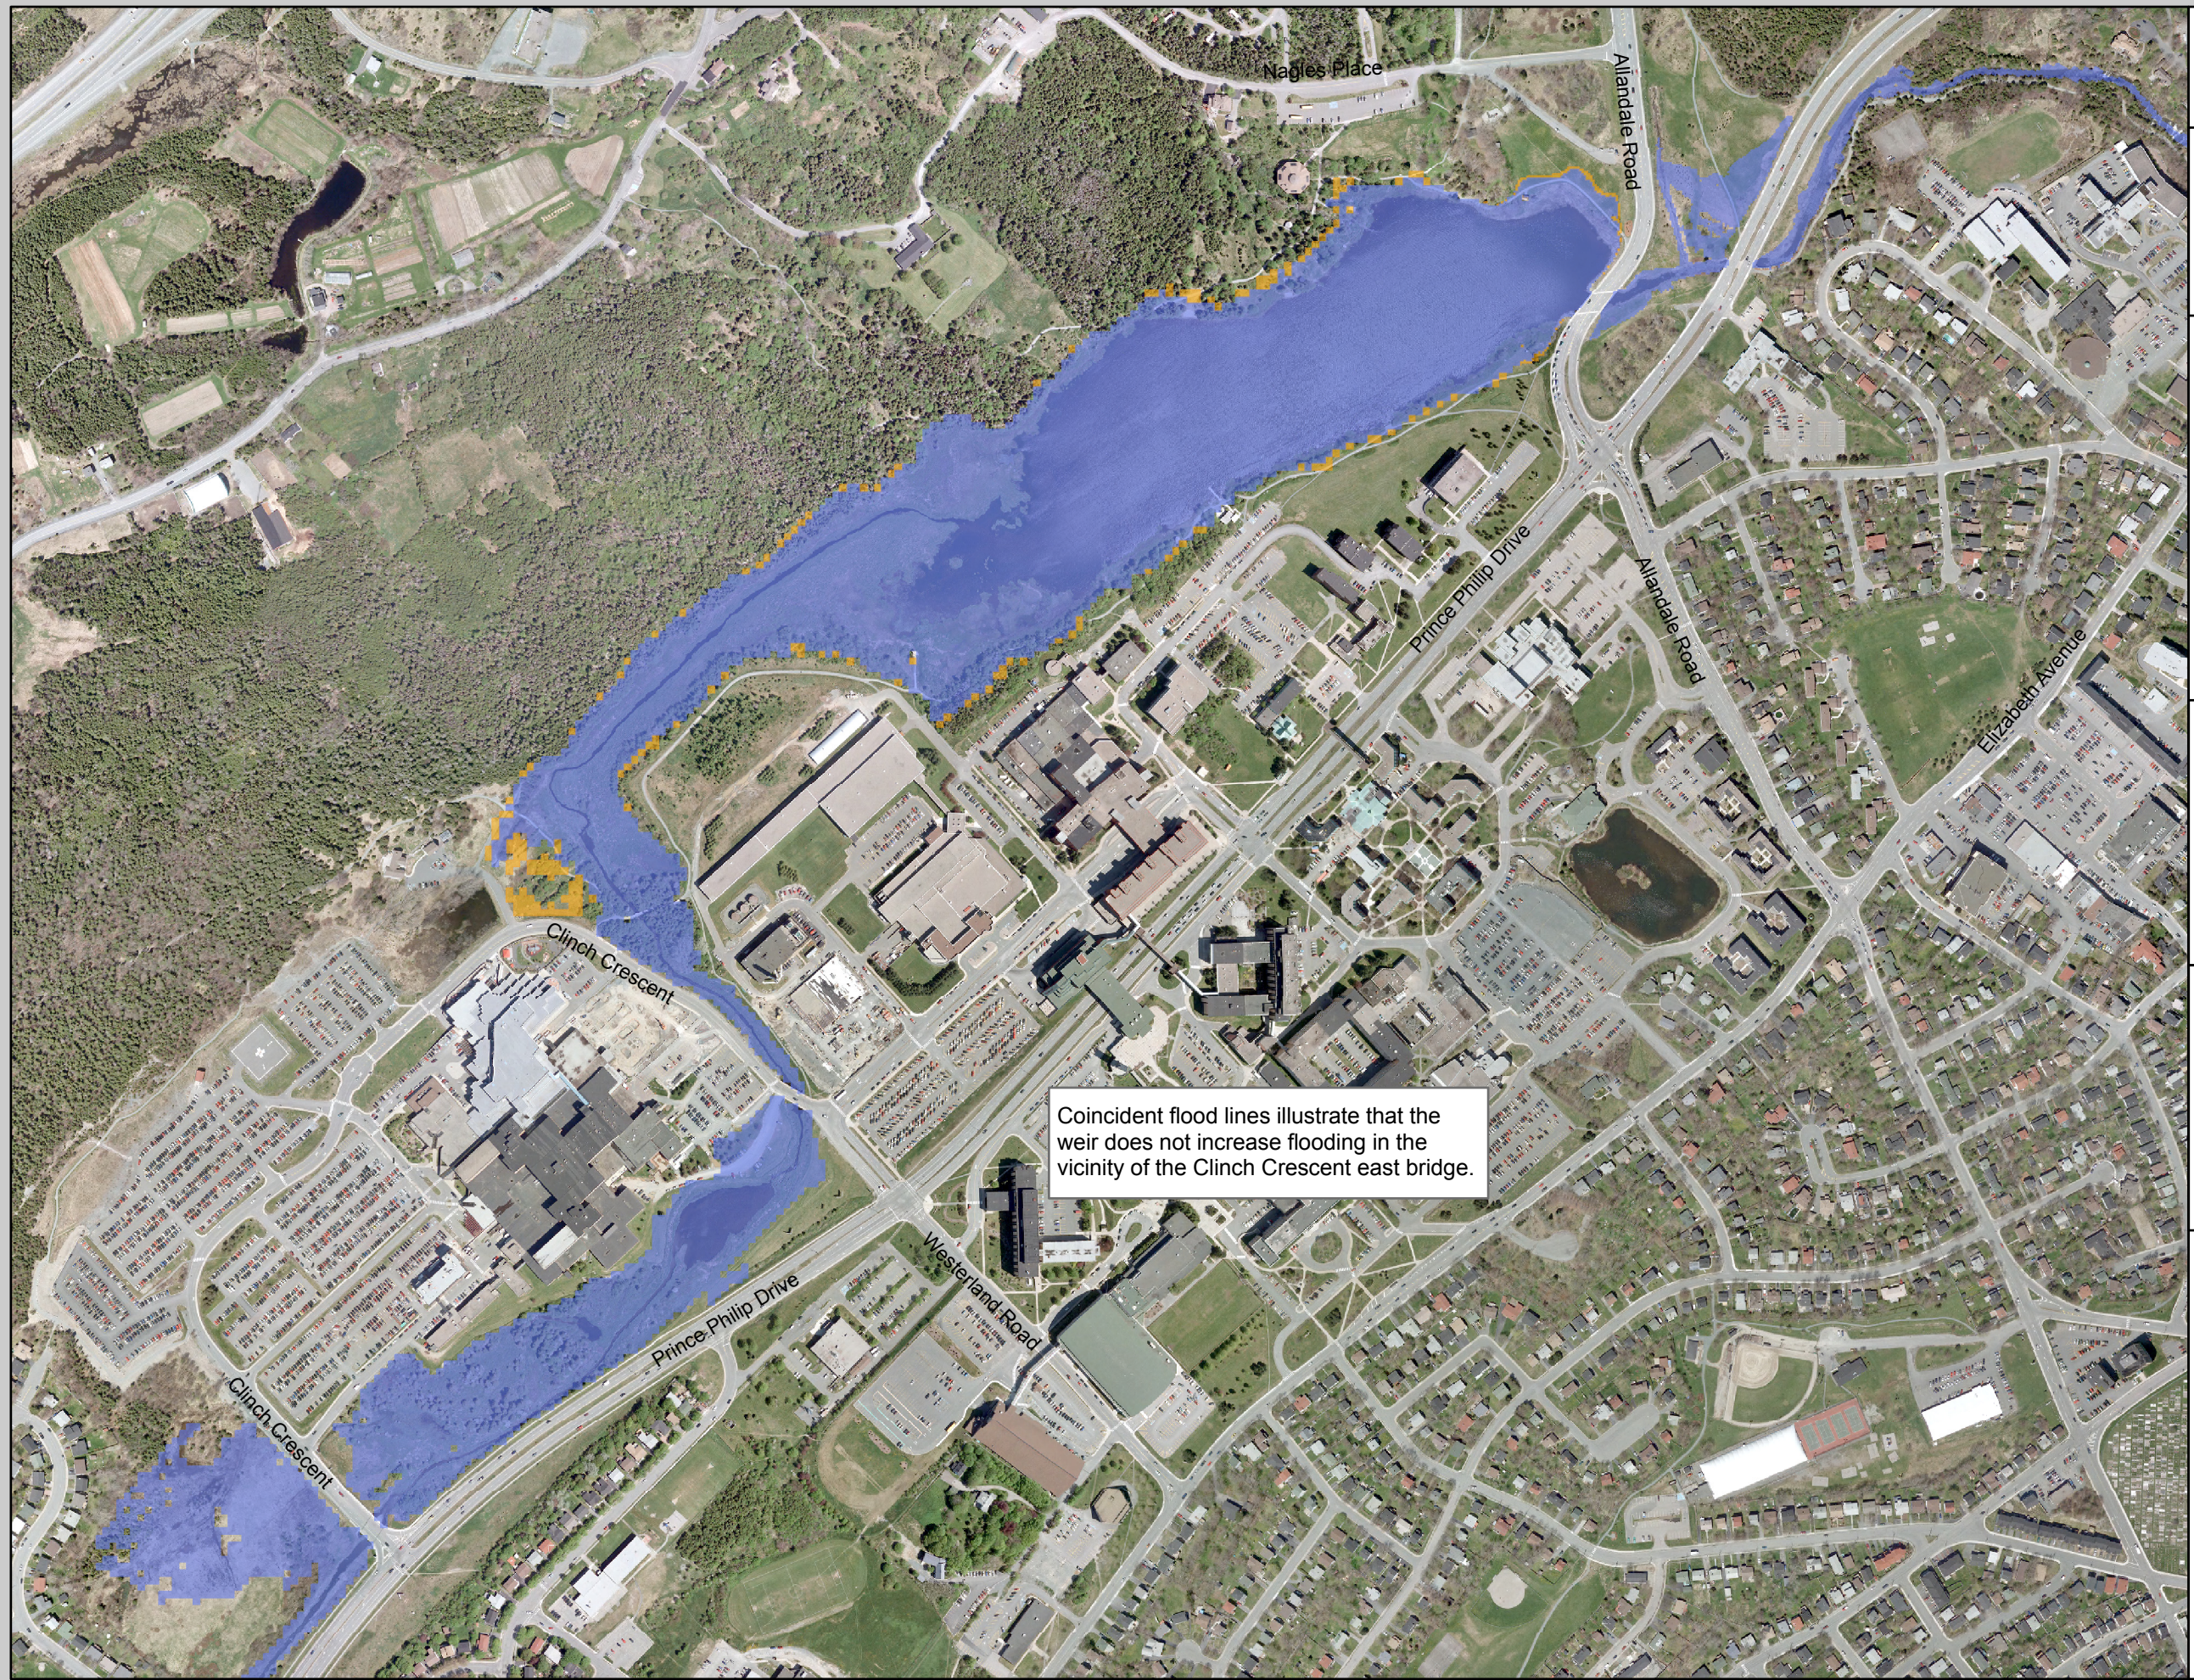
- 1:20 AEP + 30%
Pre-Construction
- 1:20 AEP + 30%
Post-Construction

Sensitivity Analysis
Pre- and Post-Weir Construction
Floodplain Delineation

Coincident flood lines illustrate that the weir does not increase flooding in the vicinity of the Clinch Crescent east bridge.

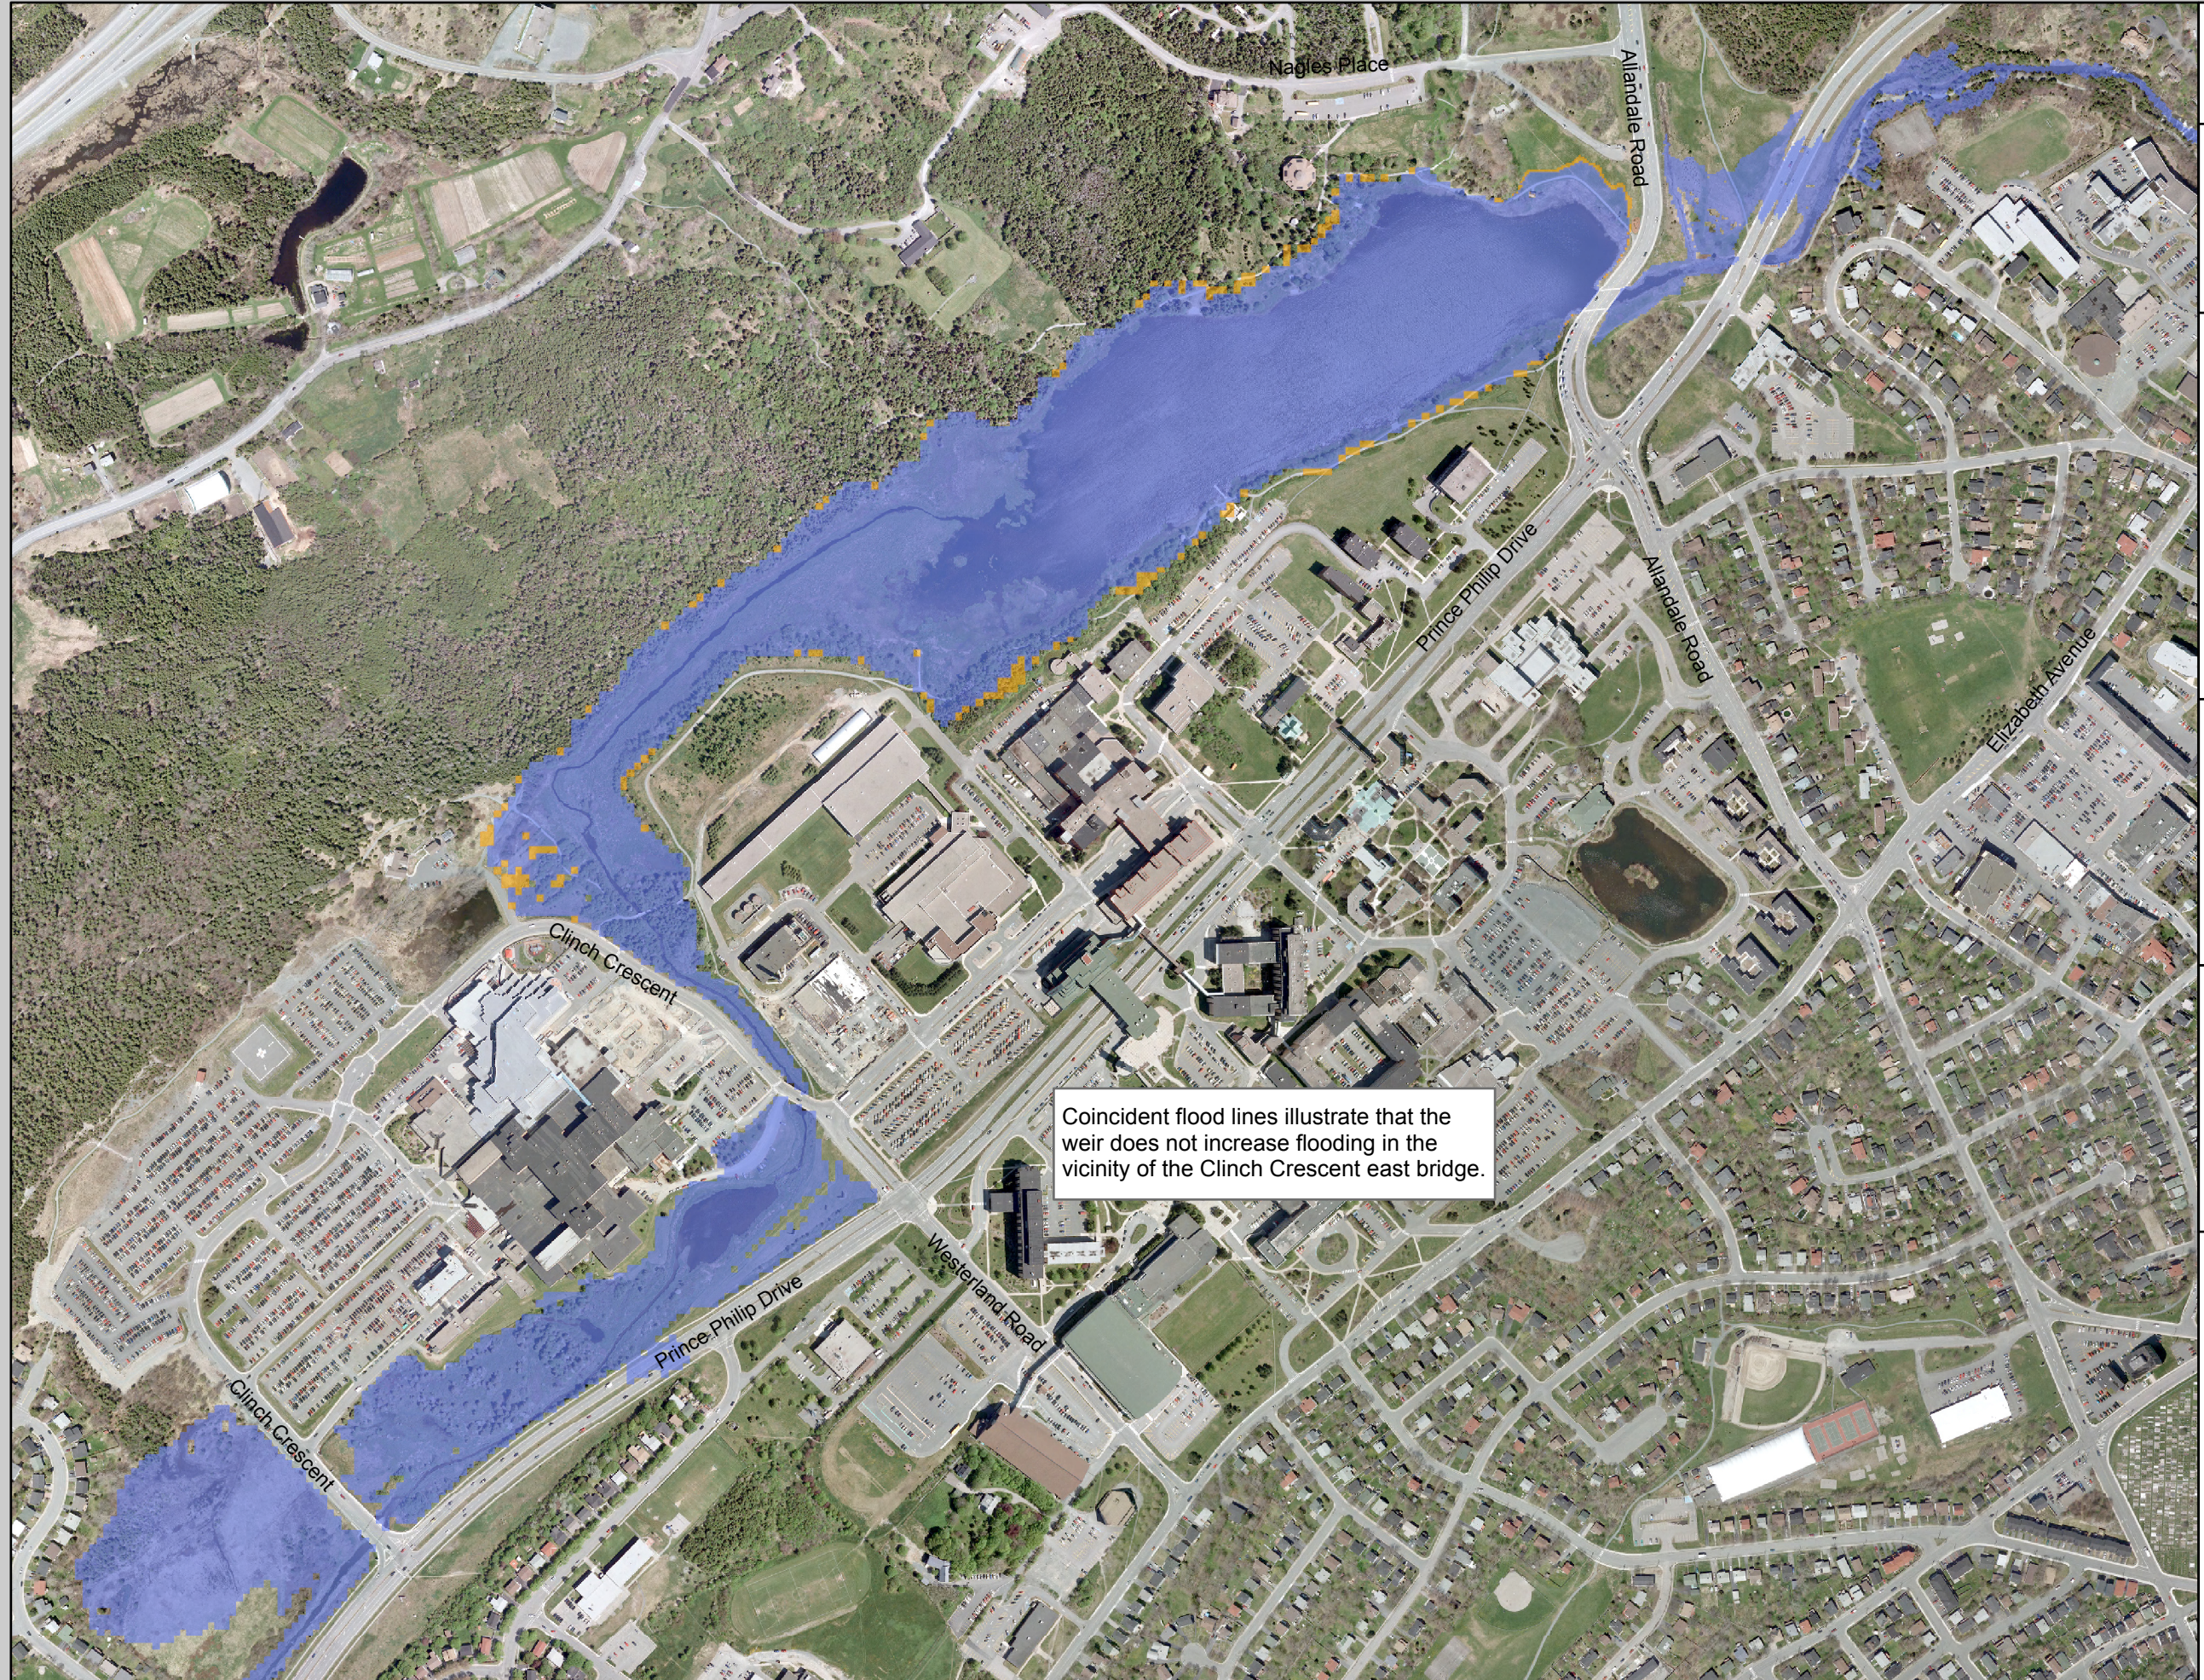
1:50 AEP + 30%
Pre-Construction
-

1:50 AEP + 30%
Post-Construction

Sensitivity Analysis
Pre- and Post-Weir Construction
Floodplain Delineation

Coincident flood lines illustrate that the weir does not increase flooding in the vicinity of the Clinch Crescent east bridge.

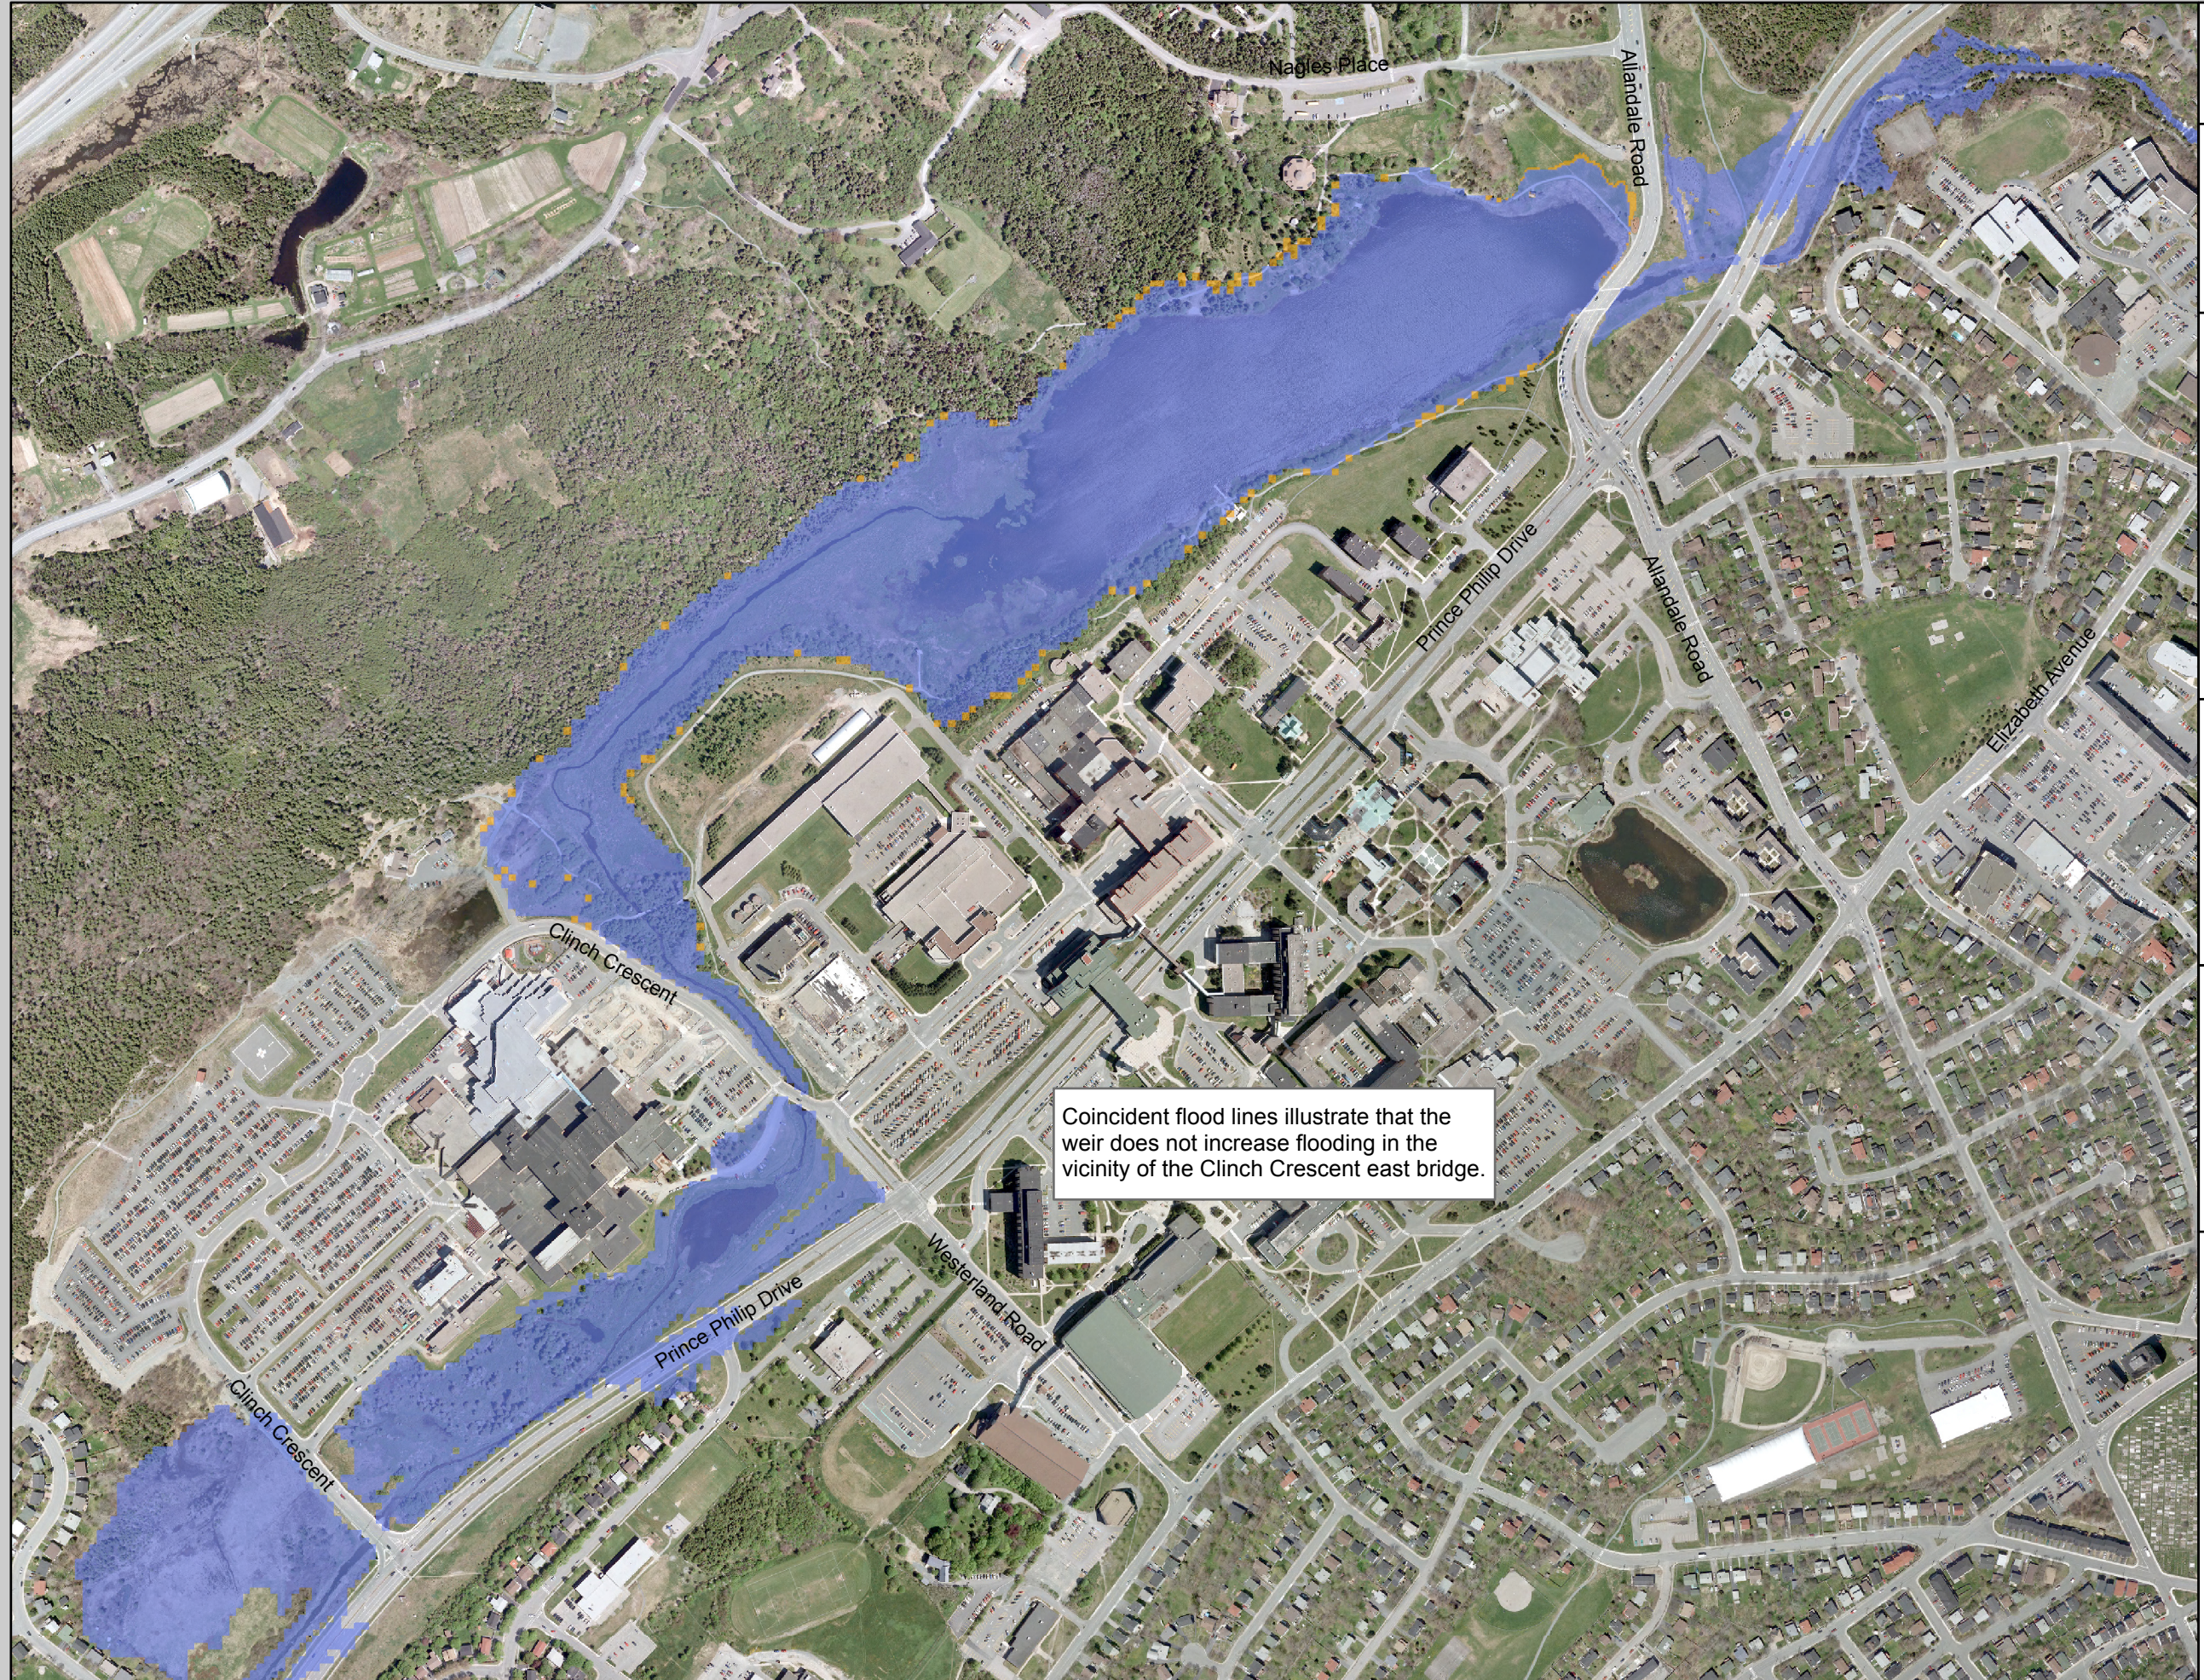
1:100 AEP + 30% Pre-Construction
-

1:100 AEP + 30% Post-Construction

Sensitivity Analysis
Pre- and Post-Weir Construction
Floodplain Delineation

Coincident flood lines illustrate that the weir does not increase flooding in the vicinity of the Clinch Crescent east bridge.
