# Total Methylmercury (ng/L) in Water

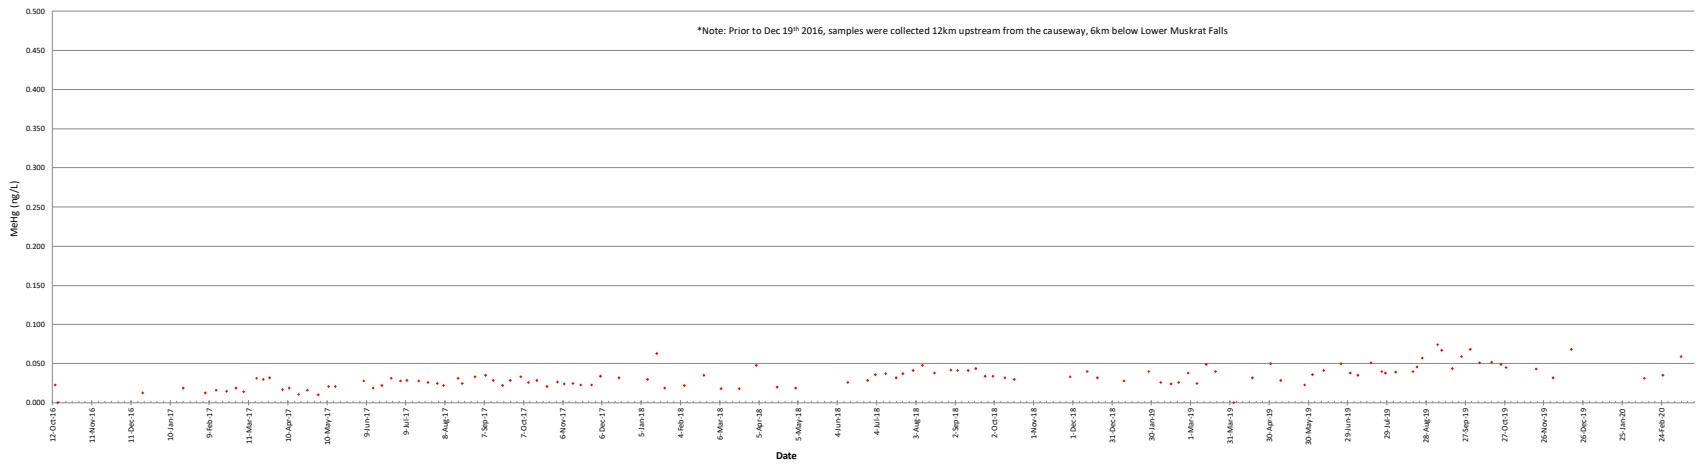
Site N6 - Causeway

\*Note: Prior to Dec 19<sup>th</sup> 2016, samples were collected 12km upstream from the causeway, 6km below Lower Muskrat Falls
