Teck Duck Pond Operations Real-Time Water Quality Monitoring Network Annual Report 2015

2016-04-07

Government of Newfoundland & Labrador
Department of Environment and
Conservation
Water Resources Management Division

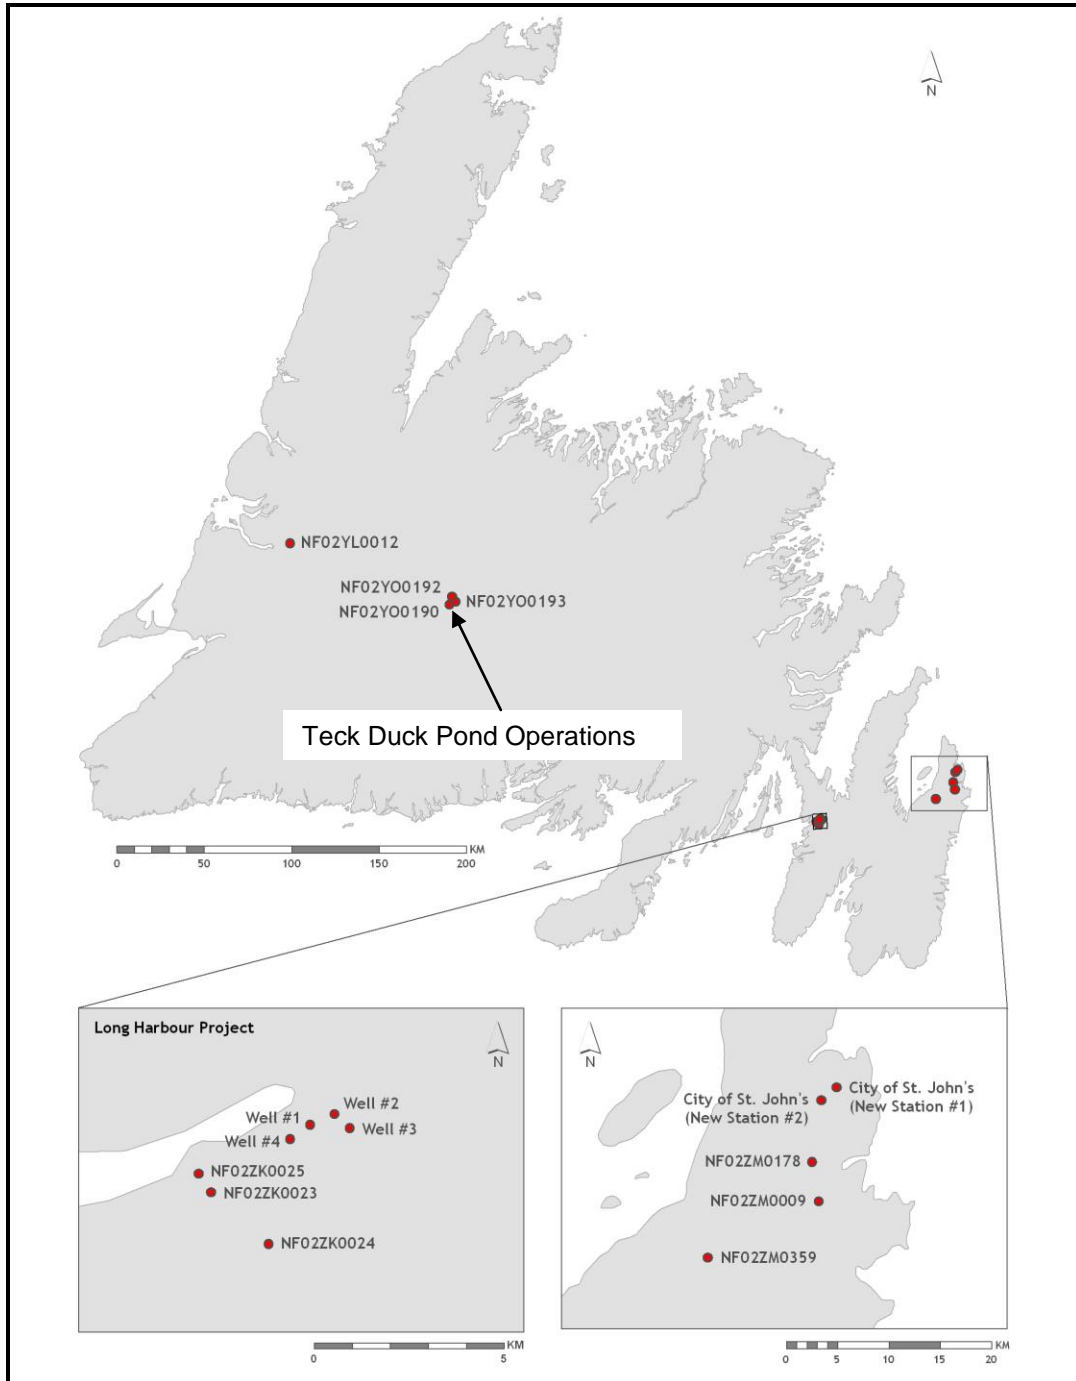
Figure 1: Real-Time Water Quality Monitoring Stations, Newfoundland

The Real-Time Water Quality Monitoring Network at Teck Duck Pond Operations began in 2006 when the property was being developed by Aur Resources Inc. This network forms part of a larger network of government run and government-industry partnership run real-time water quality stations throughout the Province. **Figure 1** depicts the Real-Time Water Quality Monitoring Network at Teck Duck Pond Operations in relation to the others on the island portion of the Province.

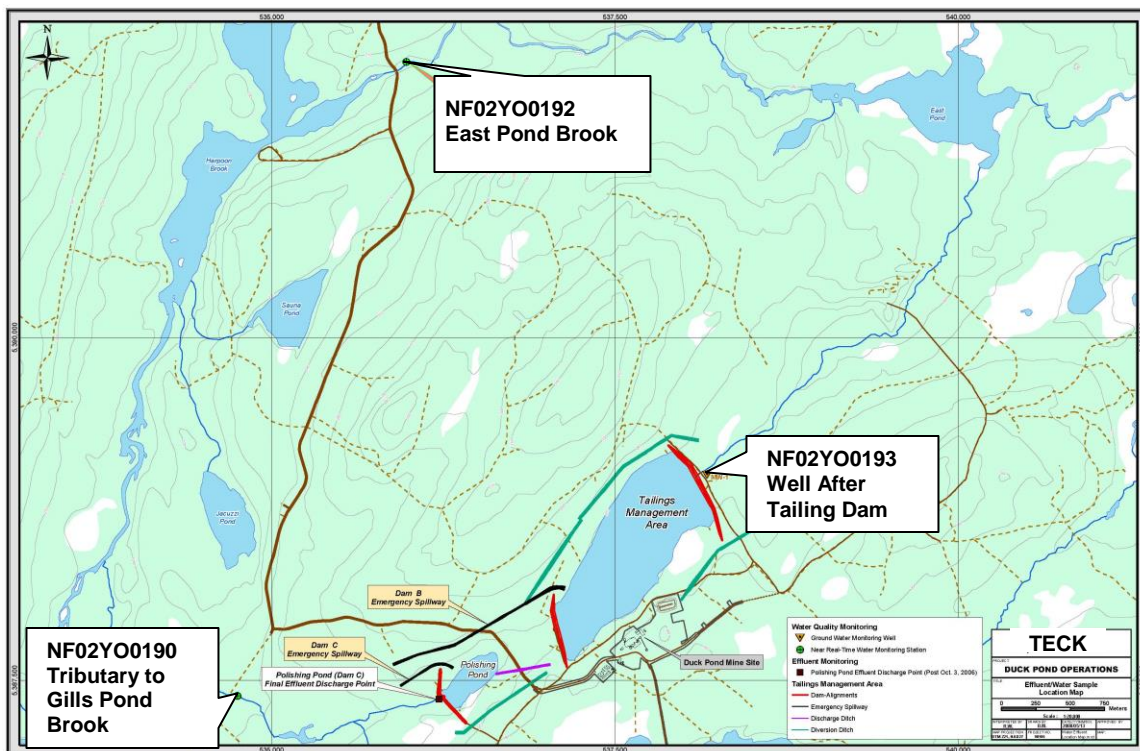
**Figure 2: Real-Time Water Quality Monitoring Stations
Teck Duck Pond Operations**

Three permanent stations (**Figure 2**) are established at Teck Duck Pond Operations; two in surface water streams and one in a ground water monitoring well:

- **Tributary to Gills Pond Brook Station (NF02YO0190)** is located 1700 m downstream of the final release point for the site's Tailings Management Area / Polishing Pond. This station is located such that any impacts from normal mine/mill discharge on receiving waters can be measured. This station has been fully operational since May 10, 2006 during the mine/mill construction phase.

- **East Pond Brook Station (NF02YO0192)** is located several kilometers downstream of the Tailings Management Area. This station is located such that any surface water impacts from the Tailing Management Area via seepage through Dam A may be measured. This station has been fully operational since September 7, 2006, during the mine/mill construction phase.

- **Monitoring Well After Tailings Dam Station (NF02YO0193)** is located approximately 100 meters below Tailings Dam A. This station is located such that any ground water impacts from the Tailing Management Area via seepage through Dam A may be measured. This station has also been fully operational since September 7, 2006.

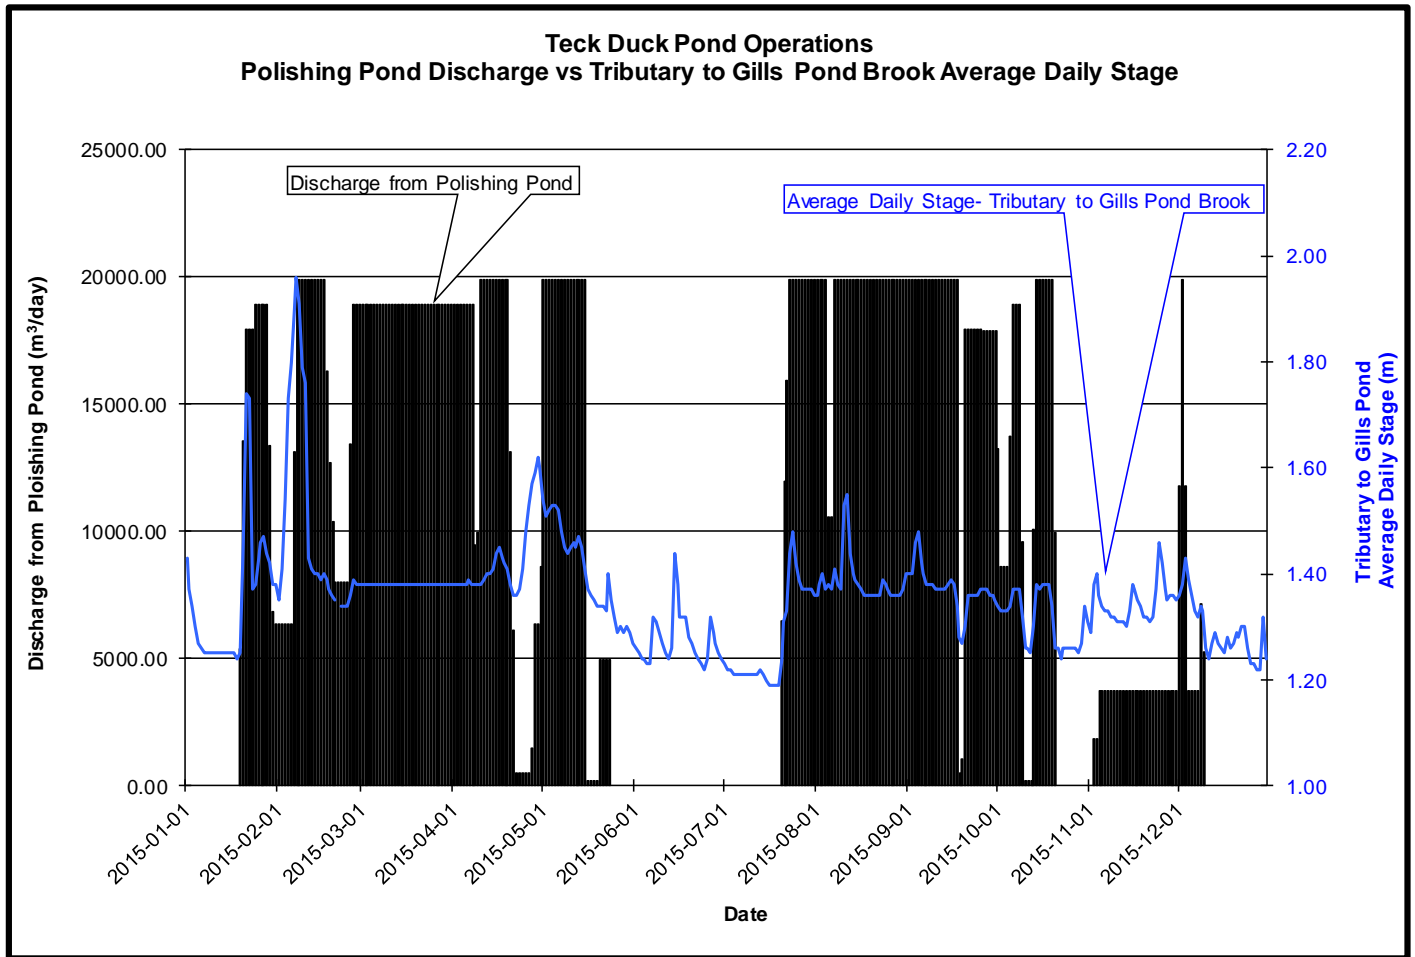
Figure 3 illustrates the Total Daily Discharge from Polishing Pond in relation to the Average Daily Stage or Water Level in the receiving waters, Tributary to Gills Pond Brook. Increases in stage above normal baseline levels are quite evident during discharge periods.

The highest peaks during January and February are the result of the backwater effect due to in-stream icing conditions. It is also interesting to note, that there is usually a peak in the Average Daily Stage for several days, each time discharge from Polishing Pond is initiated, or when discharge rates are increased. This is considered to be a surge.

Other peaks are the result of significant precipitation/runoff events.

Please note that the stage illustrated on this graph is the Average Daily Stage, which is different than the hourly stage measurements illustrated and discussed in Section 4.1; some of the extreme high and low hourly values are normalized in the average.

The stage data is raw data that is transmitted via satellite and published on our web page. It has not been corrected for backwater effect. Water Survey of Canada is responsible for QA/QC of water quantity data. Corrected data can be obtained upon request.

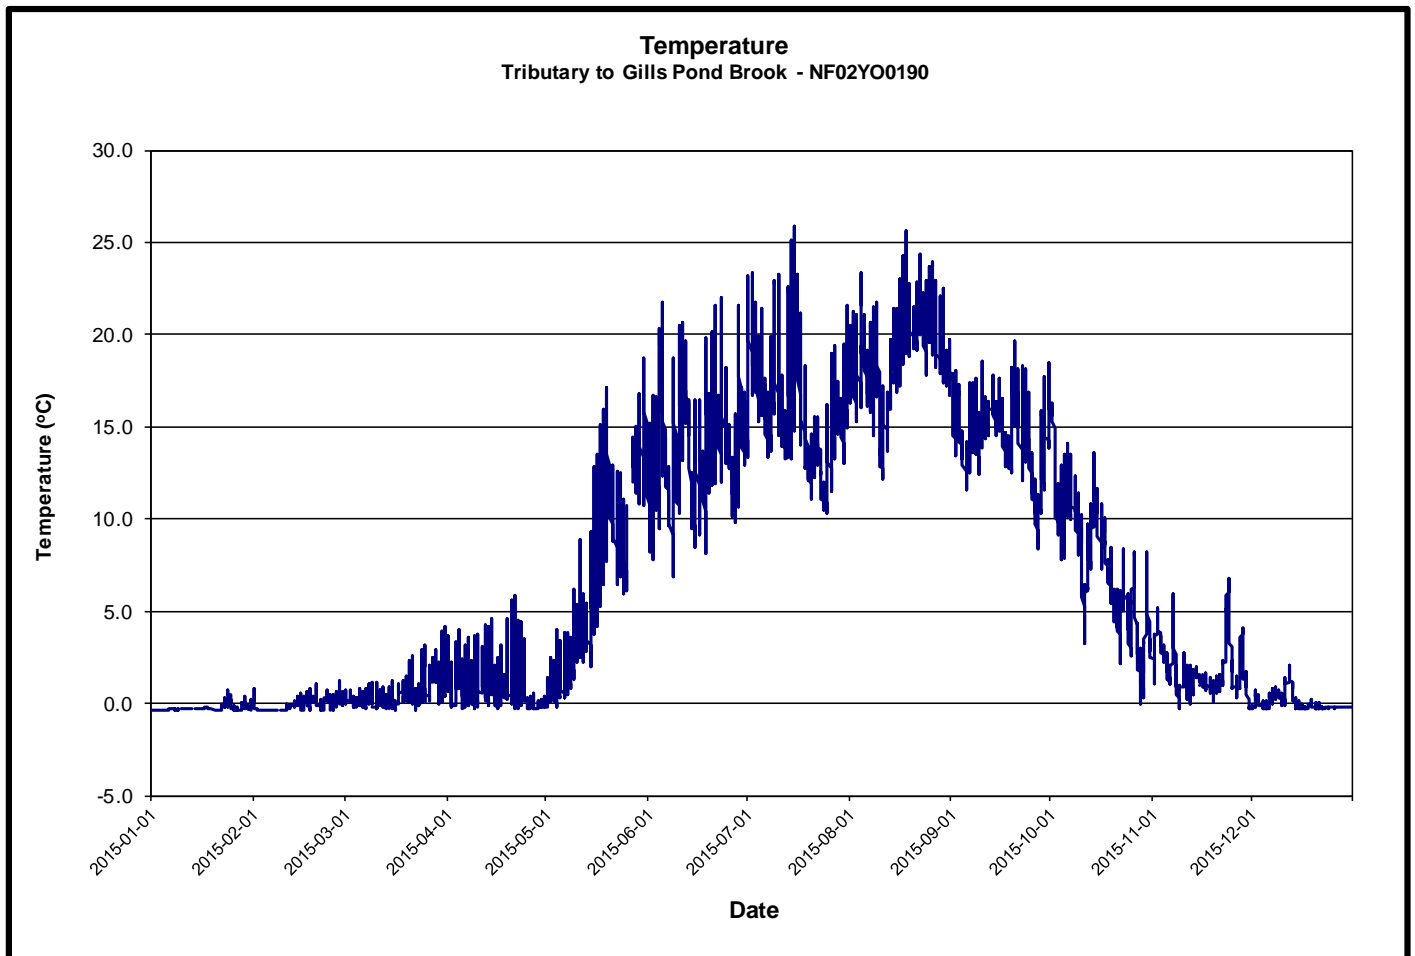
Figure 4

The water temperature (**Figure 4**) ranged from a minimum of $-0.39\text{ }^{\circ}\text{C}$ to a maximum of $25.84\text{ }^{\circ}\text{C}$. In the winter months, under the cover of ice in the stream, temperatures were generally at or slightly below the freezing point. The highest temperatures were measured in July and August. The temperature profile for this stream is very similar to that of East Pond Brook (**Figure 10**). There are no obvious changes in temperature during discharge periods (**Figure 3**). Accordingly discharge from the Polishing Pond does not appear to have any significant impact on the water temperature at this station.

Dissolved oxygen (**Figure 7**) ranged from a minimum of 7.37 mg/L to a maximum of 13.96 mg/L. Generally, dissolved oxygen is inversely proportional to water temperature; this being evident in comparison to **Figure 4**.

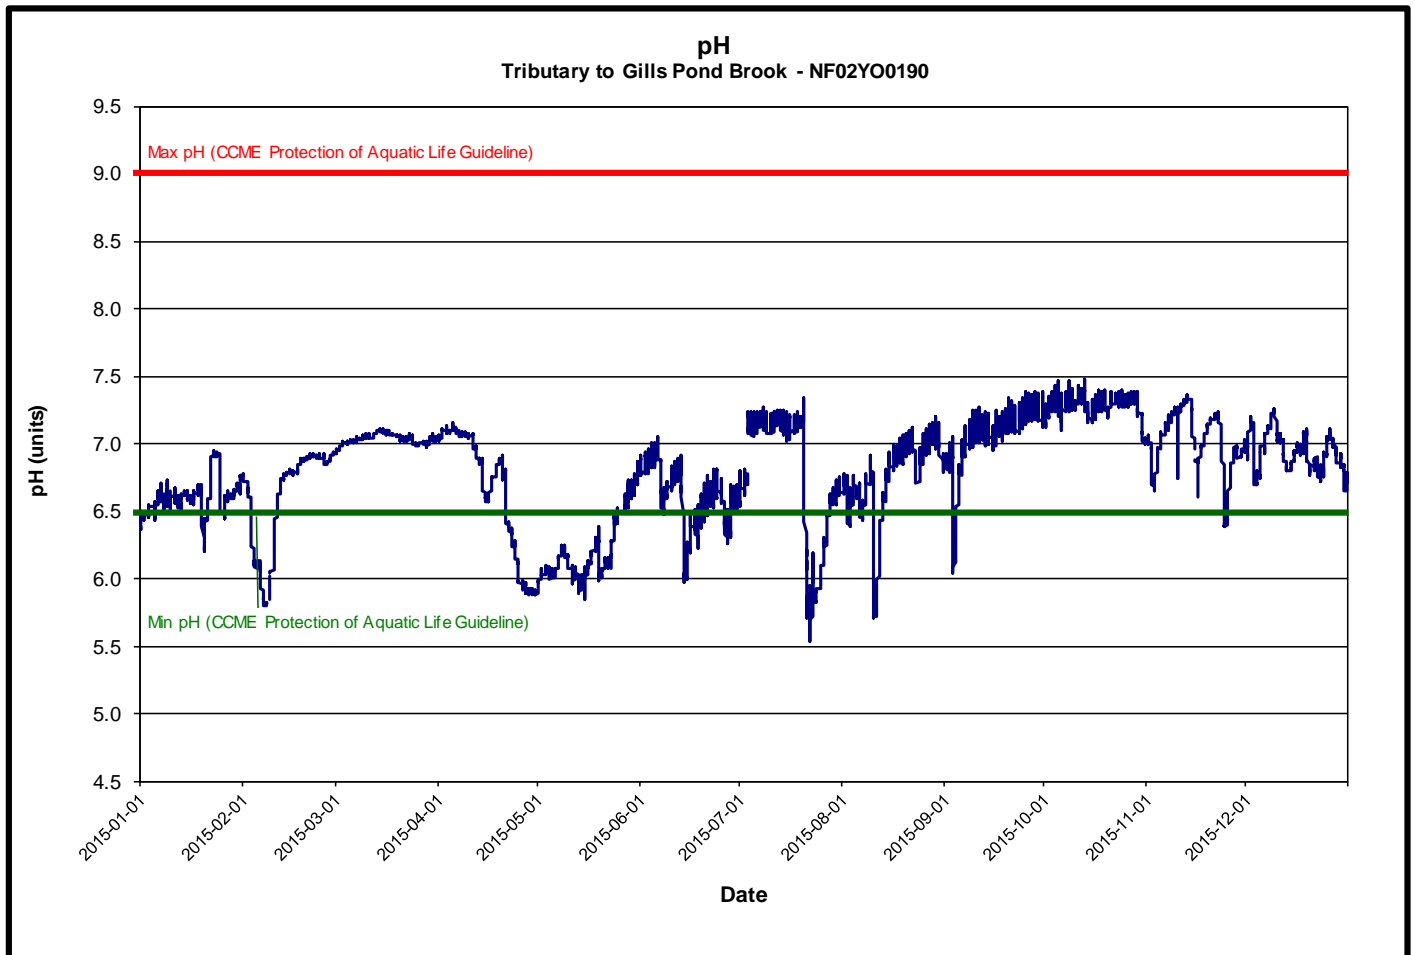
Figure 5

The pH (**Figure 5**) ranged from a minimum of 5.54 to a maximum of 7.48. The pH of this stream is naturally quite low, often being documented to be near or below the lower limit of the recommended range (6.5 – 9.0 – see colored lines on **Figure 5**) for the CCME *Canadian Water Quality Guidelines for the Protection of Aquatic Life* ⁽¹⁾. It should be noted however, that discharge from Polishing Pond often has a pH higher than the natural background pH of the receiving waters. Thus, when there is discharge from Polishing Pond (**Figure 3**), there is generally an increased pH in the stream at this station, which often brings the water within the pH range recommended by CCME. The pH profile throughout the year is similar to East Pond Brook (**Figure 11**), except for the influences of the discharge periods.

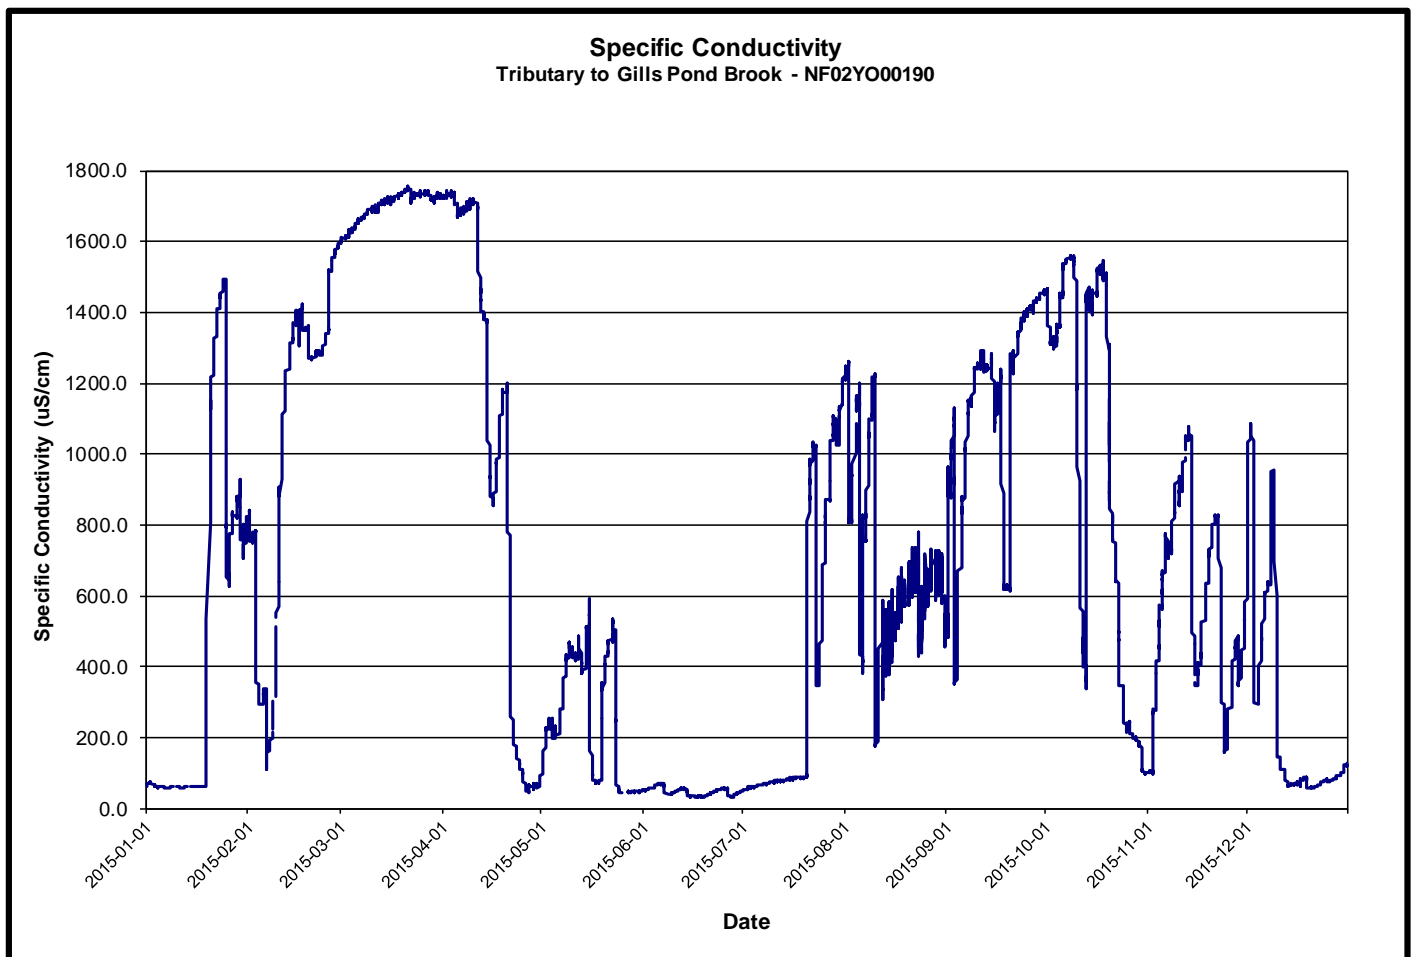
Figure 6

The specific conductivity (**Figure 6**) is affected by the amount of dissolved metals and salts in the water. Pristine waters in this part of the island generally have a specific conductance of less than 50 $\mu\text{S}/\text{cm}$. Outside the periods when there is discharge from Polishing Pond (**Figure 3**), the specific conductivity in this stream would generally be quite low. During the past year, the minimum specific conductivity was measured to be 29.3 $\mu\text{S}/\text{cm}$. When there is discharge from the Polishing Pond, conductivity increases significantly, the highest value being measured to be 1755.0 $\mu\text{S}/\text{cm}$. In fact this value was the highest specific conductance recorded at this location to date. The significant increases and decreases in specific conductivity correspond closely with the beginning and end of the discharge periods from polishing pond (**Figure 3**).

It is interesting to note, that specific conductivity dips, sometimes significantly, during increased stage following periods of snowmelt or rainfall. Snowmelt and rainfall contributions to the stream's discharge would generally have an extremely low (approaching zero) background specific conductivity and would effectively 'dilute' water in stream. This is particularly more evident when there is discharge from the Polishing Pond.

There is no recommended limit or range for specific conductance, although it is a key indicator of the dissolved metals and salts in the discharge from Polishing Pond.

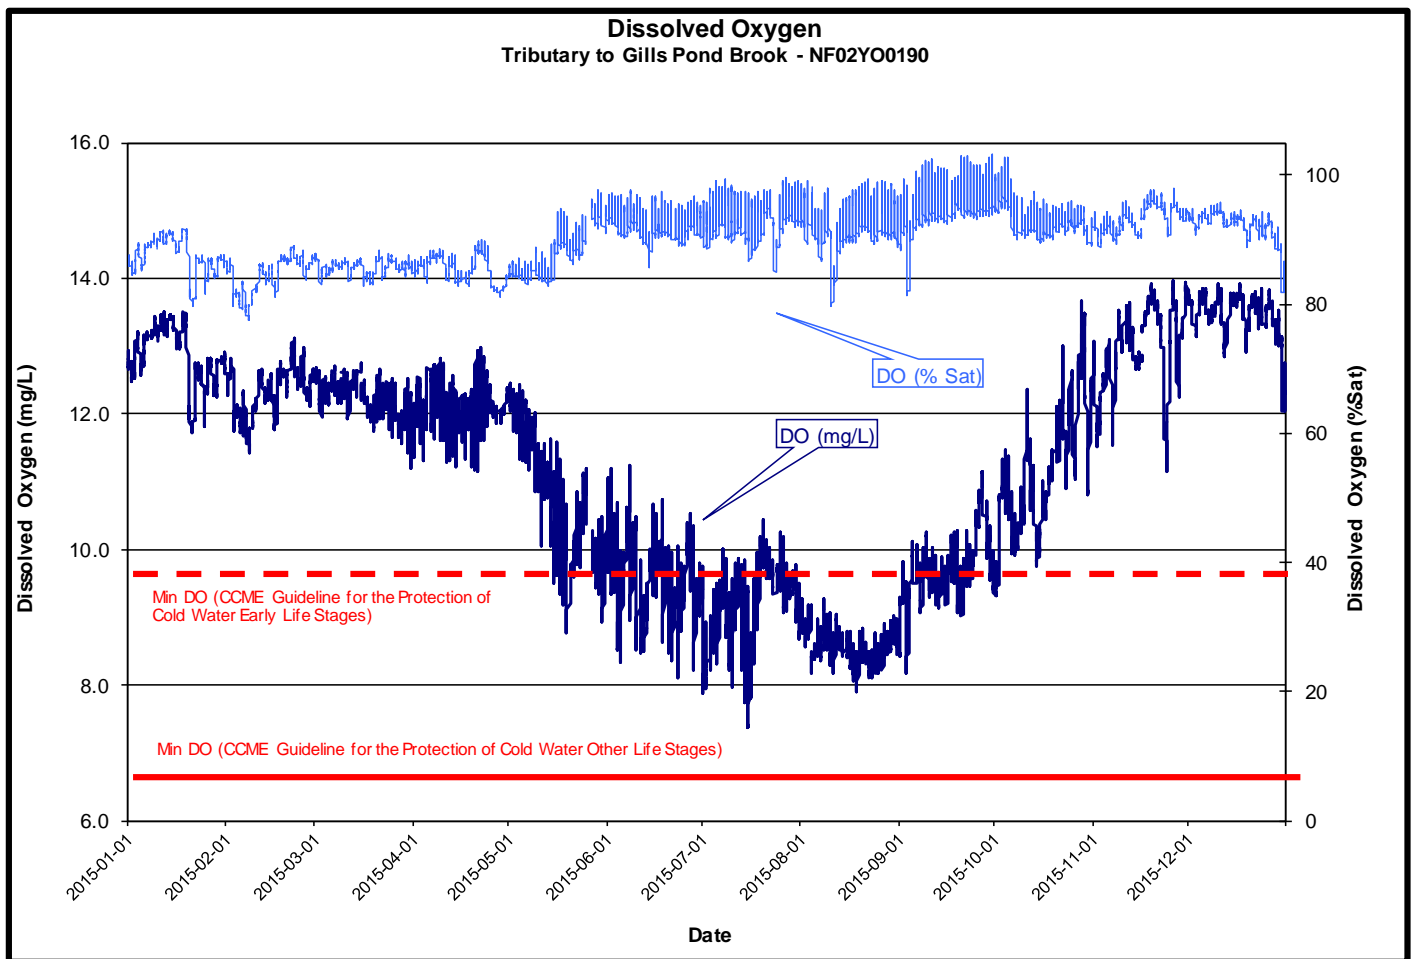
Figure 7

The CCME *Canadian Water Quality Guidelines for the Protection of Aquatic Life* ⁽¹⁾ for dissolved oxygen establish two separate lower limits for cold water biota: other life stages – above 6.5 mg/L; and early life stages – above 9.5 mg/L. While dissolved oxygen remained above 6.5 mg/L, in the warmer months, it did not remain above 9.5 mg/L, the recommended lower limit for early life stage cold water biota. This is a function of the inverse relationship to the warmer water temperatures. During the period when dissolved oxygen was below 9.5 mg/L, the percent saturation (DO % Sat) usually remained in the normal range between 80 % and 100 %, indicating that the water was fully saturated with oxygen. In fact, the dissolved oxygen in waters in East Pond Brook (**Figure 13**) has a very similar profile. There does not appear to be any appreciable change in dissolved oxygen resultant from discharge from Polishing Pond.

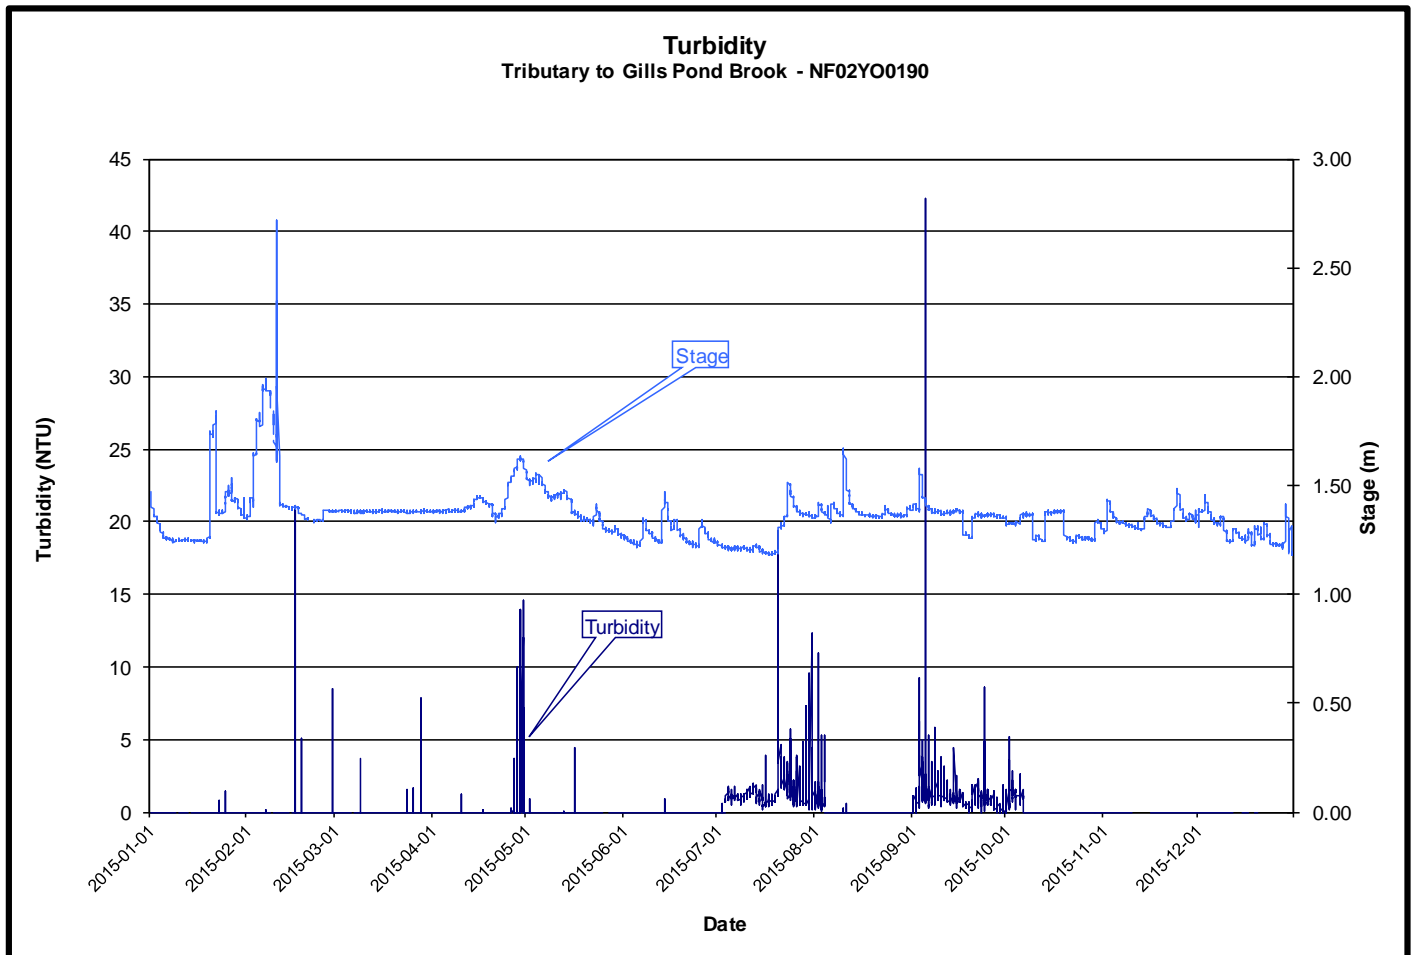
Figure 8

Turbidity (**Figure 8**) ranged from a minimum of 0.0 NTU to a maximum of 42.3 NTU. During periods when there was no discharge from Polishing Pond, turbidity values were generally at or close to zero. The frequency and intensity of turbidity spikes was generally greater during periods of discharge from Polishing Pond (**Figure 3**), or following runoff from precipitation and snowmelt events. The highest spikes in turbidity often coincide with the onset of, or increase to, the discharge rate from Polishing Pond.

From time to time, leaves, algae and other natural in-stream debris became caught on the turbidity sensor, causing interference and false-positive readings. Data for these periods has been removed. Any unusual turbidity measurements will continue to be investigated by staff of the Department of Environment and Conservation and/or Teck Duck Pond Operations.

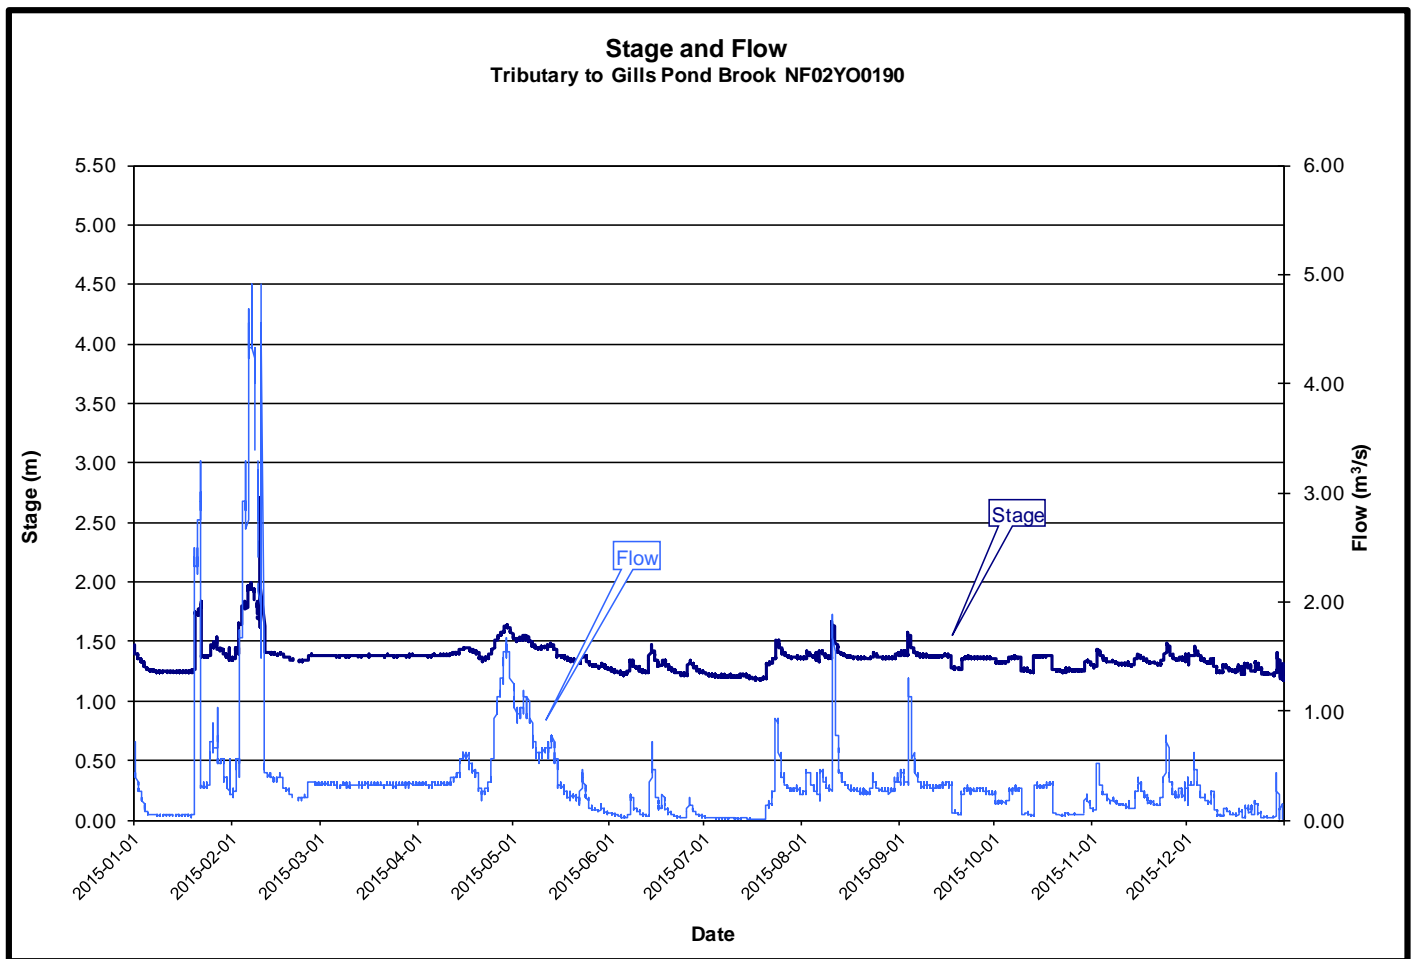
Figure 9

The stage or water level (**Figure 9**) was recorded to be between 1.18 m and 2.72 m. The flow or discharge ranged from a minimum of 0.01 m³/s to a maximum of 4.92 m³/s. At this location, stage is referenced to an arbitrary bench mark. The highest stage was recorded in January and February, presumably due to the backwater effect from ice formation.

For the remainder of the year, however, stage and flow were within normal ranges, with the higher levels corresponding to periods of controlled release from Polishing Pond (**Figure 3**) and following snow melt and rainfall events.

The flow or discharge is calculated based upon a stage-discharge curve which is developed over time. There are periods during the year, when extreme high and low flows could not be calculated as they were outside the range of the existing curve.

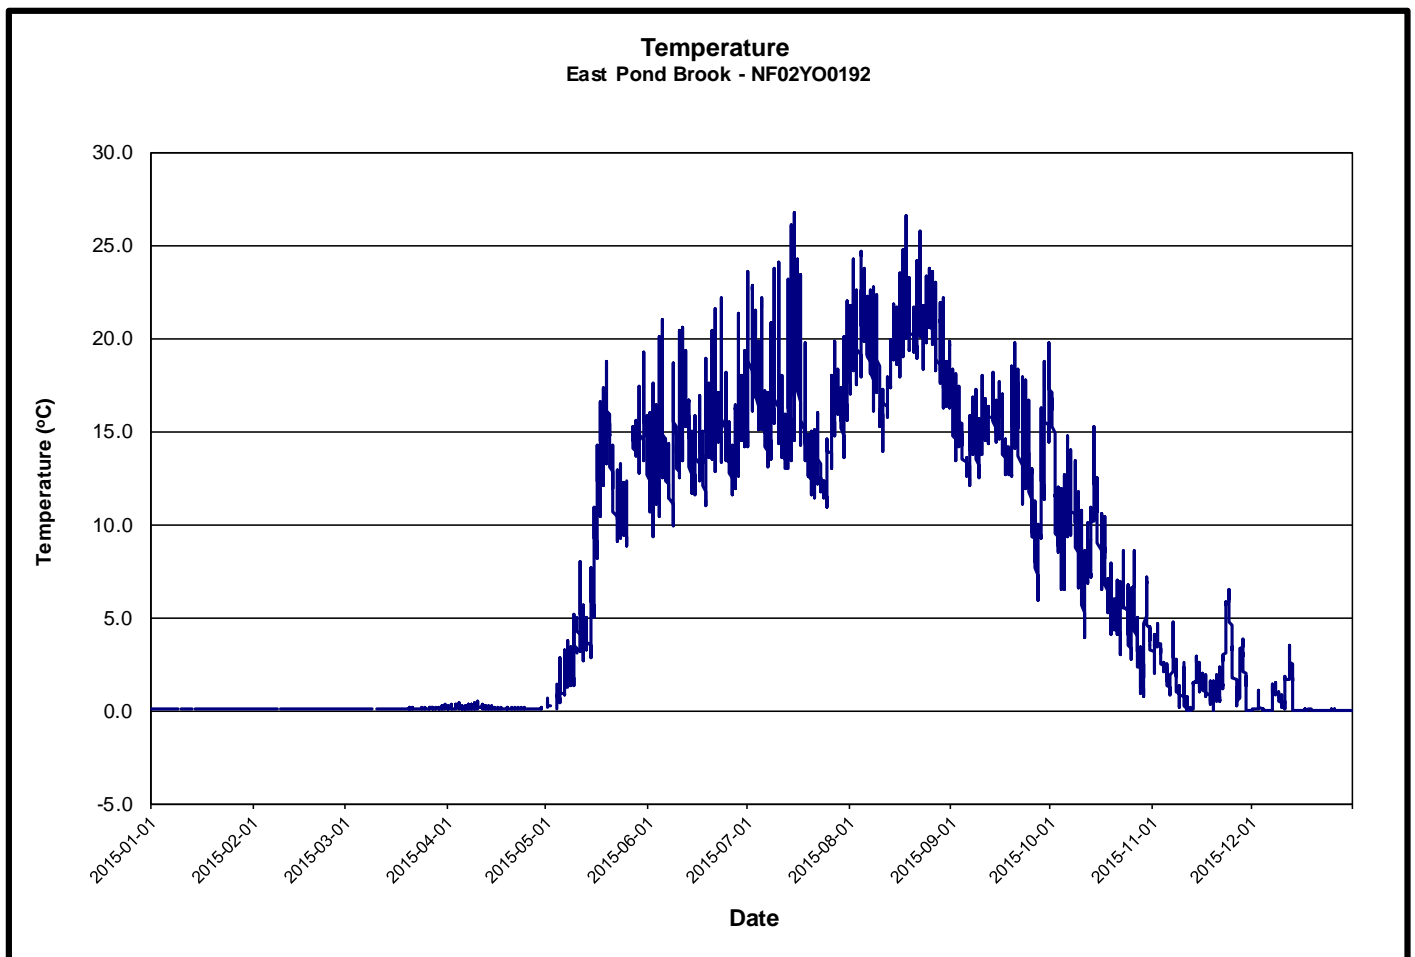
Figure 10

The water temperature (**Figure 10**) ranged from a minimum of $-0.02\text{ }^{\circ}\text{C}$ to a maximum of $26.74\text{ }^{\circ}\text{C}$. In the winter months, under the cover of ice in the stream, temperatures were generally at or slightly above the freezing point. The highest temperatures were measured in July and August. The temperature profile for this stream is very similar to that of Tributary to Gills Pond Brook (**Figure 4**).

Dissolved oxygen (**Figure 13**) ranged from a minimum of 7.64 mg/L to a maximum of 14.28 mg/L. Generally, dissolved oxygen is inversely proportional to water temperature; this being evident in comparison to **Figure 10**.

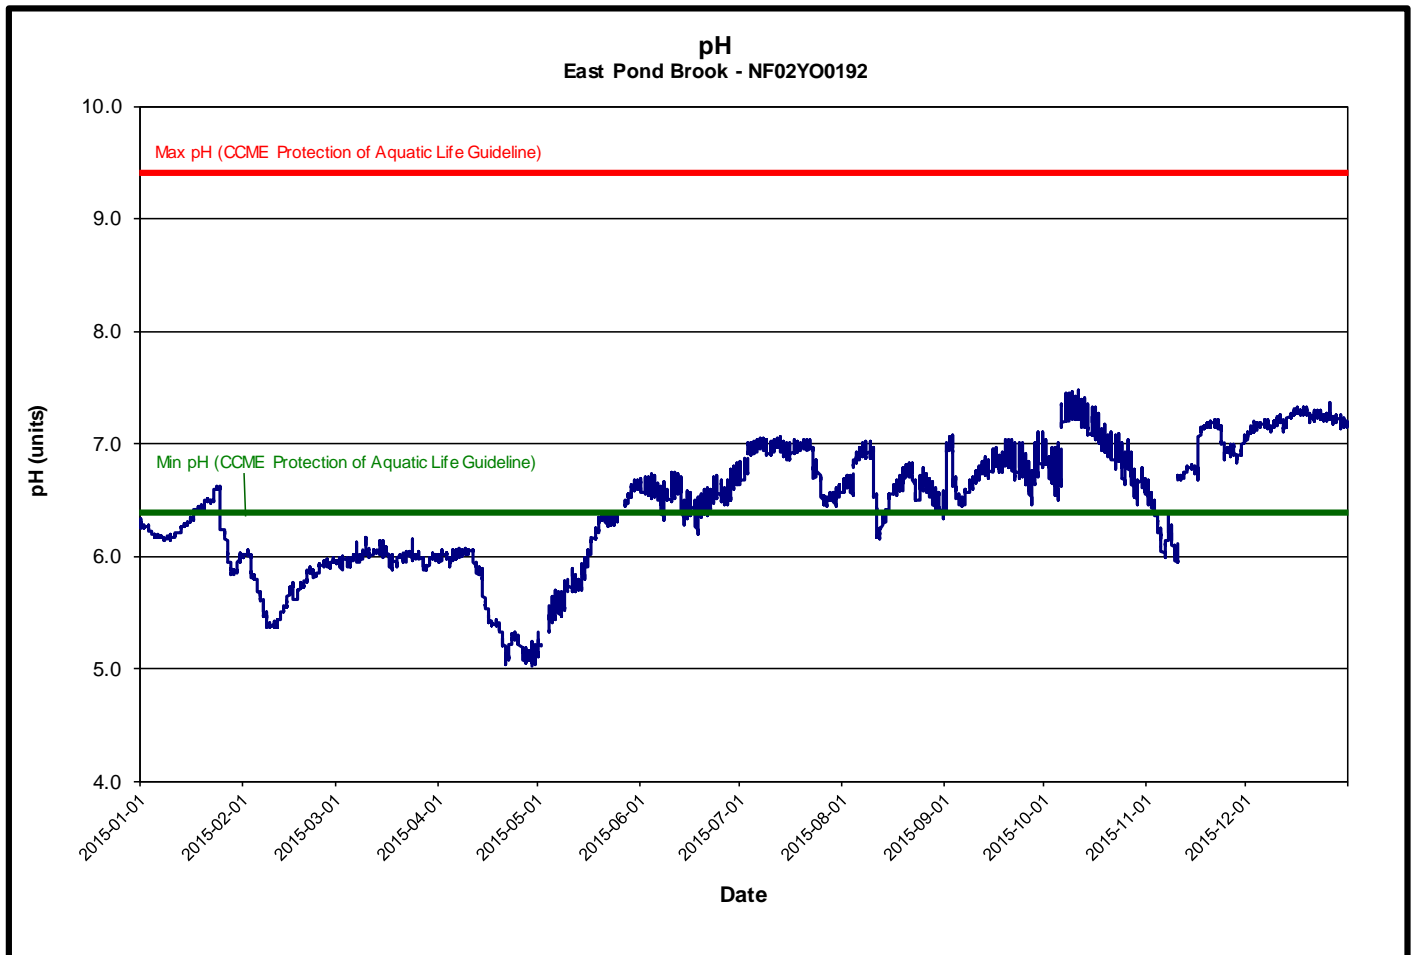
Figure 11

The pH (**Figure 11**) ranged from a minimum of 4.94 to a maximum of 7.47. The pH of this stream is naturally quite low, often being documented to be near or below the lower limit of the recommended range (6.5 – 9.0 – see colored lines on **Figure 11**) for the CCME *Canadian Water Quality Guidelines for the Protection of Aquatic Life* ⁽¹⁾.

Variation in pH is influenced by a number of factors. For example, there is an inverse relationship with stage (**Figure 15**) which is influenced by snowmelt and precipitation. All variations in pH appear to be due to natural influences.

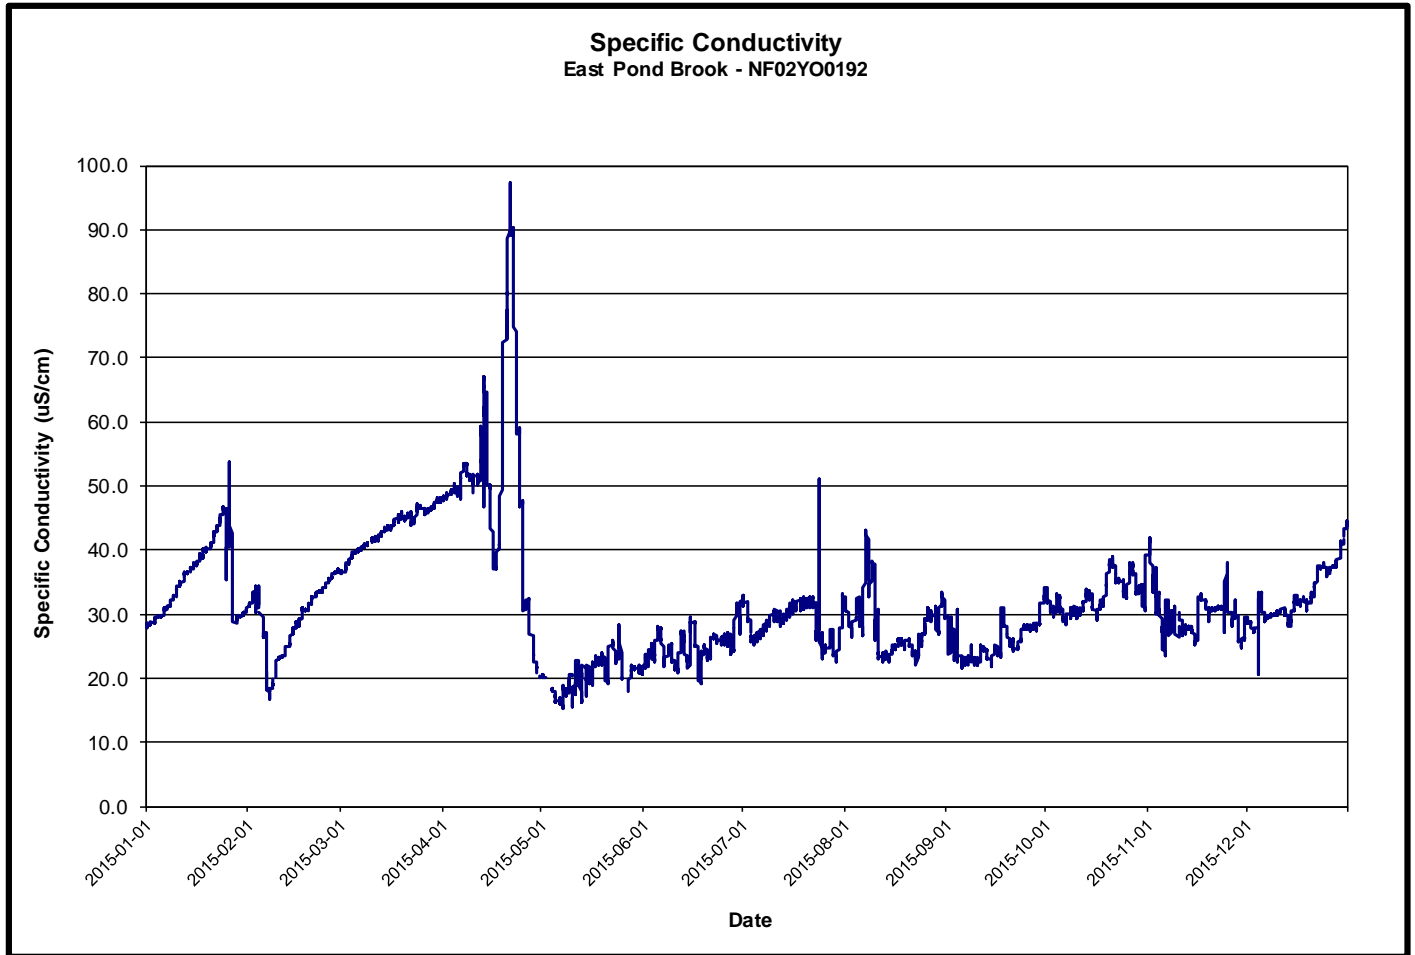
Figure 12

The specific conductivity (**Figure 12**) is affected by the amount of dissolved metals and salts in the water. Pristine waters in this part of the island generally have a specific conductance of less than 50 $\mu\text{S}/\text{cm}$.

During the past year, the specific conductivity ranged between 15.3 $\mu\text{S}/\text{cm}$ and 97.3 $\mu\text{S}/\text{cm}$.

These values are typical for this stream.

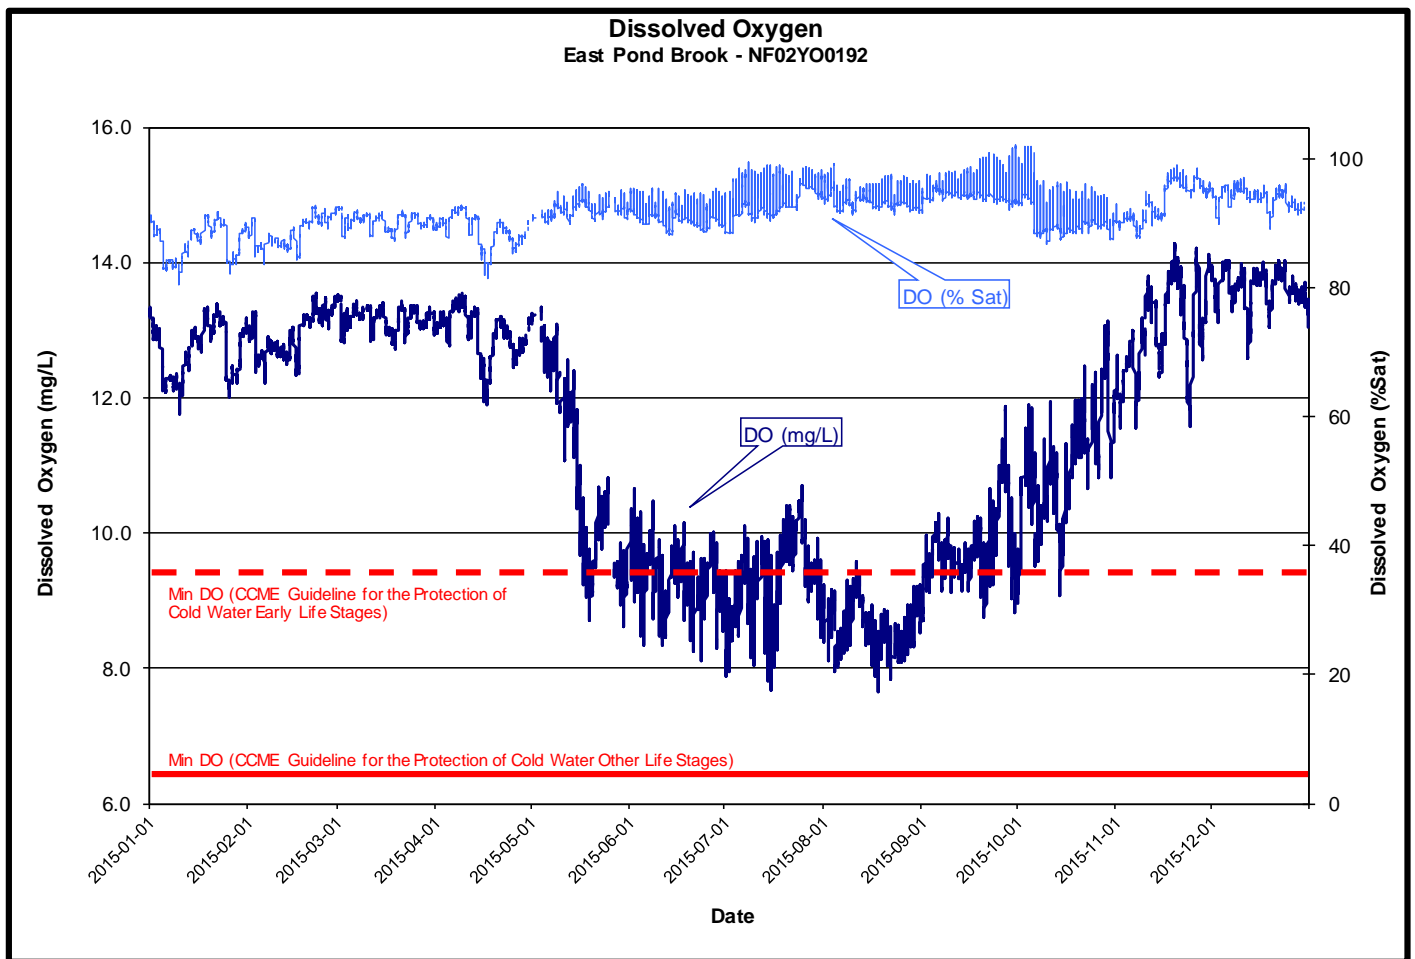
Figure 13

The CCME *Canadian Water Quality Guidelines for the Protection of Aquatic Life* ⁽¹⁾ for dissolved oxygen establish two separate lower limits for cold water biota: other life stages – above 6.5 mg/L; and early life stages – above 9.5 mg/L. While dissolved oxygen consistently remained above 6.5 mg/L, in the warmer months, it did not remain above 9.5 mg/L, the recommended lower limit for early life stage cold water biota. This is a natural function of the inverse relationship to the warmer water temperatures. During the period when dissolved oxygen was below 9.5 mg/L, the percent saturation (DO % Sat) generally remained in the normal range between 80 % and 100 %, indicating that the water was fully saturated with oxygen.

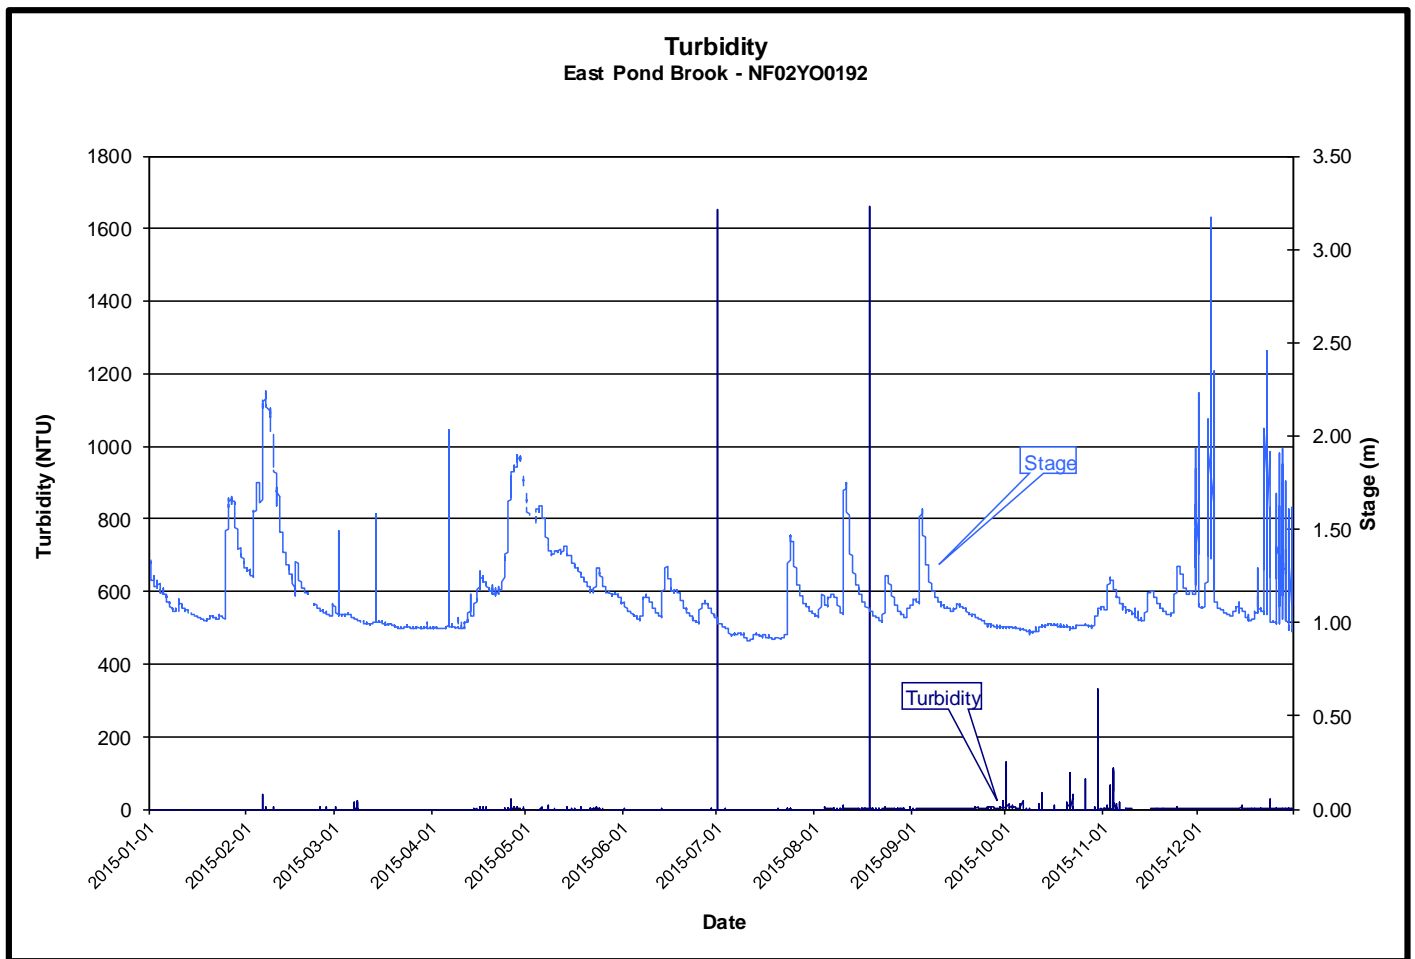
Figure 14

Turbidity (**Figure 14**) ranged from a minimum of 0.0 NTU to a maximum of 1660.0 NTU. Generally, turbidity values in this stream are at or close to zero.

Several turbidity spikes occurred during increases in stage, and are likely the result of a precipitation-runoff event. The highest spikes in July and August 2015 are single one hour recordings, when water levels were very low. These high values may have been the result of an accumulation of algae near the sensor, or the passage of natural in-stream debris near the sensor.

There were a couple of occasions when leafy debris was noted to have been caught in the sensor, resulting in false-positive data. Data for these periods have been removed from the data set.

From October through to the end of the year, there were higher-than-normal turbidity values recorded in this stream. On occasion, the stream was visibly turbid, and grab sample results analysed at commercial laboratories confirmed these higher values. Investigation could not determine the source of the turbidity. There is no indication that it was the result of anything related to the mine's activities.
