Teck Duck Pond Operations Real-Time Water Quality Monitoring Network Annual Report 2015

2016-04-07

Government of Newfoundland & Labrador
Department of Environment and
Conservation
Water Resources Management Division

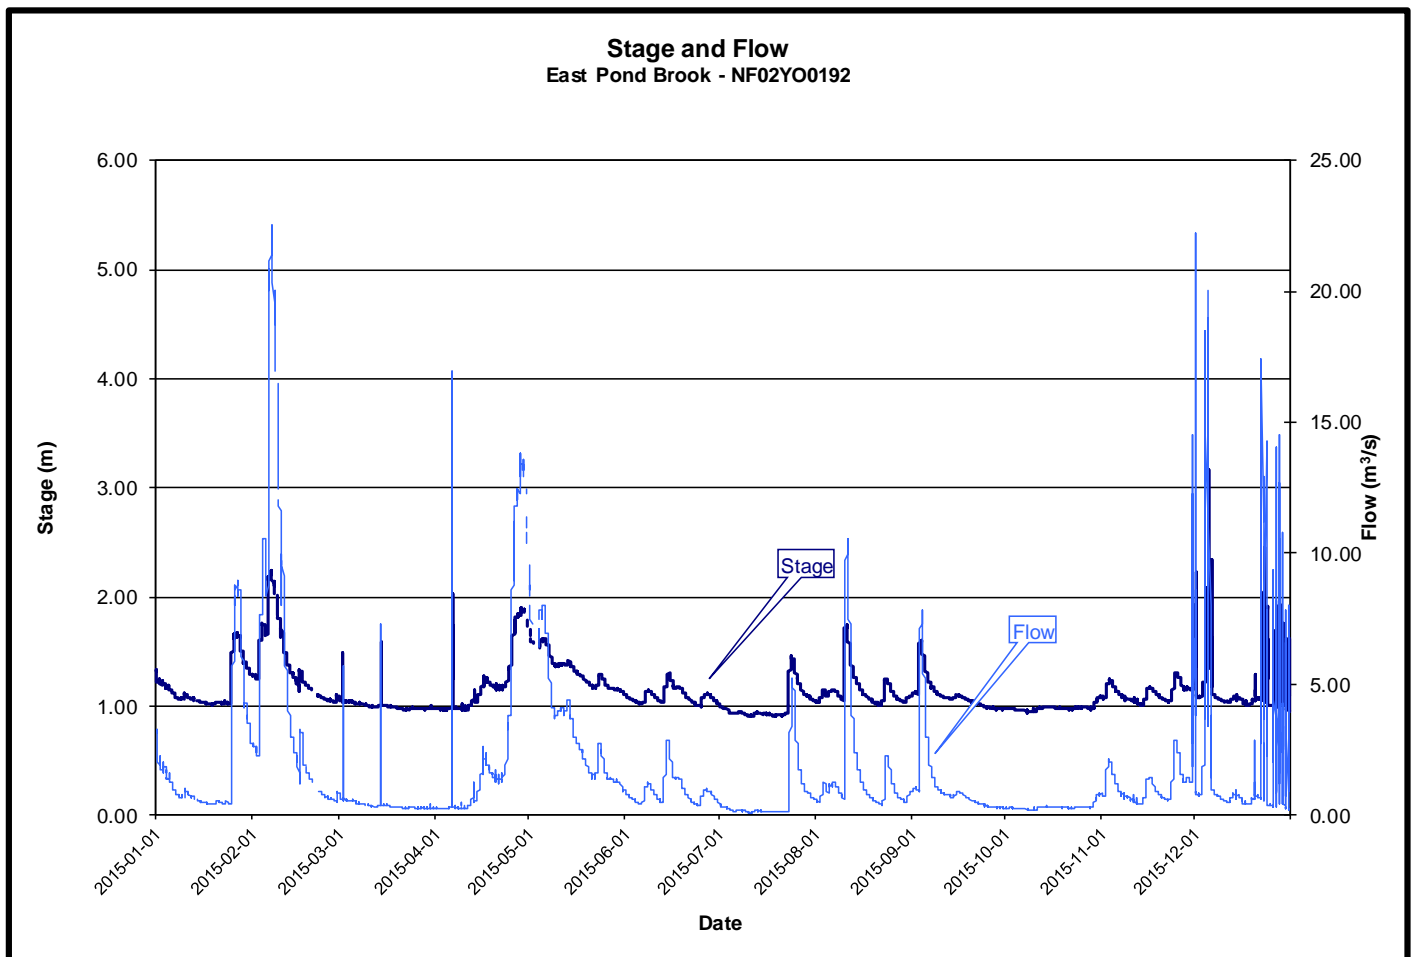
Figure 15

The stage or water level (**Figure 15**) was recorded to be between 0.90 m and 3.17 m. The flow or discharge ranged from a minimum of 0.09 m³/s to a maximum of 22.52 m³/s. At this location, stage is referenced to an arbitrary bench mark. Peaks in stage during January, February and December are attributed to the backwater effect from ice formation.

For the remainder of the year, however, stage and flow were within normal ranges, with the higher levels following snow melt and rainfall events.

The flow or discharge is calculated based upon a stage-discharge curve which is developed over time. There are periods during the year, when extreme high and low flows could not be calculated as they were outside the range of the existing curve.

Variation in pH is influenced by a number of factors. For example, there is an inverse relationship with stage (**Figure 15**) which is influenced by snowmelt and precipitation. All variations in pH appear to be due to natural influences.

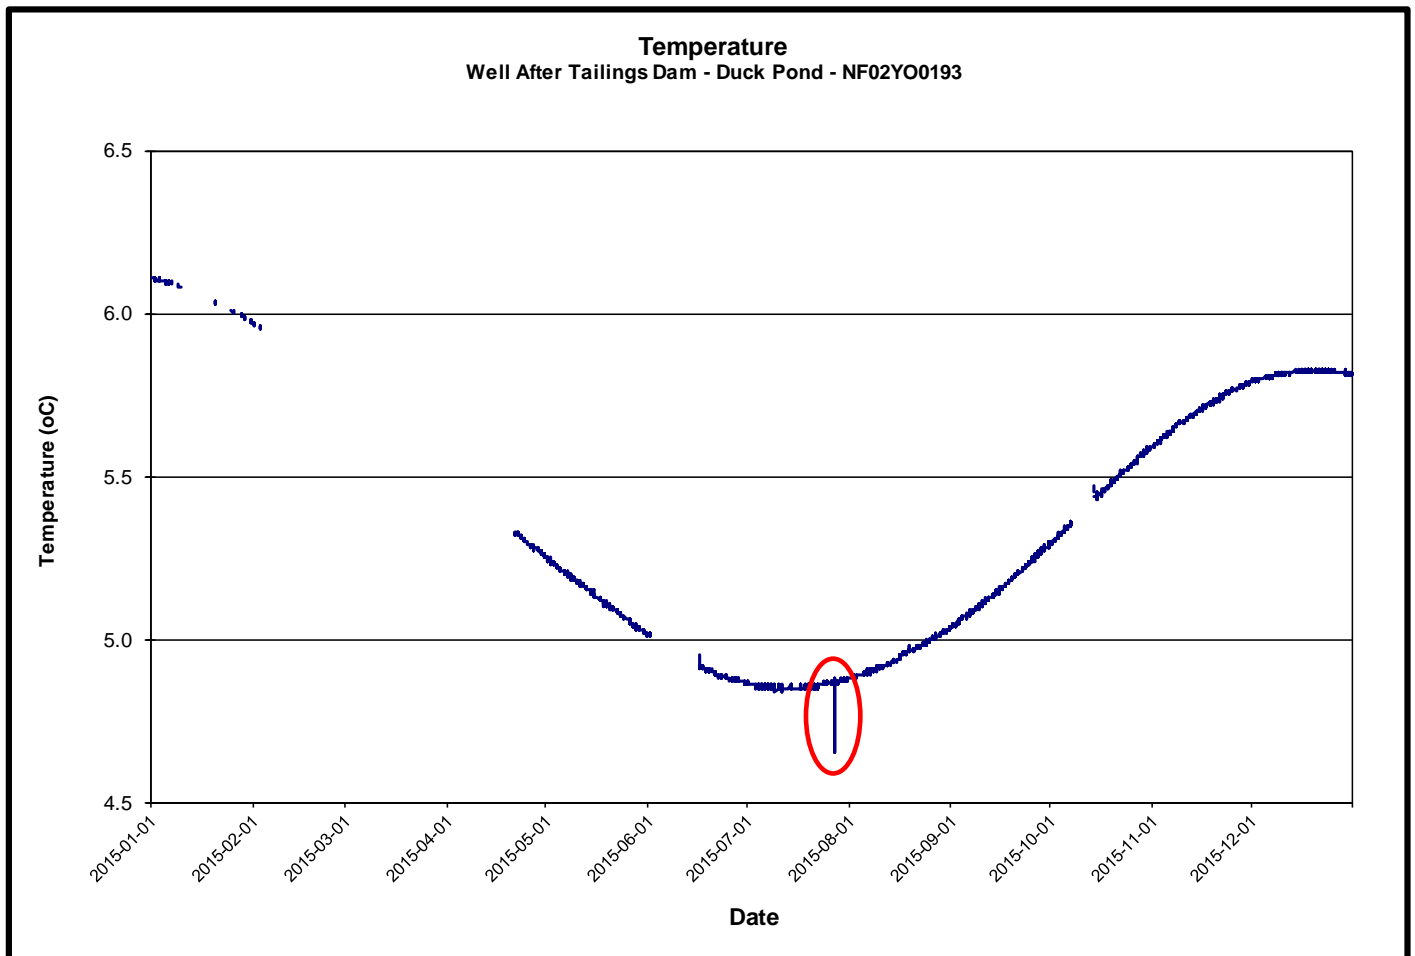
Figure 16

Water temperature (**Figure 16**) ranged from a minimum of 4.65 °C to a maximum of 6.11 °C. Lower temperatures were recorded in the summer months, while the higher temperatures were recorded in winter months. While the temperature profile is very similar to previous years, it has been noted that despite the seasonal variation, the mean temperature in this well appears to be slightly less than it was in 2014, following a period of slight increases since 2006. This change and its potential implications will be subject to further analysis in collaboration with Pollution Prevention Division of ENVC.

There was a short-term drop in temperature on July 27, 2015 (red ellipse). This corresponded with the well being purged by Teck Staff as part of their ongoing monitoring program.

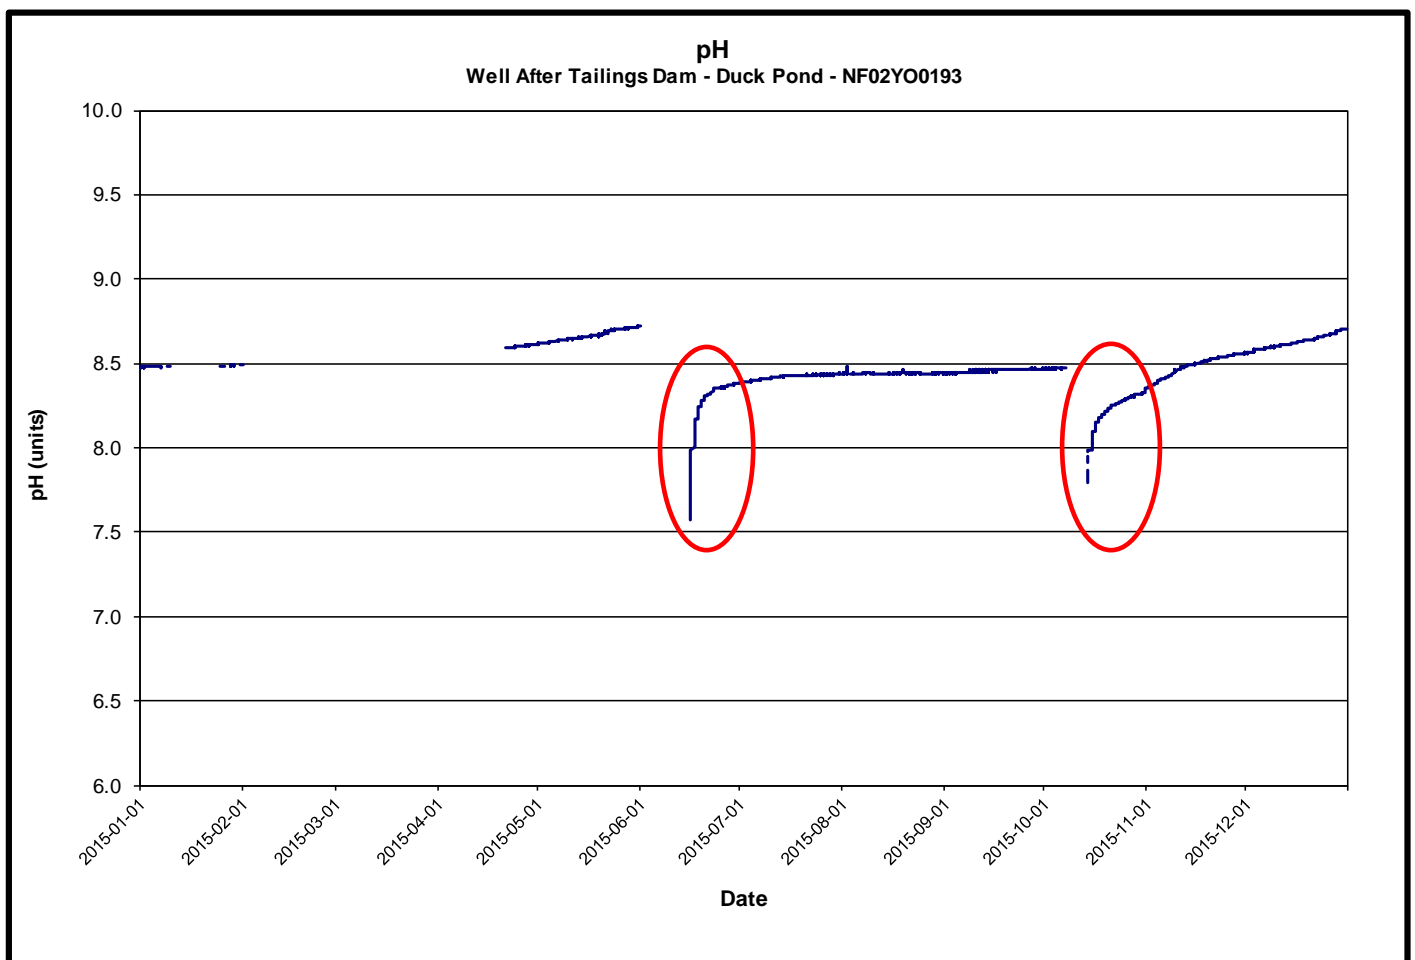
Figure 17

The pH measurements for this well are depicted in **Figure 17**. Values ranged from a minimum of 7.57 to maximum of 8.72.

At the beginning of each deployment period, as highlighted by the red ellipses, there is a significant increase in pH which essentially ‘levels off’ for the remainder of that period. This response in pH is typical of previous deployments. Prior to an investigation of this feature in 2011, it was believed that this was a function of the well being purged. However, it has been determined that the rapid change in pH at the beginning of each deployment is simply a function of the water in the small diameter well being displaced, as the instrument is deployed in the well⁽²⁾, thus temporarily disturbing the relatively ‘static’ nature of the well. Accordingly, it has been decided to minimize the number of deployments of the instrument in this well, and maximize the length of the deployment periods (approximately 6 months). Furthermore, it has also been demonstrated that purging the well has no long term (i.e. less than 60 minutes) effect on the water quality, including pH, in the well⁽⁴⁾. The effects of purging the well at the beginning of deployment, and during deployment continue to be monitored, as it is necessary to sample this well from time to time while the instrument is deployed. A draft Standardized Purging and Sampling Protocol⁽³⁾ has been developed for this particular well.

pH levels appear to be typical based upon historical data.

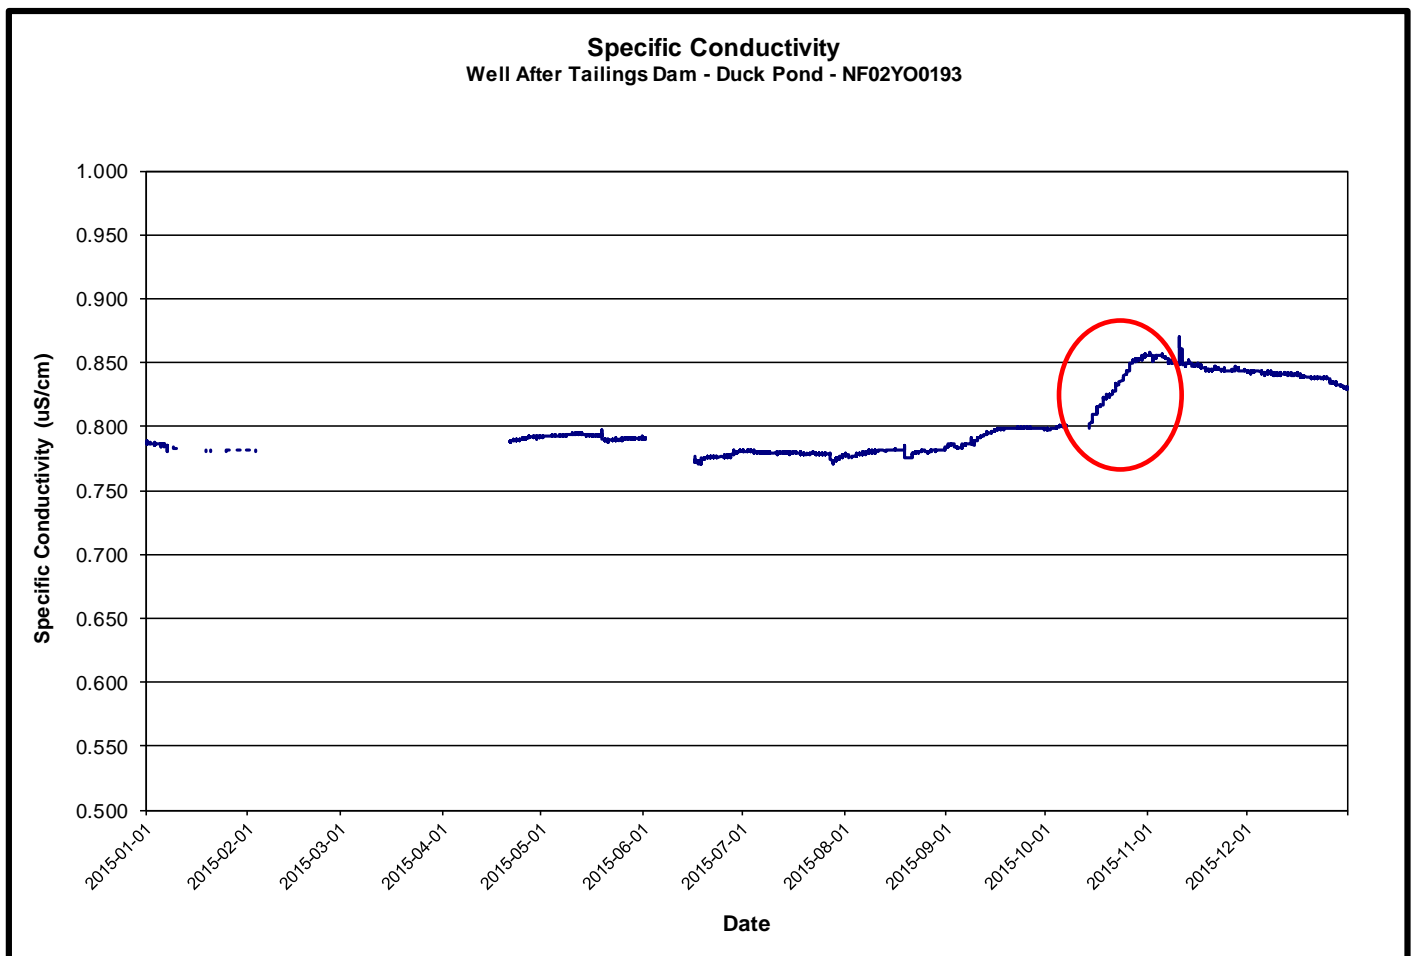
Figure 18

Specific conductivity in this well is higher than surrounding surface waters due to the highly mineralized nature of the material through which it is drilled. The well is also located such that it can be used to measure changes in ground water resultant from seepage from Tailing Dam A.

Specific conductance in this well (**Figure 18**) ranged from a minimum of 0.771 mS/cm to a maximum of 0.870 mS/cm.

There was a fairly rapid increase (see red ellipse) in specific conductance beginning on October 14, 2015, followed by a steady decrease until the end of the year. This change corresponds with Teck's actions to place waste rock in the Tailings Pond for the period from October 16, 2015 to November 18, 2015. Prior to this, water levels in the Tailings Pond were reduced to minimum levels. This work was completed in accordance with the mine closure plan.

This change and its potential implications will be subject to ongoing monitoring, and further analysis in collaboration with Pollution Prevention Division of ENVC.

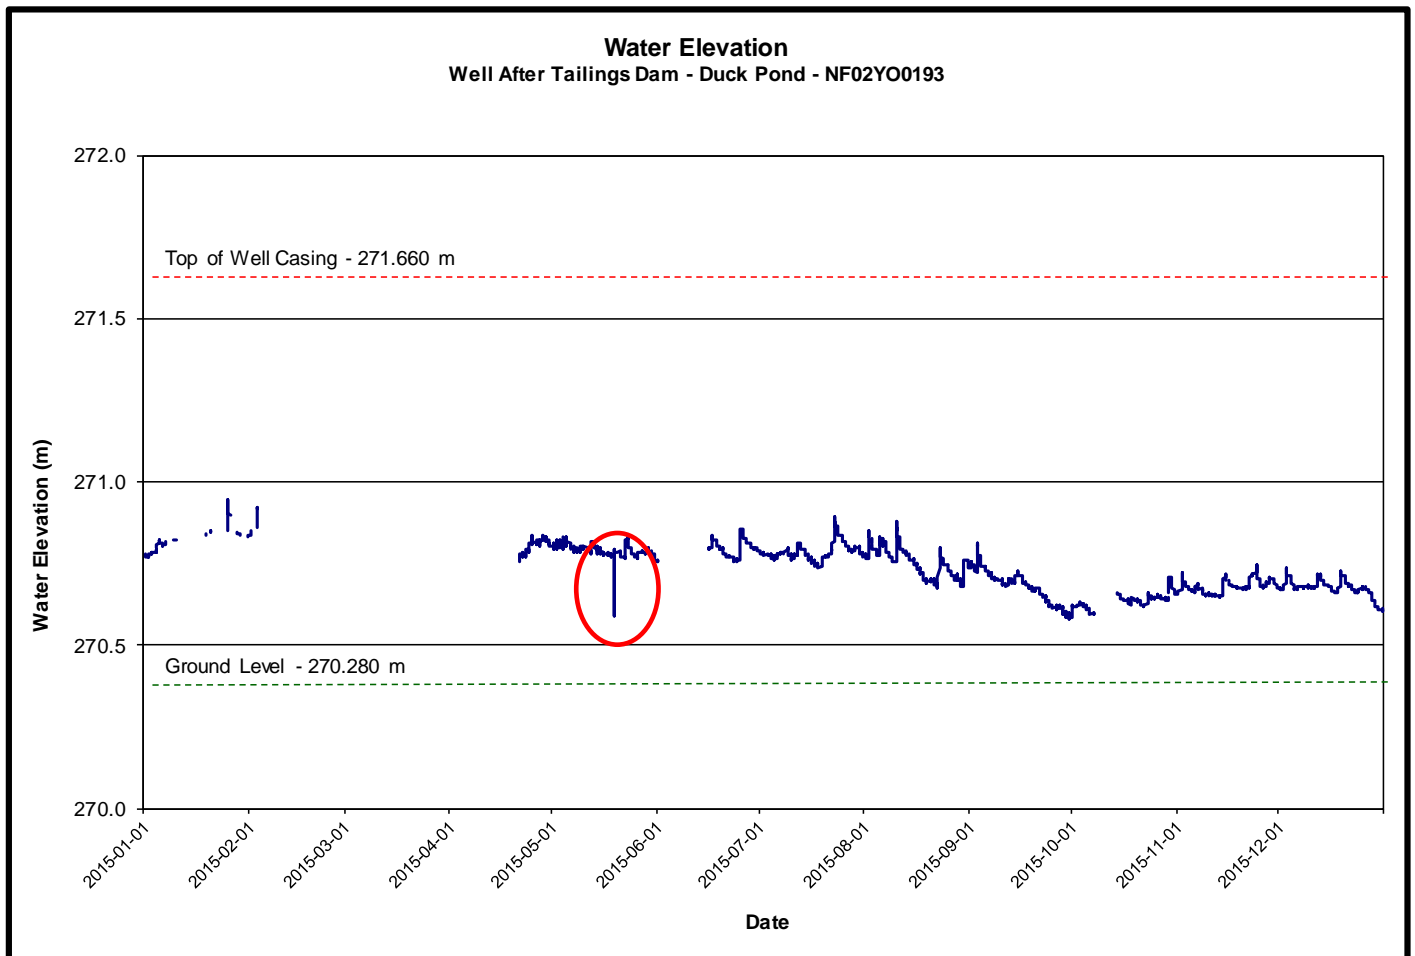
Figure 19

This shallow well is located in a glacial till, less than 100 meters from the toe of Tailings Dam A and less than 50 meters from a small stream (Trout Brook). The water elevation (**Figure 19**) in this well ranged between a minimum of 270.58 m and maximum of 270.95 m.

There is excellent agreement between recorded and measured water elevations throughout the year, with the maximum differential being measured to be 0.011 m. This indicates that the water elevation being logged is extremely accurate.

There was a short-term drop in water elevation on May 19, 2015 (red ellipse). This corresponded with the well being purged by Teck Staff as part of their ongoing monitoring program.

An analysis of the long term water elevation of this well⁽⁴⁾, shows a significant correlation (Pearson Correlation Coefficient = 0.84) with the water level in the Tailings Management Area (TMA). Thus as water levels in the TMA rise and fall, so does the water elevation in this well, suggesting as we would expect, a hydraulic connection between the two. During particular seasons, a weak correlation (Pearson Correlation Coefficient = 0.19) exists between the water elevation in this well and the water level East Pond Brook, suggesting that, over shorter periods, changes in the well's water elevation are influenced to some degree by the nearby stream.
