Real-Time Water Quality Report Waterford River at Kilbride

Deployment Period
April 7, 2017 to May 23, 2017

Government of Newfoundland & Labrador Department of Municipal Affairs & Environment Water Resources Management Division

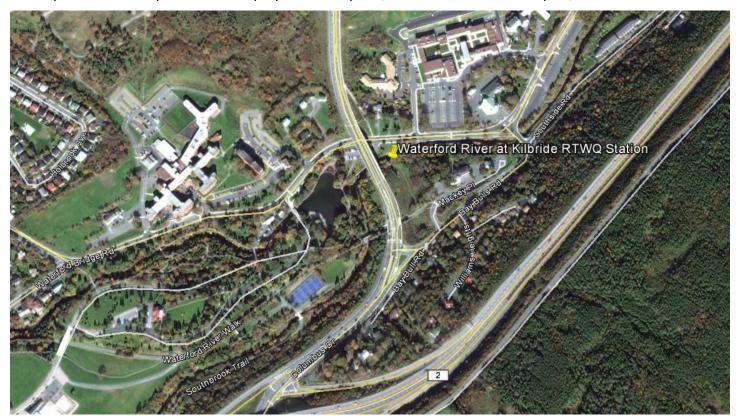
Figure 1: Waterford River at Kilbride Real-Time Water Quality and Quantity Station.

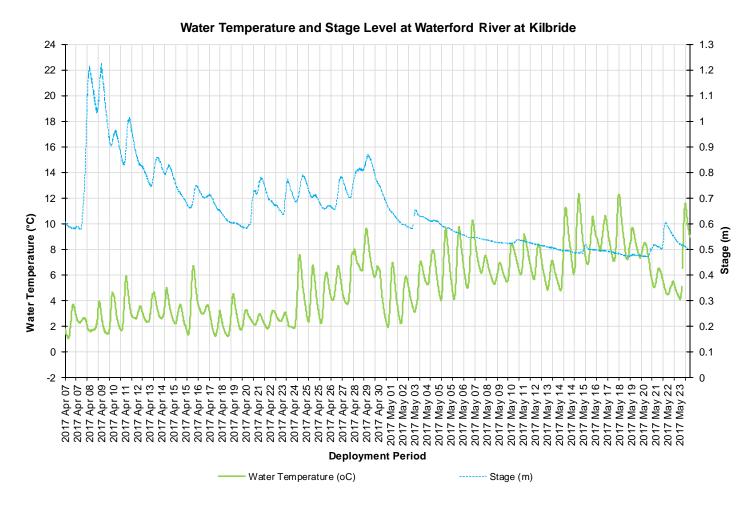
Figure 2: Water temperature (°C) and Stage (m) values at Waterford River at Kilbride

Water temperature ranged from 1.06°C to 12.33°C during this deployment period (Figure 2).

The water temperature at this station displays diurnal variations although slightly elongated due to the depth of water at this station. Deeper streams are influenced more subtly by natural diurnal variations in air temperatures (Appendix I).

Over the duration of the deployment period the water temperature gradually increases as the air temperatures increase with the warmer temperatures of spring. During high stage events there is a slight spike in the water temperatures for a short period of time until the temperatures return to the natural diurnal pattern.

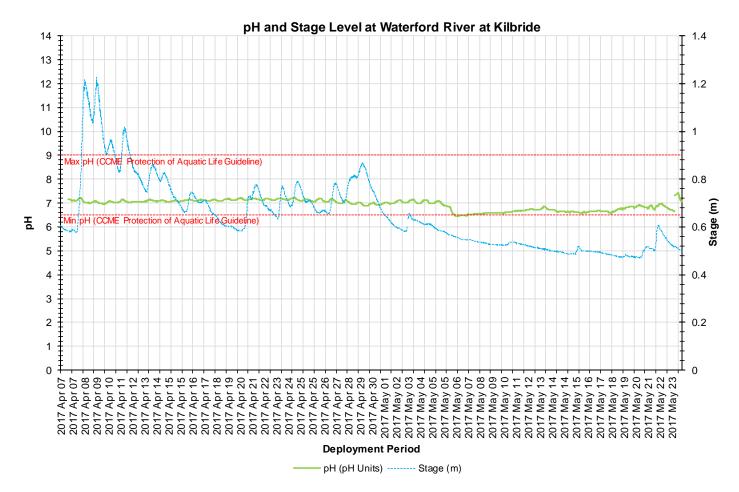
Figure 3: pH (pH units) and stage level (m) values at Waterford River at Kilbride

Throughout the deployment period, pH values ranged between 6.44 pH units and 7.23 pH units (Figure 3).

The pH levels are reasonably consistent and remained within the guidelines indicated on the graph, until May 5th, when pH dipped to just below the CCME guideline. This dip in pH also corresponds with a decrease in stage level. As the deployment period continues the pH increases slightly to just above the minimum CCME guideline.

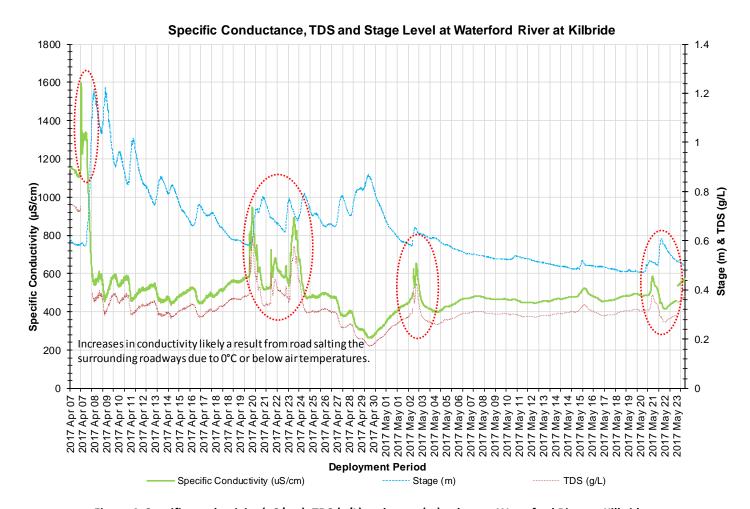
Figure 4: Specific conductivity (μS/cm), TDS (g/L) and stage (m) values at Waterford River at Kilbride.

The conductivity levels were within 263.0 μ S/cm and 1601.0 μ S/cm during this deployment period. TDS (a calculated value) ranged from 0.1710 g/L to 0.7470 g/L (Figure 4).

At the beginning of the deployment, when stage levels rise, the specific conductance levels drop in response, as the increased amount of water in the river system dilutes the solids that are present (as noted on Figure 4). This is evident on the graph until April 19th, 2017.

During this deployment there were several high spikes in conductivity levels during stage increases. The conductivity spikes correspond with 0°C or below air temperatures; this indicates that there was road salting occurring on the surrounding roadways to break up ice. The road salt was being flushed into the brook causing the specific conductivity to increase. The material that is flushed into Waterford River increases the particle matter in the water column for a short period of time and indicates higher than normal conductivity levels on the instrument.

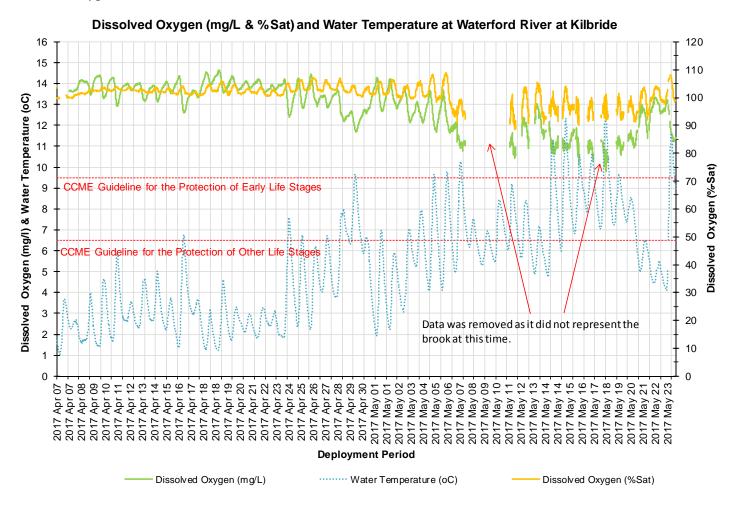
Figure 5: Dissolved Oxygen (mg/L & Percent Saturation) values at Waterford River at Kilbride.

During the deployment the dissolved oxygen concentration levels ranged within a minimum of 10.43mg/L to a maximum of 14.64mg/L. The percent saturation levels for dissolved oxygen ranged within 88.6% Saturation to 108.8% Saturation (Figure 5). Toward the end of the deployment period, intermittent dissolved oxygen data was removed from the dataset as it did not represent the brook.

The dissolved oxygen concentration remained above the Guideline for the Protection of Early Life Stages (9.5mg/L) for the majority of deployment, until May 14th 2017. Water temperature is graphed with dissolved oxygen as it directly influences the concentration levels of dissolved oxygen in the water column. When the dissolved oxygen is below the CCME guideline on May 14th 2017, the water temperatures have increased during that time frame as well. This data is representing the natural relationship between temperature and dissolved oxygen.

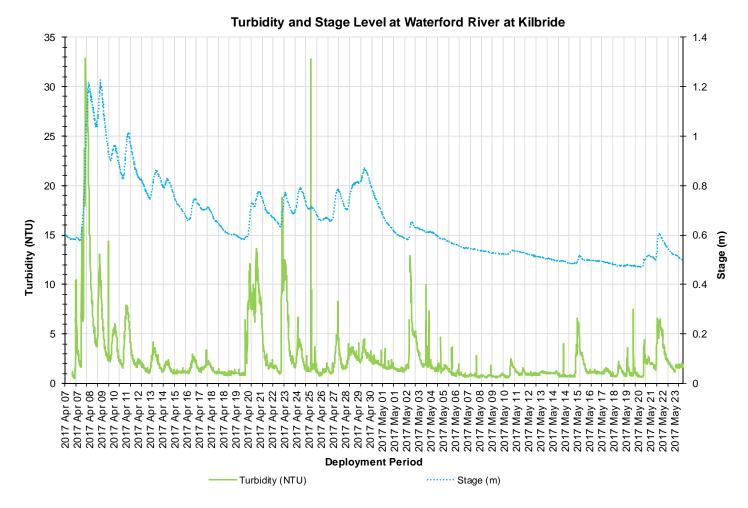
Figure 6: Turbidity (NTU) and stage level (m) values at Waterford River at Kilbride.

Turbidity levels during the deployment ranged within 0.5 NTU and 32.9 NTU (Figure 6). The deployment data had a median of 1.5NTU.

The higher turbidity events throughout the deployment period correlate with increases in stage possibly from precipitation. Total precipitation can increase the presence of suspended material in water, through the movement of soil and sediment from nearby urban areas. The turbidity data returns to lower levels after the high peaks. The large turbidity event on April 25th did not occur during a high stage event. The low air temperature on that day indicates it may have been a result of snowfall.

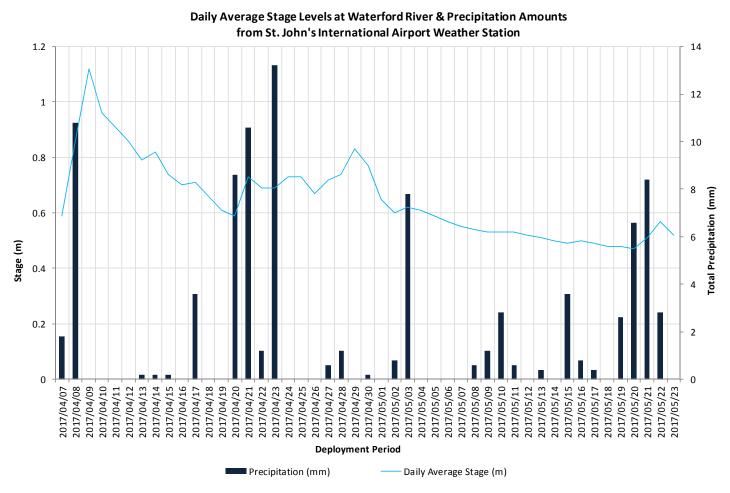
Figure 7: Daily average stage values at Waterford River at Kilbride and daily total precipitation from St. John's Airport Weather Station.

Stage is important to display as it provides an estimation of water level at the station and can explain some of the events that are occurring with other parameters (i.e. Specific Conductivity, DO, turbidity). Stage will increase during rainfall events (Figure 7) and during any surrounding snow or ice melt as runoff will collect in the brooks. However, direct snowfall will not cause stage to rise significantly.

During the deployment period, the stage values ranged from 0.47m to 1.23m. The larger peaks in stage do correspond with substantial rainfall and/or snowfall events as noted on Figure 7. Precipitation data was obtained from Environment Canada's St. John's Airport weather station. Precipitation ranges for the deployment period were a minimum of 0.0 mm and a maximum of 13.2 mm on April 24th 2017.
