Real-Time Water Quality Report

Outer Cove Brook Network

Deployment Period
August 6 to September 4, 2013

Government of Newfoundland & Labrador
Department of Environment and Conservation
Water Resources Management Division

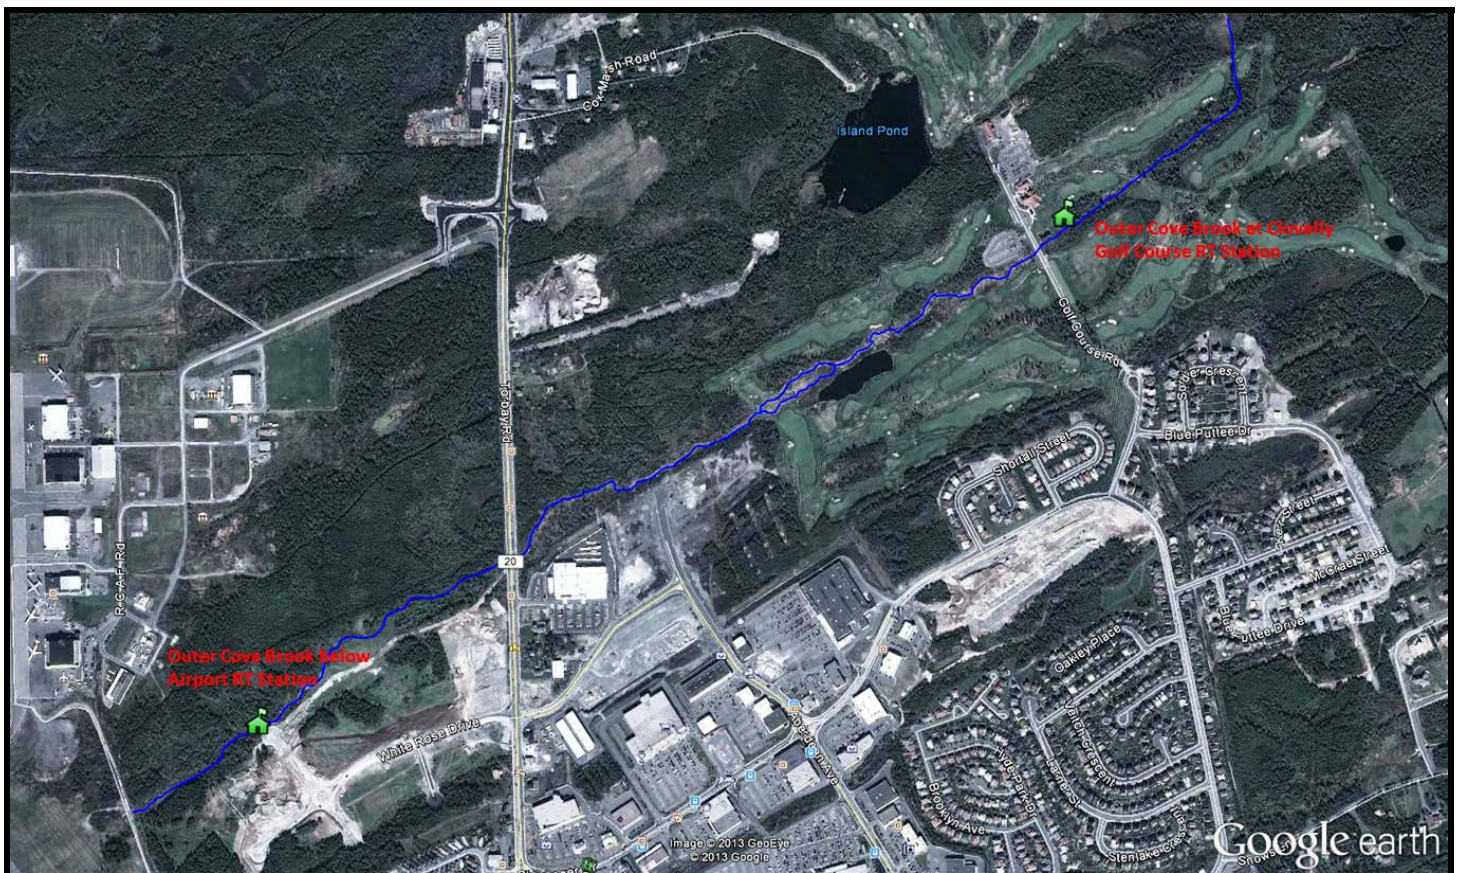
Figure 1: Outer Cove Brook Real-Time Water Quality and Quantity Stations.

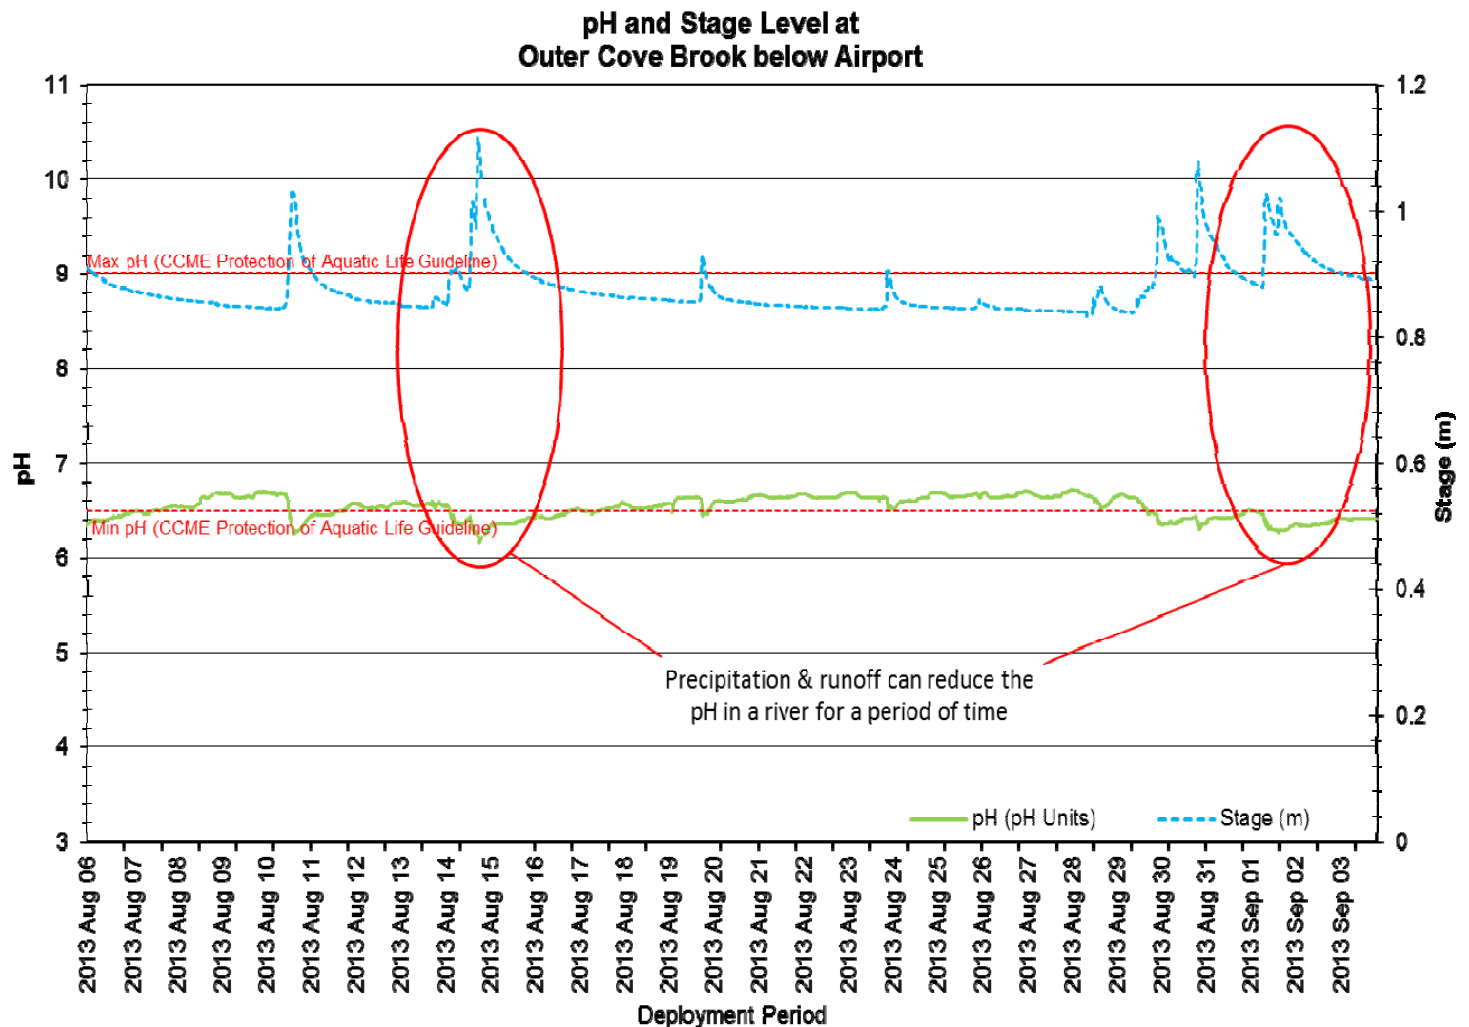
Figure 3: Quarter-hourly pH (pH units) and stage level (m) values at Outer Cove Brook below Airport for the deployment period August 6, 2013 to September 4, 2013.

- Throughout this deployment period pH values ranged between 6.16 pH units and 6.72 pH units (Figure 3).
- During the deployment, the pH values at this station hover around the minimum CCME Guideline for the Protection of Aquatic Life (between 6.5 and 9 pH units), dropping below the guideline after precipitation events such as those on August 15th and September 2nd (Figure 3). This is a natural occurrence between rainfall and pH levels.
- The CCME guideline provides a basis by which to judge the overall health of the brook. Naturally, all streams and brooks are different. In the case of Outer Cove Brook below Airport, pH is within the normal range for stream water in St. John's.

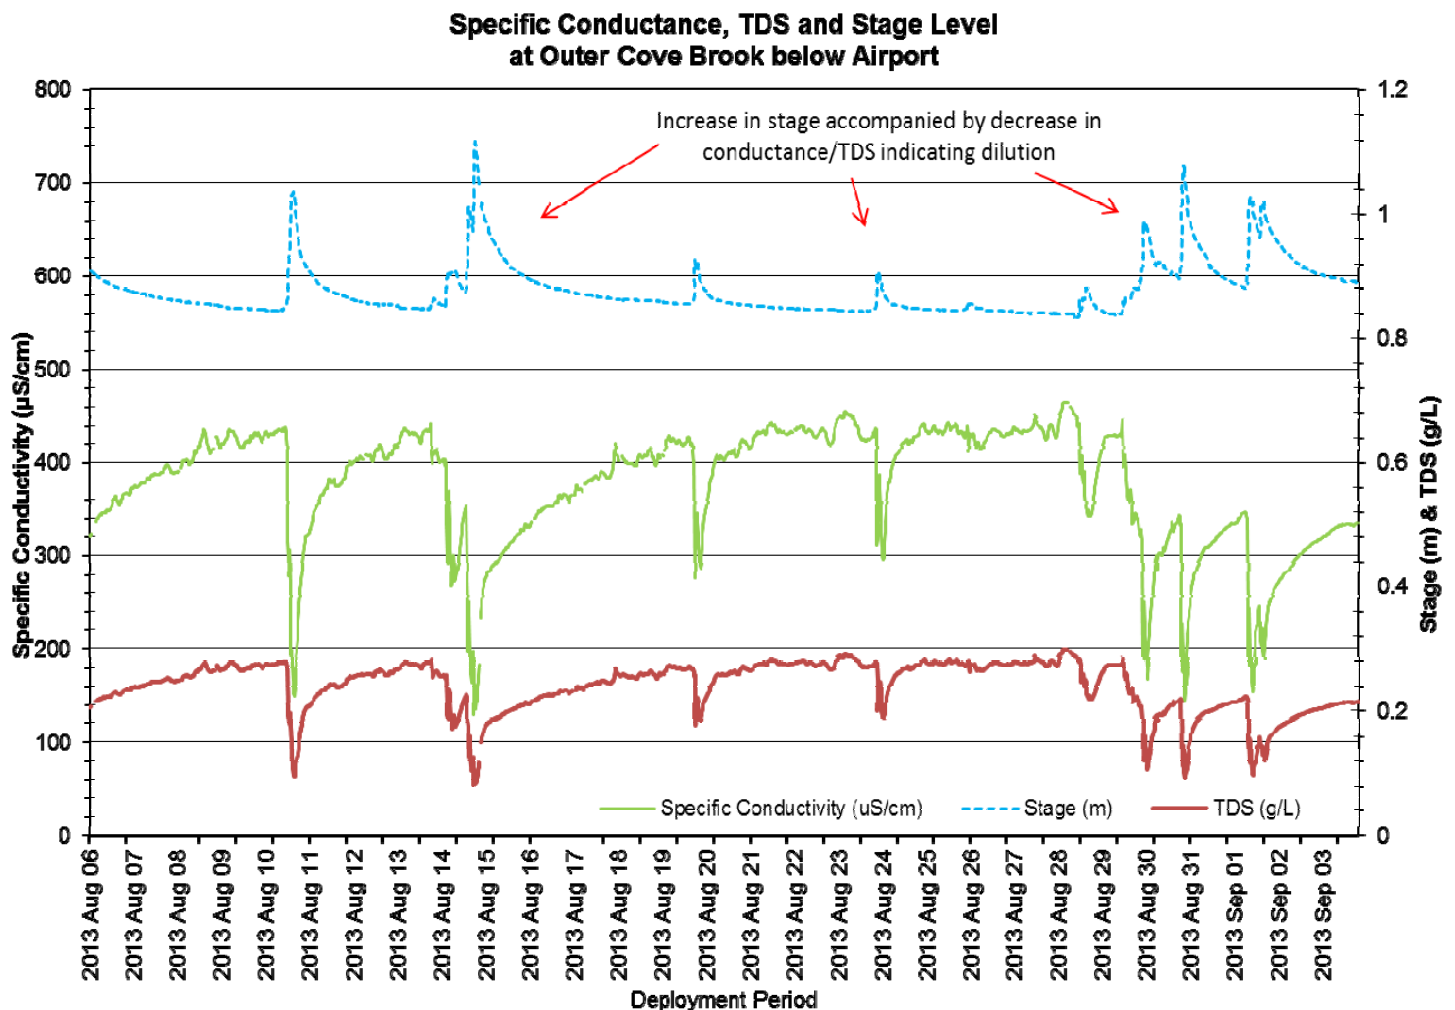
Figure 4: Quarter-hourly specific conductivity ($\mu\text{S}/\text{cm}$), TDS (g/L) and stage (m) values at Outer Cove Brook below Airport for the deployment period August 6, 2013 to September 4, 2013.

- The conductivity levels were within 129.1 $\mu\text{S}/\text{cm}$ and 465.0 $\mu\text{S}/\text{cm}$ during this deployment period. TDS ranged from 0.0826 g/L to 0.2980 g/L.
- Generally, rainfall events, such as that which occurred on August 14th, 24th and 30th (see Figure 4), can have the effect of diluting and lowering conductance levels. When stage levels rise, the specific conductance levels drop in correlation as the increased amount of water in the river system dilutes the solids present there, thus generally decreasing the specific conductivity readings.
- Total Dissolved Solids (TDS), is a parameter that the instrument calculates by an algorithm that utilizes the data from specific conductivity and water temperature to produce a TDS value and generally always mirrors specific conductivity.

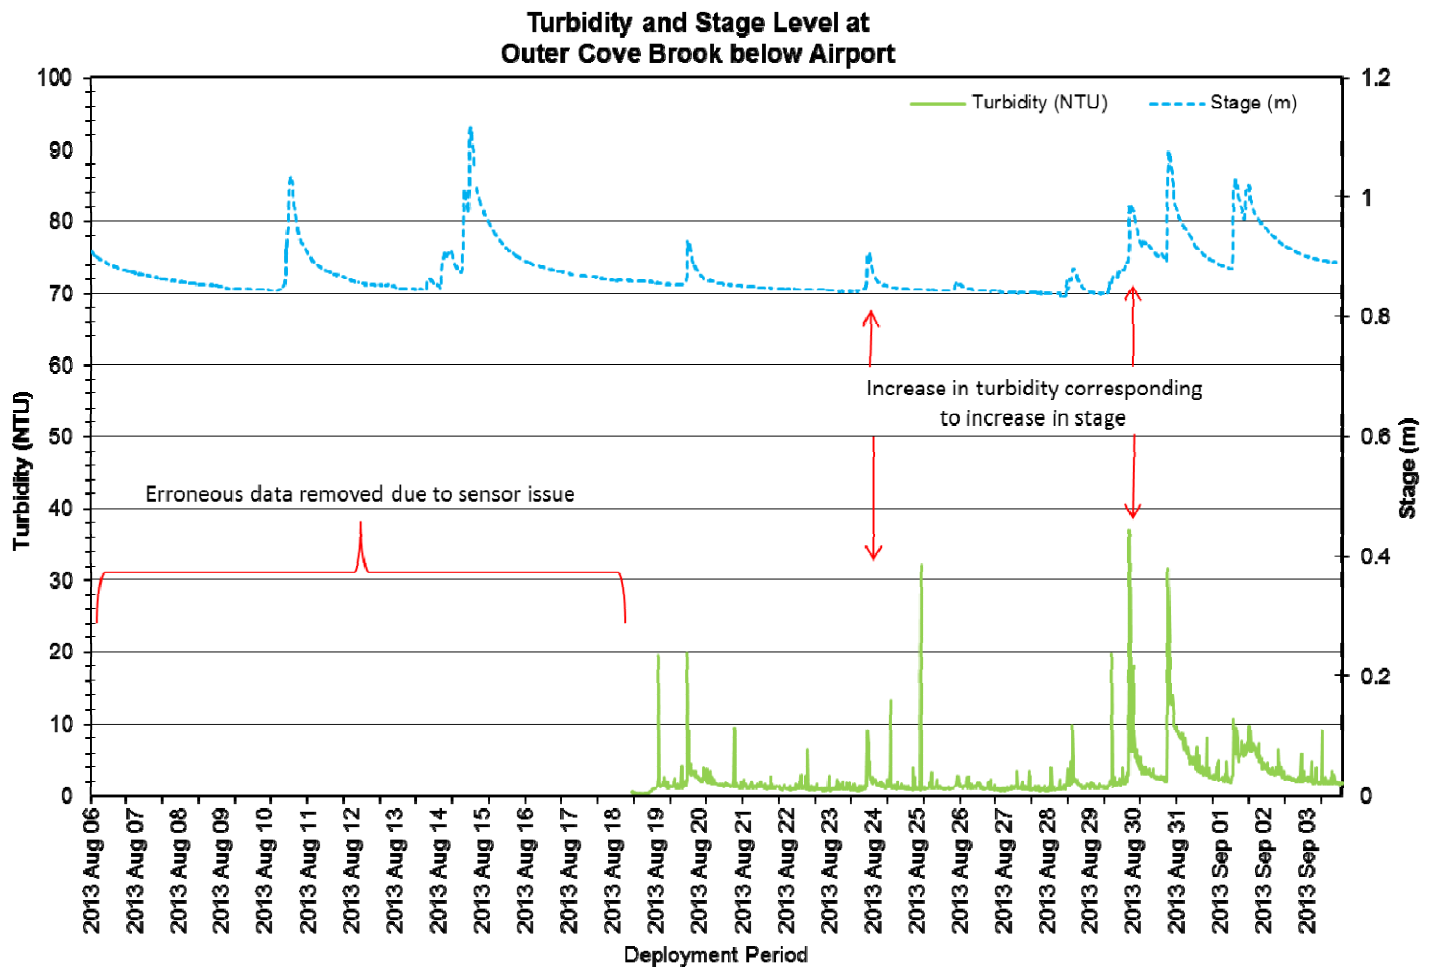
Figure 6: Quarter-hourly turbidity (NTU) and stage level (m) values at Outer Cove Brook below Airport for the deployment period August 6, 2013 to September 4, 2013.

- The 'poor' performance ranking of the turbidity sensor (with an initial reading that did not reflect the clarity of the water) during the deployment indicated that there may be an issue with the sensor. Values were monitored over the deployment, and the sonde was switched out with a different sonde on August 19th. The turbidity values from August 6th-19th were erroneous and thus removed from the dataset.

- The turbidity readings from August 19th to September 4th ranged within 0.2 NTU to 19.8 NTU.
- Several precipitation events and corresponding stage increases led to fluctuating turbidity values (see Figure 6) as sediment and debris were resuspended into the water column.

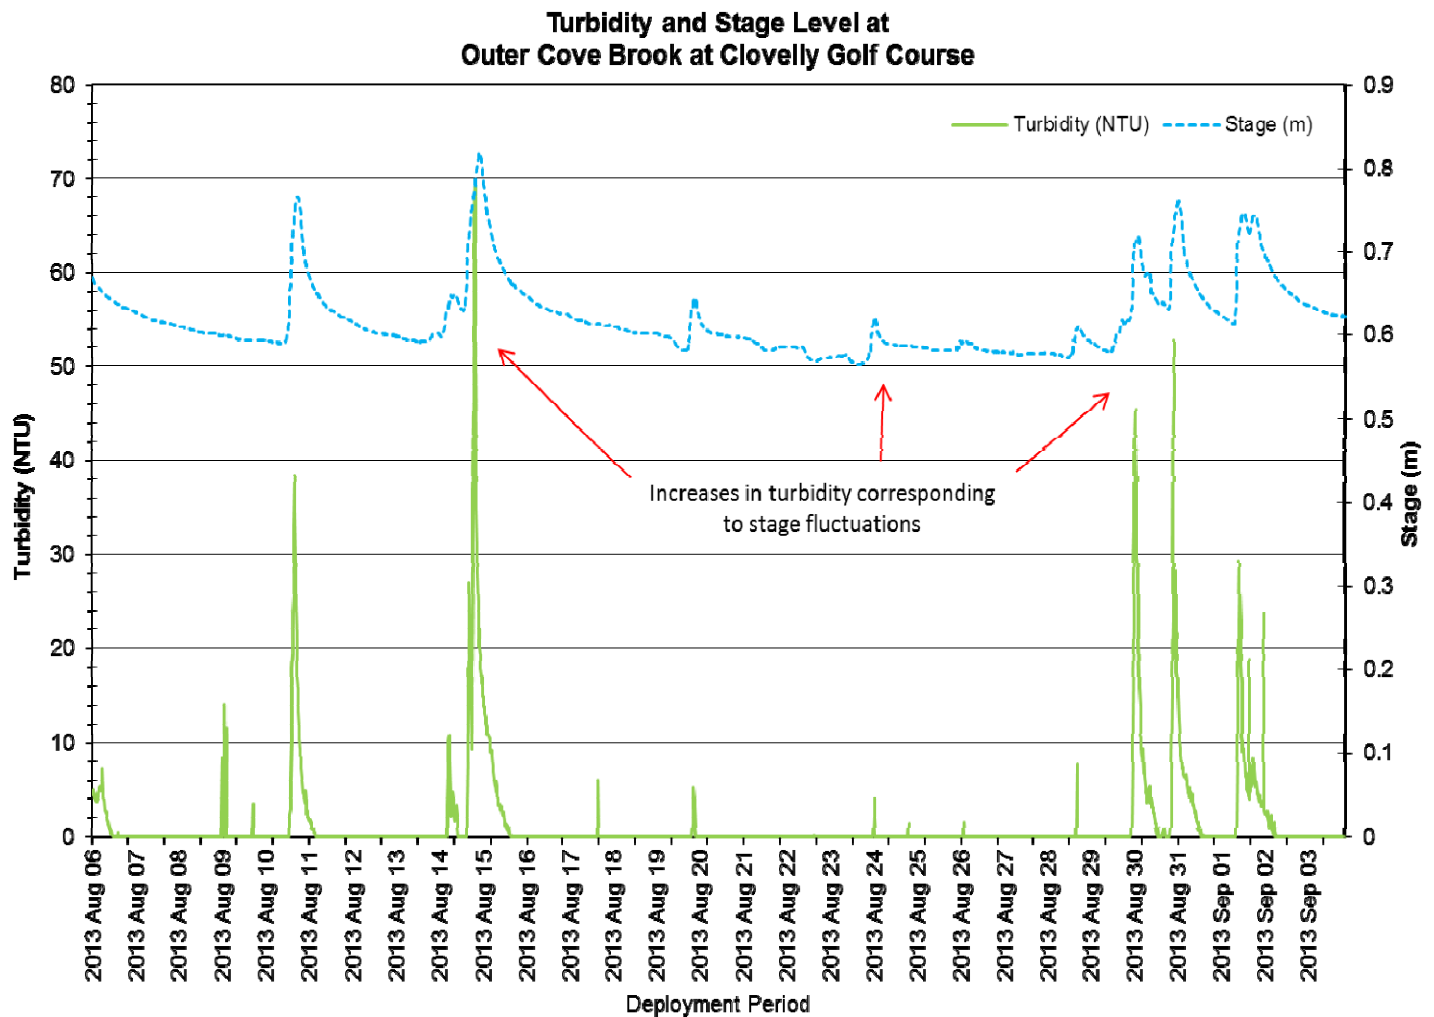
Figure 12: Quarter-hourly turbidity (NTU) and stage level (m) values at Outer Cove Brook at Clovelly Golf Course for the deployment period August 6, 2013 to September 4, 2013.

- Outer Cove Brook contains a significant amount of algae. High algal growth in the summer or leaf debris during all seasons can interfere with turbidity measurements as they block the sensor.
- The turbidity sensor can read turbidity values between 0 NTU and 3000 NTU. If a turbidity reading hits 3000NTU it is always identified as an error reading and thus is not a valid turbidity reading.
- The turbidity readings during this deployment ranged within 0.0 NTU to 69.5 NTU (Figure 12). Fluctuations in turbidity values were correlated with increases in stage and thus precipitation events.
- Several precipitation events and corresponding stage increases led to fluctuating turbidity values as sediment and debris were resuspended into the water column.
