Aerial Surveys of flow control structures within the Avalon Wilderness Reserve: A UAV Pilot Project

August 25 - 26, 2016

Government of Newfoundland & Labrador
Department of Environment and Climate Change
Water Resources Management Division
St. John's, NL, A1B 4J6 Canada

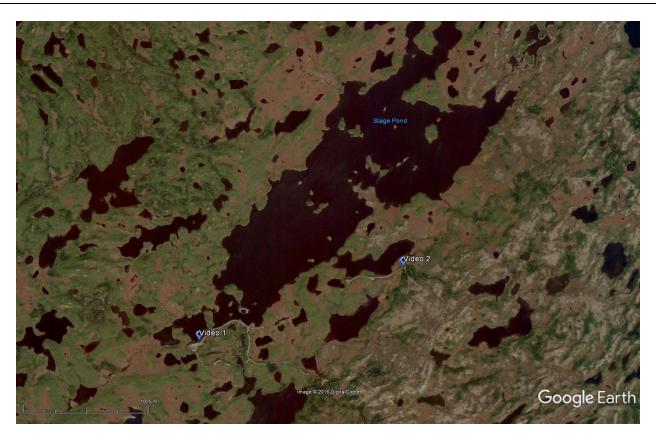
A total of two flights were flown on the afternoon of August 25th (locations are depicted in Figure 1). Unfortunately, heavy winds and rain beginning overnight prevented additional flights that had been planned for August 26th.

Figure 1: Satellite photo of Stage Pond depicting the locations of two UAV flights

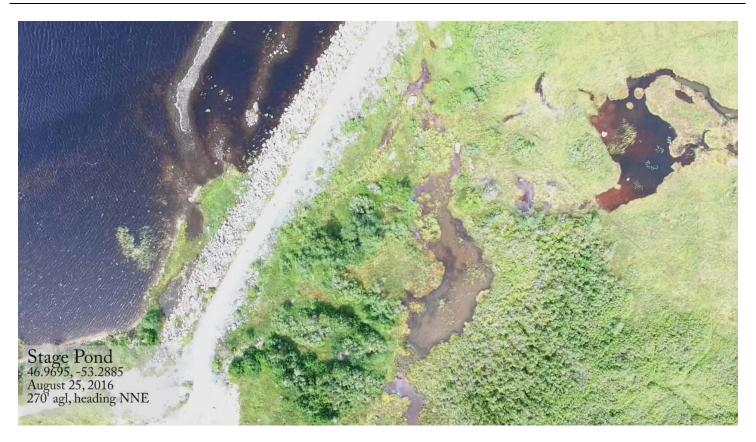
The imagery captures show two earthen dykes intended to prevent southerly flow from Stage Pond, instead directing water in an easterly fashion towards a series of hydropower generating facilities on the Southern Shore of the Avalon Peninsula. Imagery does not show any obvious deterioration, however, there does appear to be seepage emerging from the dyke in the first video, as seen in Photo 1.

Photo 1: Potential seepage from the foot of Northwest Blackwoods Pond Spillway on Stage Pond
