## Climate Change Flood Risk Map Study Humber River Communities

### FloodExtent Map Current Climate and Fully Developed Condition Humber River Deer Lake

Sheet 72 of 90

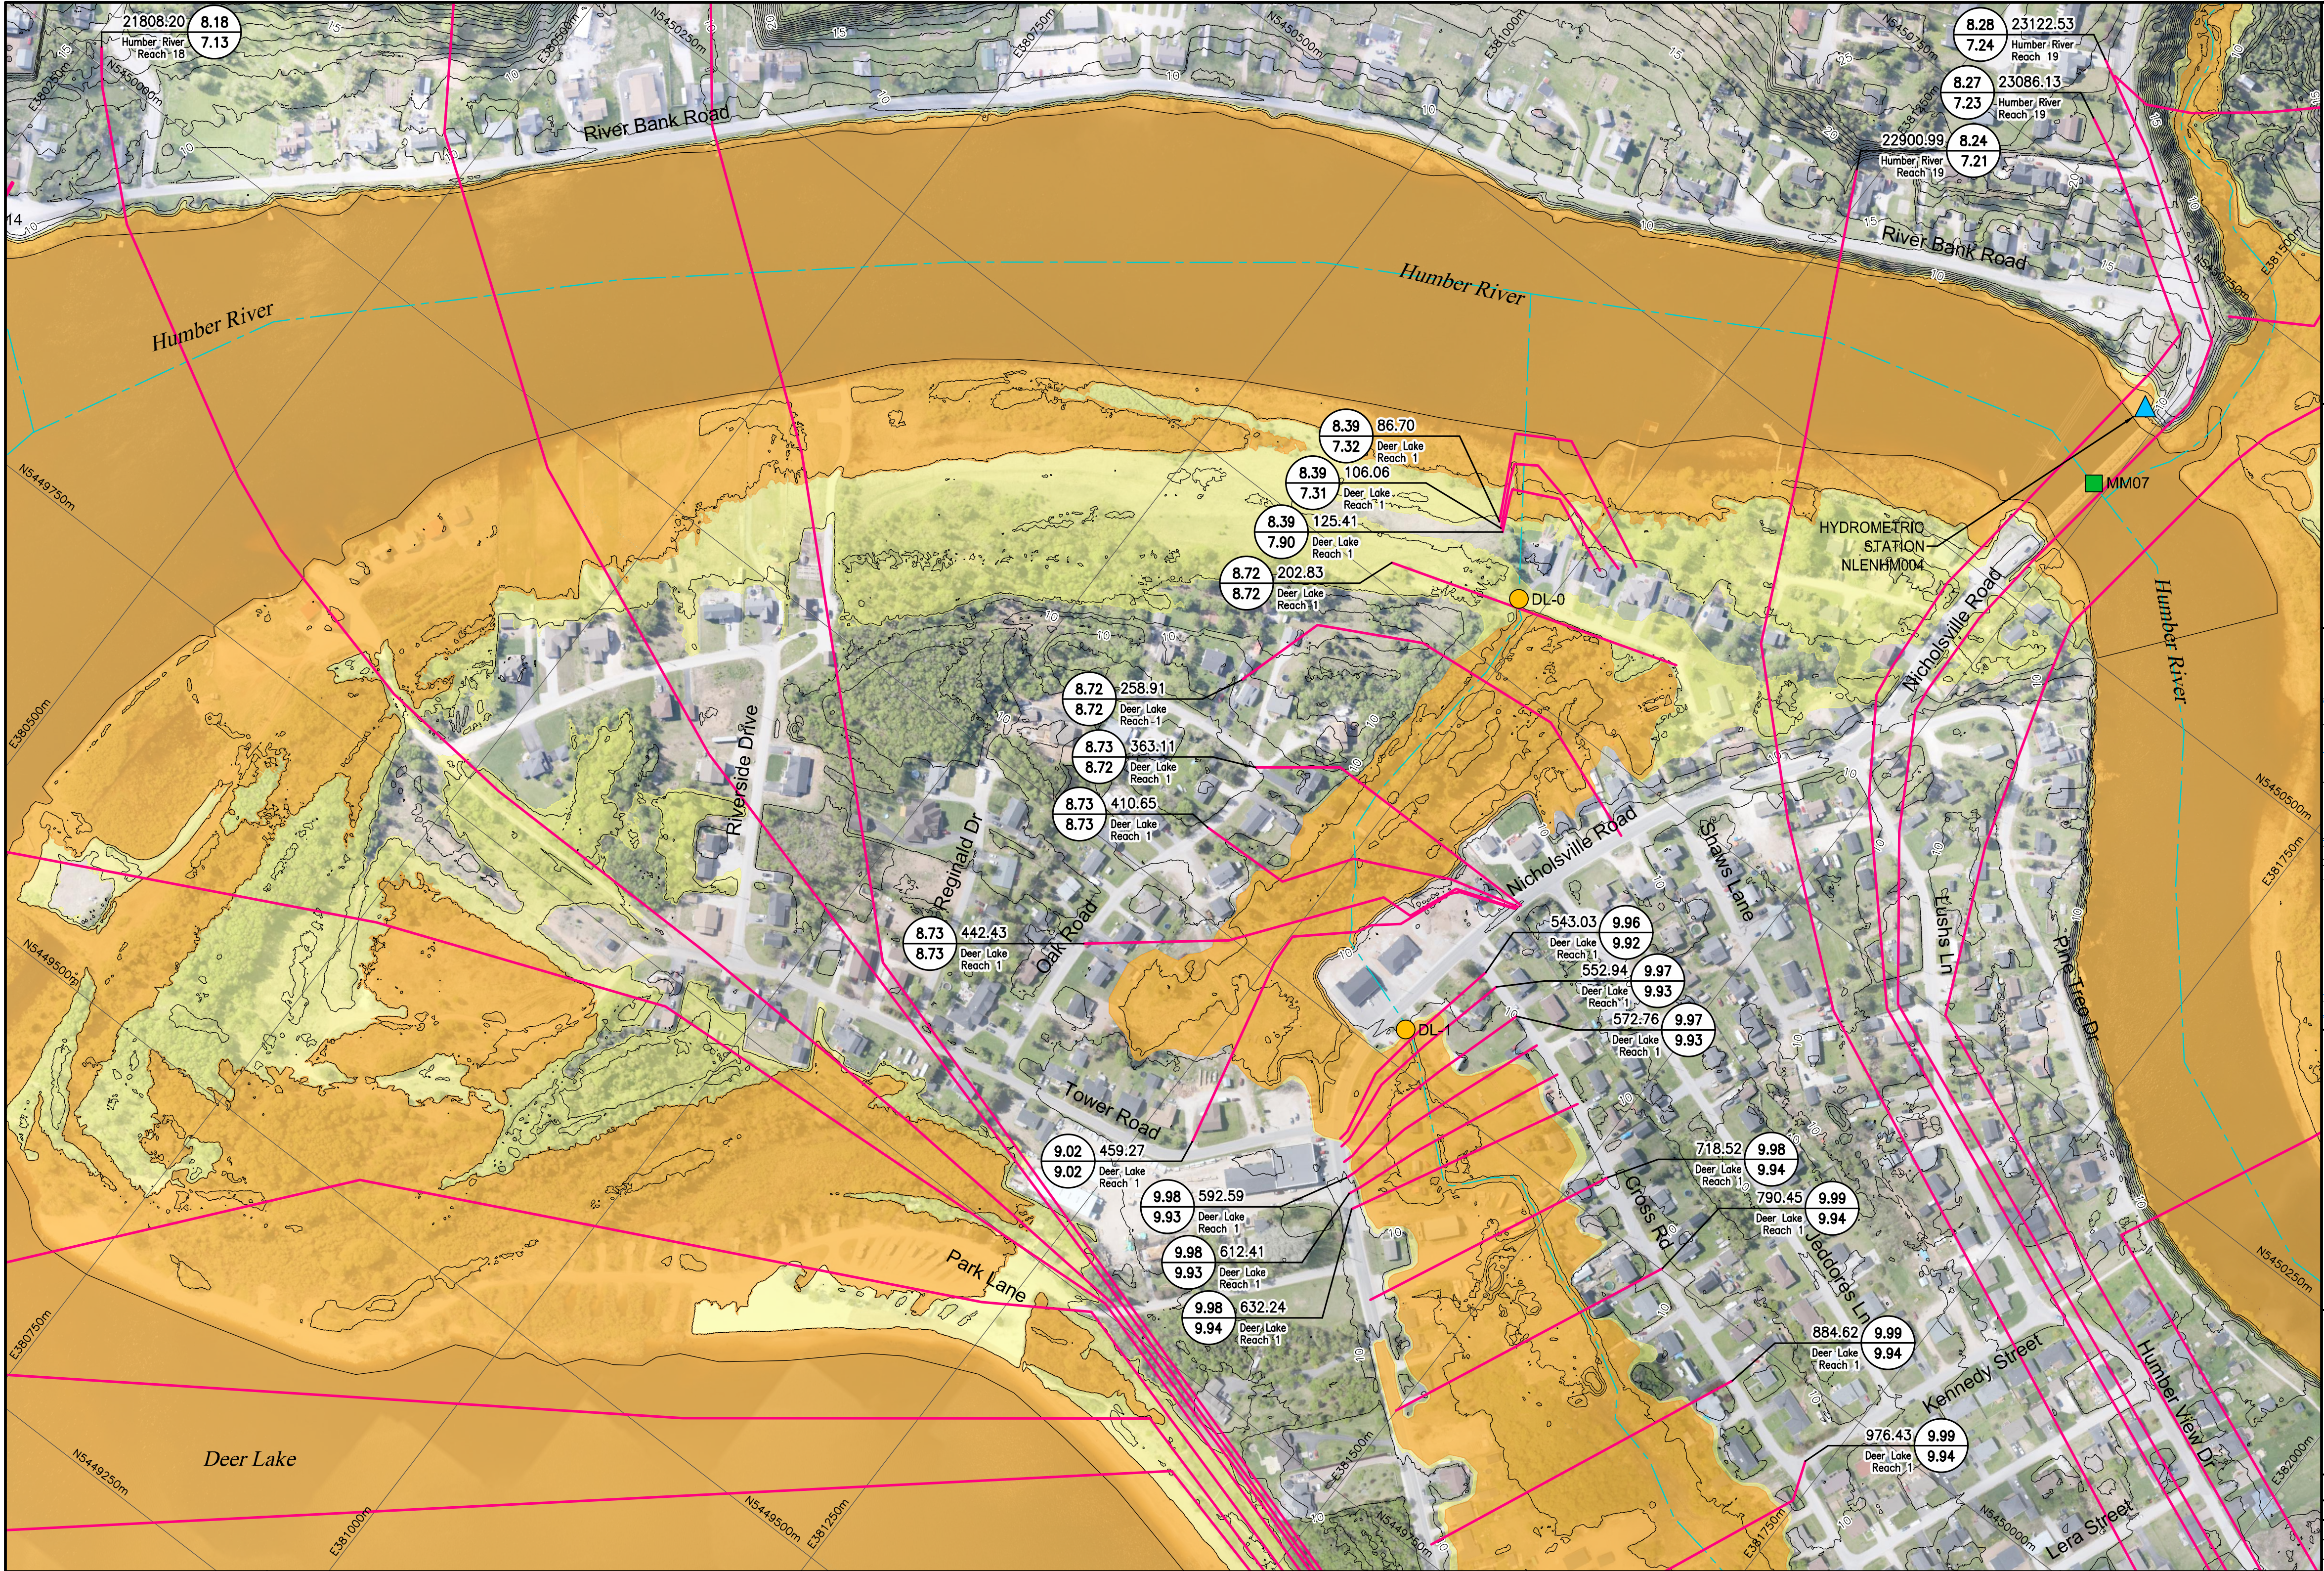
AERIAL PHOTOGRAPHY BY MOSAIC3D, JUNE 2019  
CONTOUR INTERVAL: 1.0 METRE (DATUM CGVD-2013)
