Climate Change Flood Risk Map Study Humber River Communities

1:100 AEP Flood Extent Comparison Map
Current Climate and Current Development
to Historical Condition

Deer Lake
Blue Gulch Brook, Pasadena Watercourses

Sheet 32 of 90

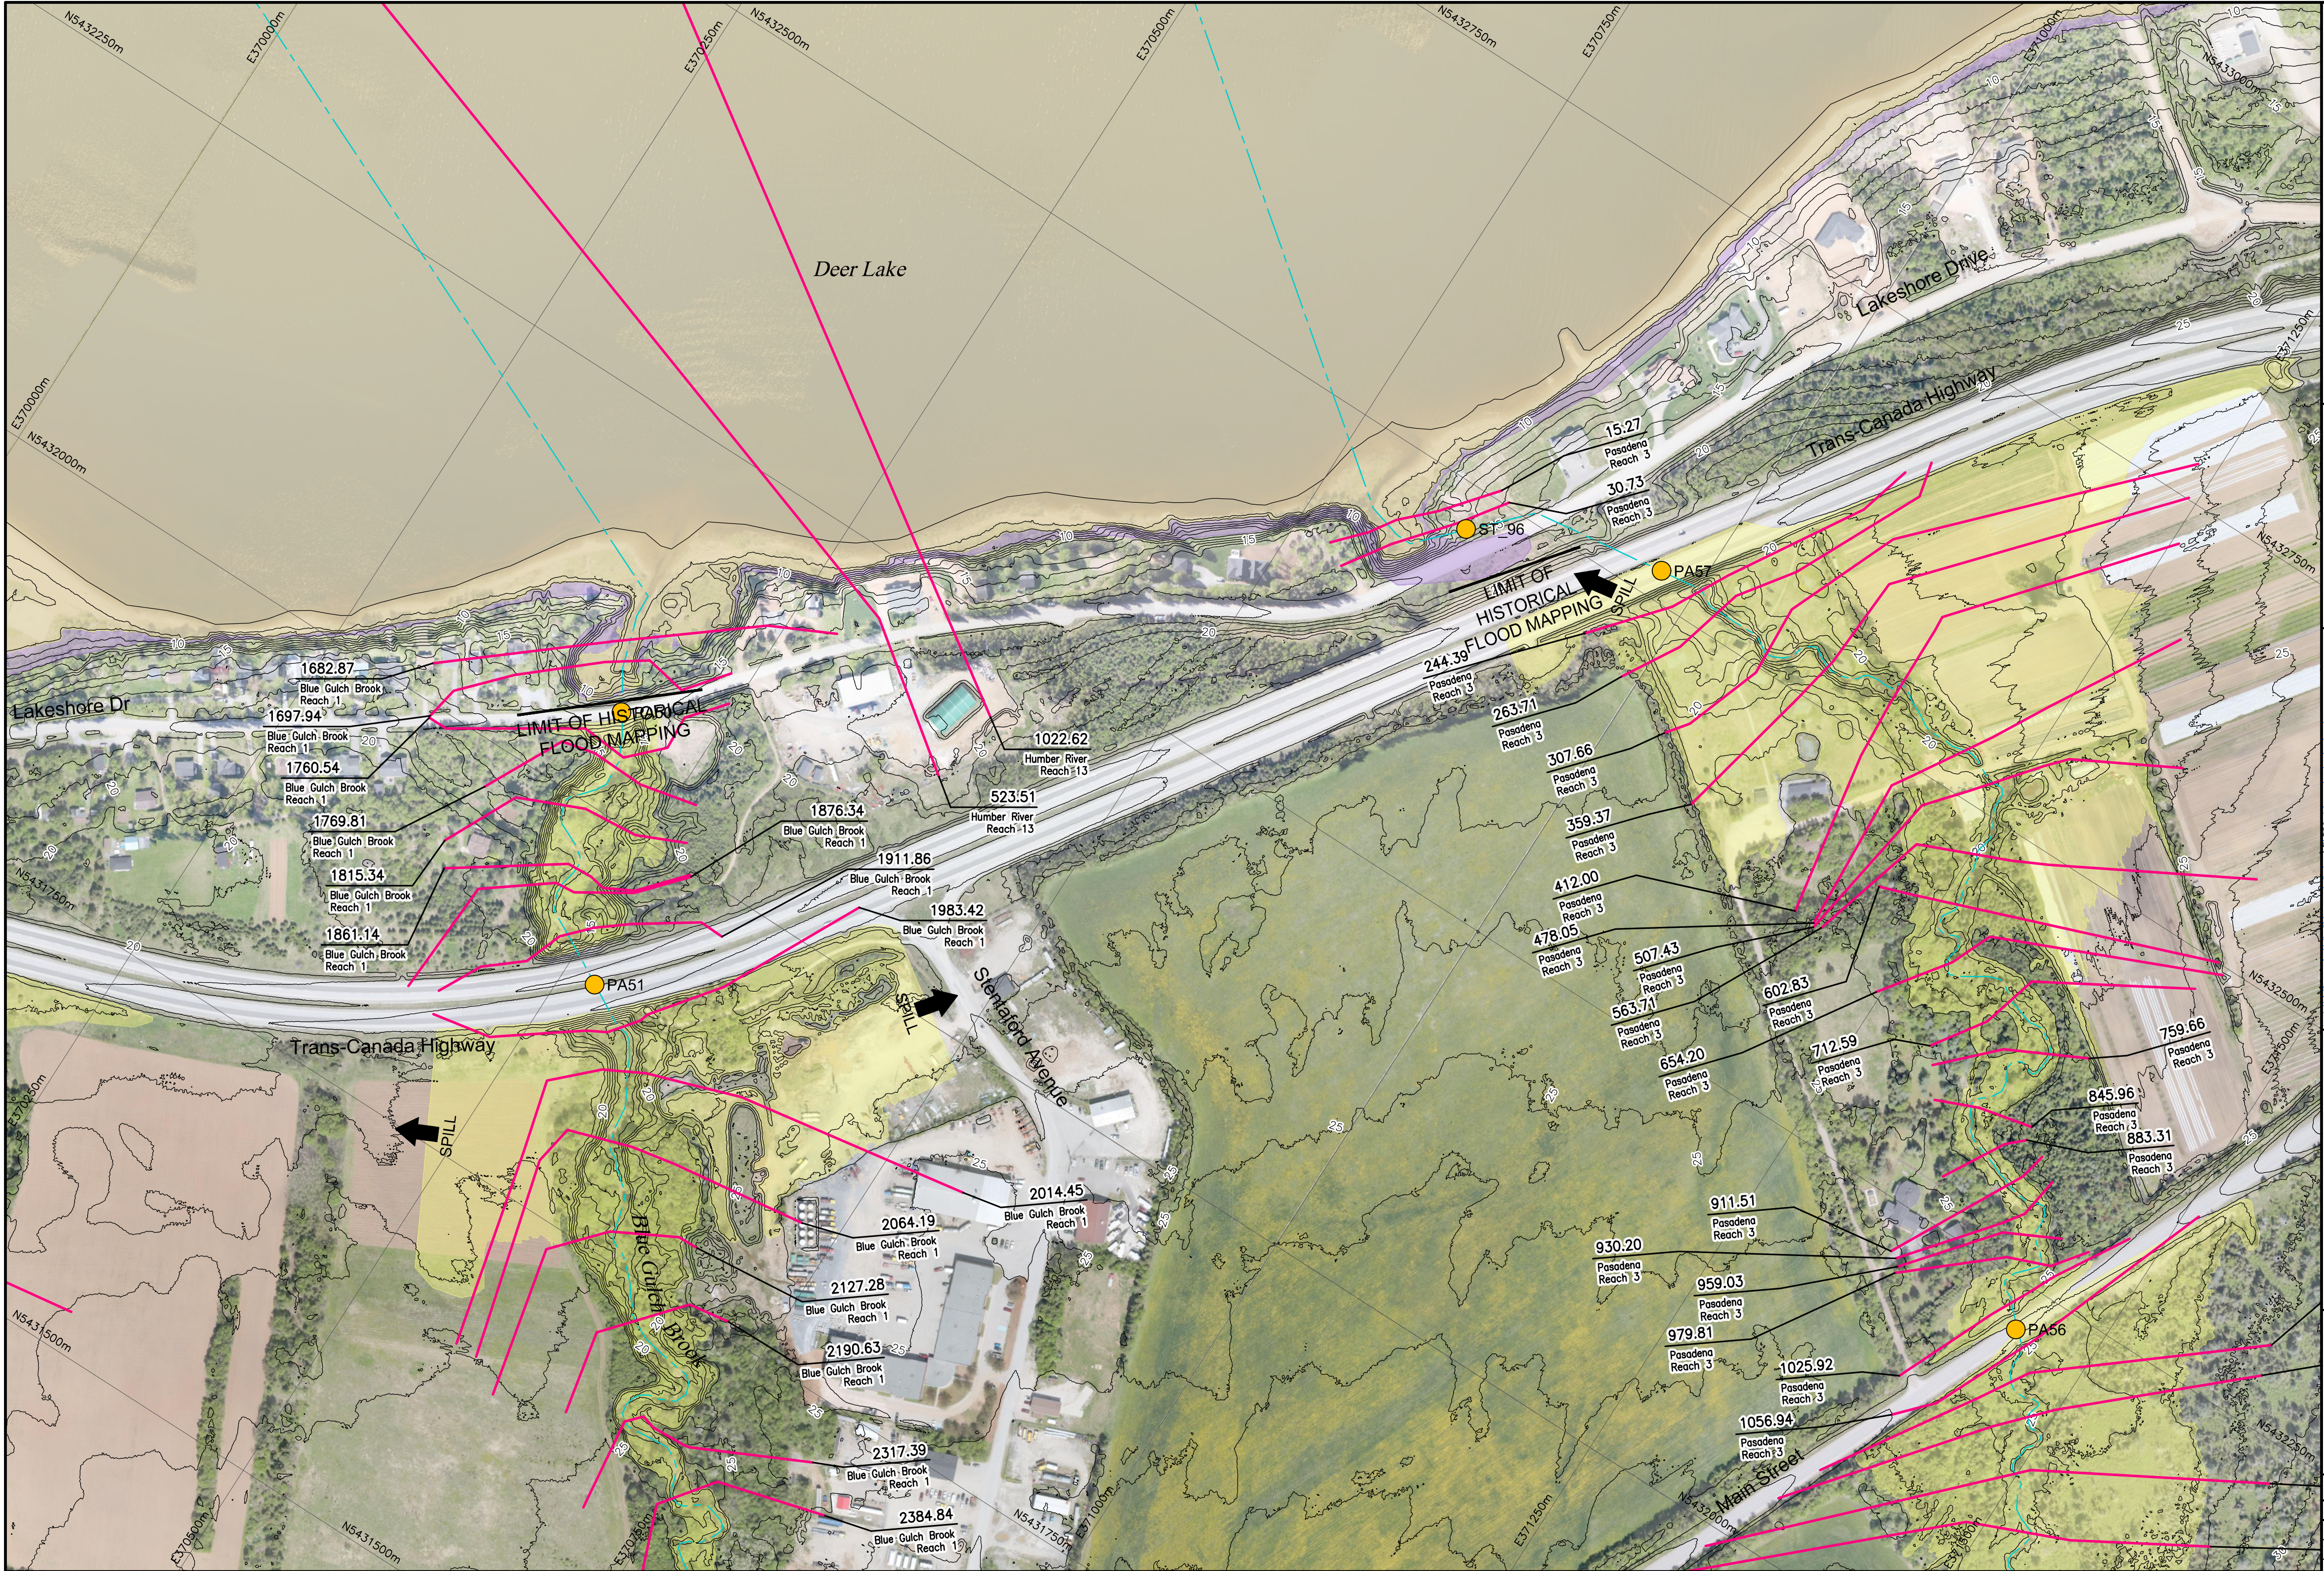
Current Climate and Current Development

1:100 AEP Flood Zone

Historical Condition

NOTE:
HISTORICAL 1:20 AEP AND 1:100 AEP FLOODLINES
HAVE BEEN DIGITIZED FROM RASTER 1:10000
FLOOD INFORMATION MAPS OF DEER LAKE AND
STEADY BROOK THAT HAVE BEEN GEO-REFERENCED
USING BEST FIT/RUBBERSHEETING PRACTICES.
