Newfoundland
Labrador
Department of Environment,
Climate Change, and Municipalities
**Climate Change
Flood Risk Map Study
Humber River Communities**

1:20 AEP Inundation Depth Mapping
Current Climate and
Current Development Condition
Humber River
Humber Resort Watercourses

Sheet 18 of 90

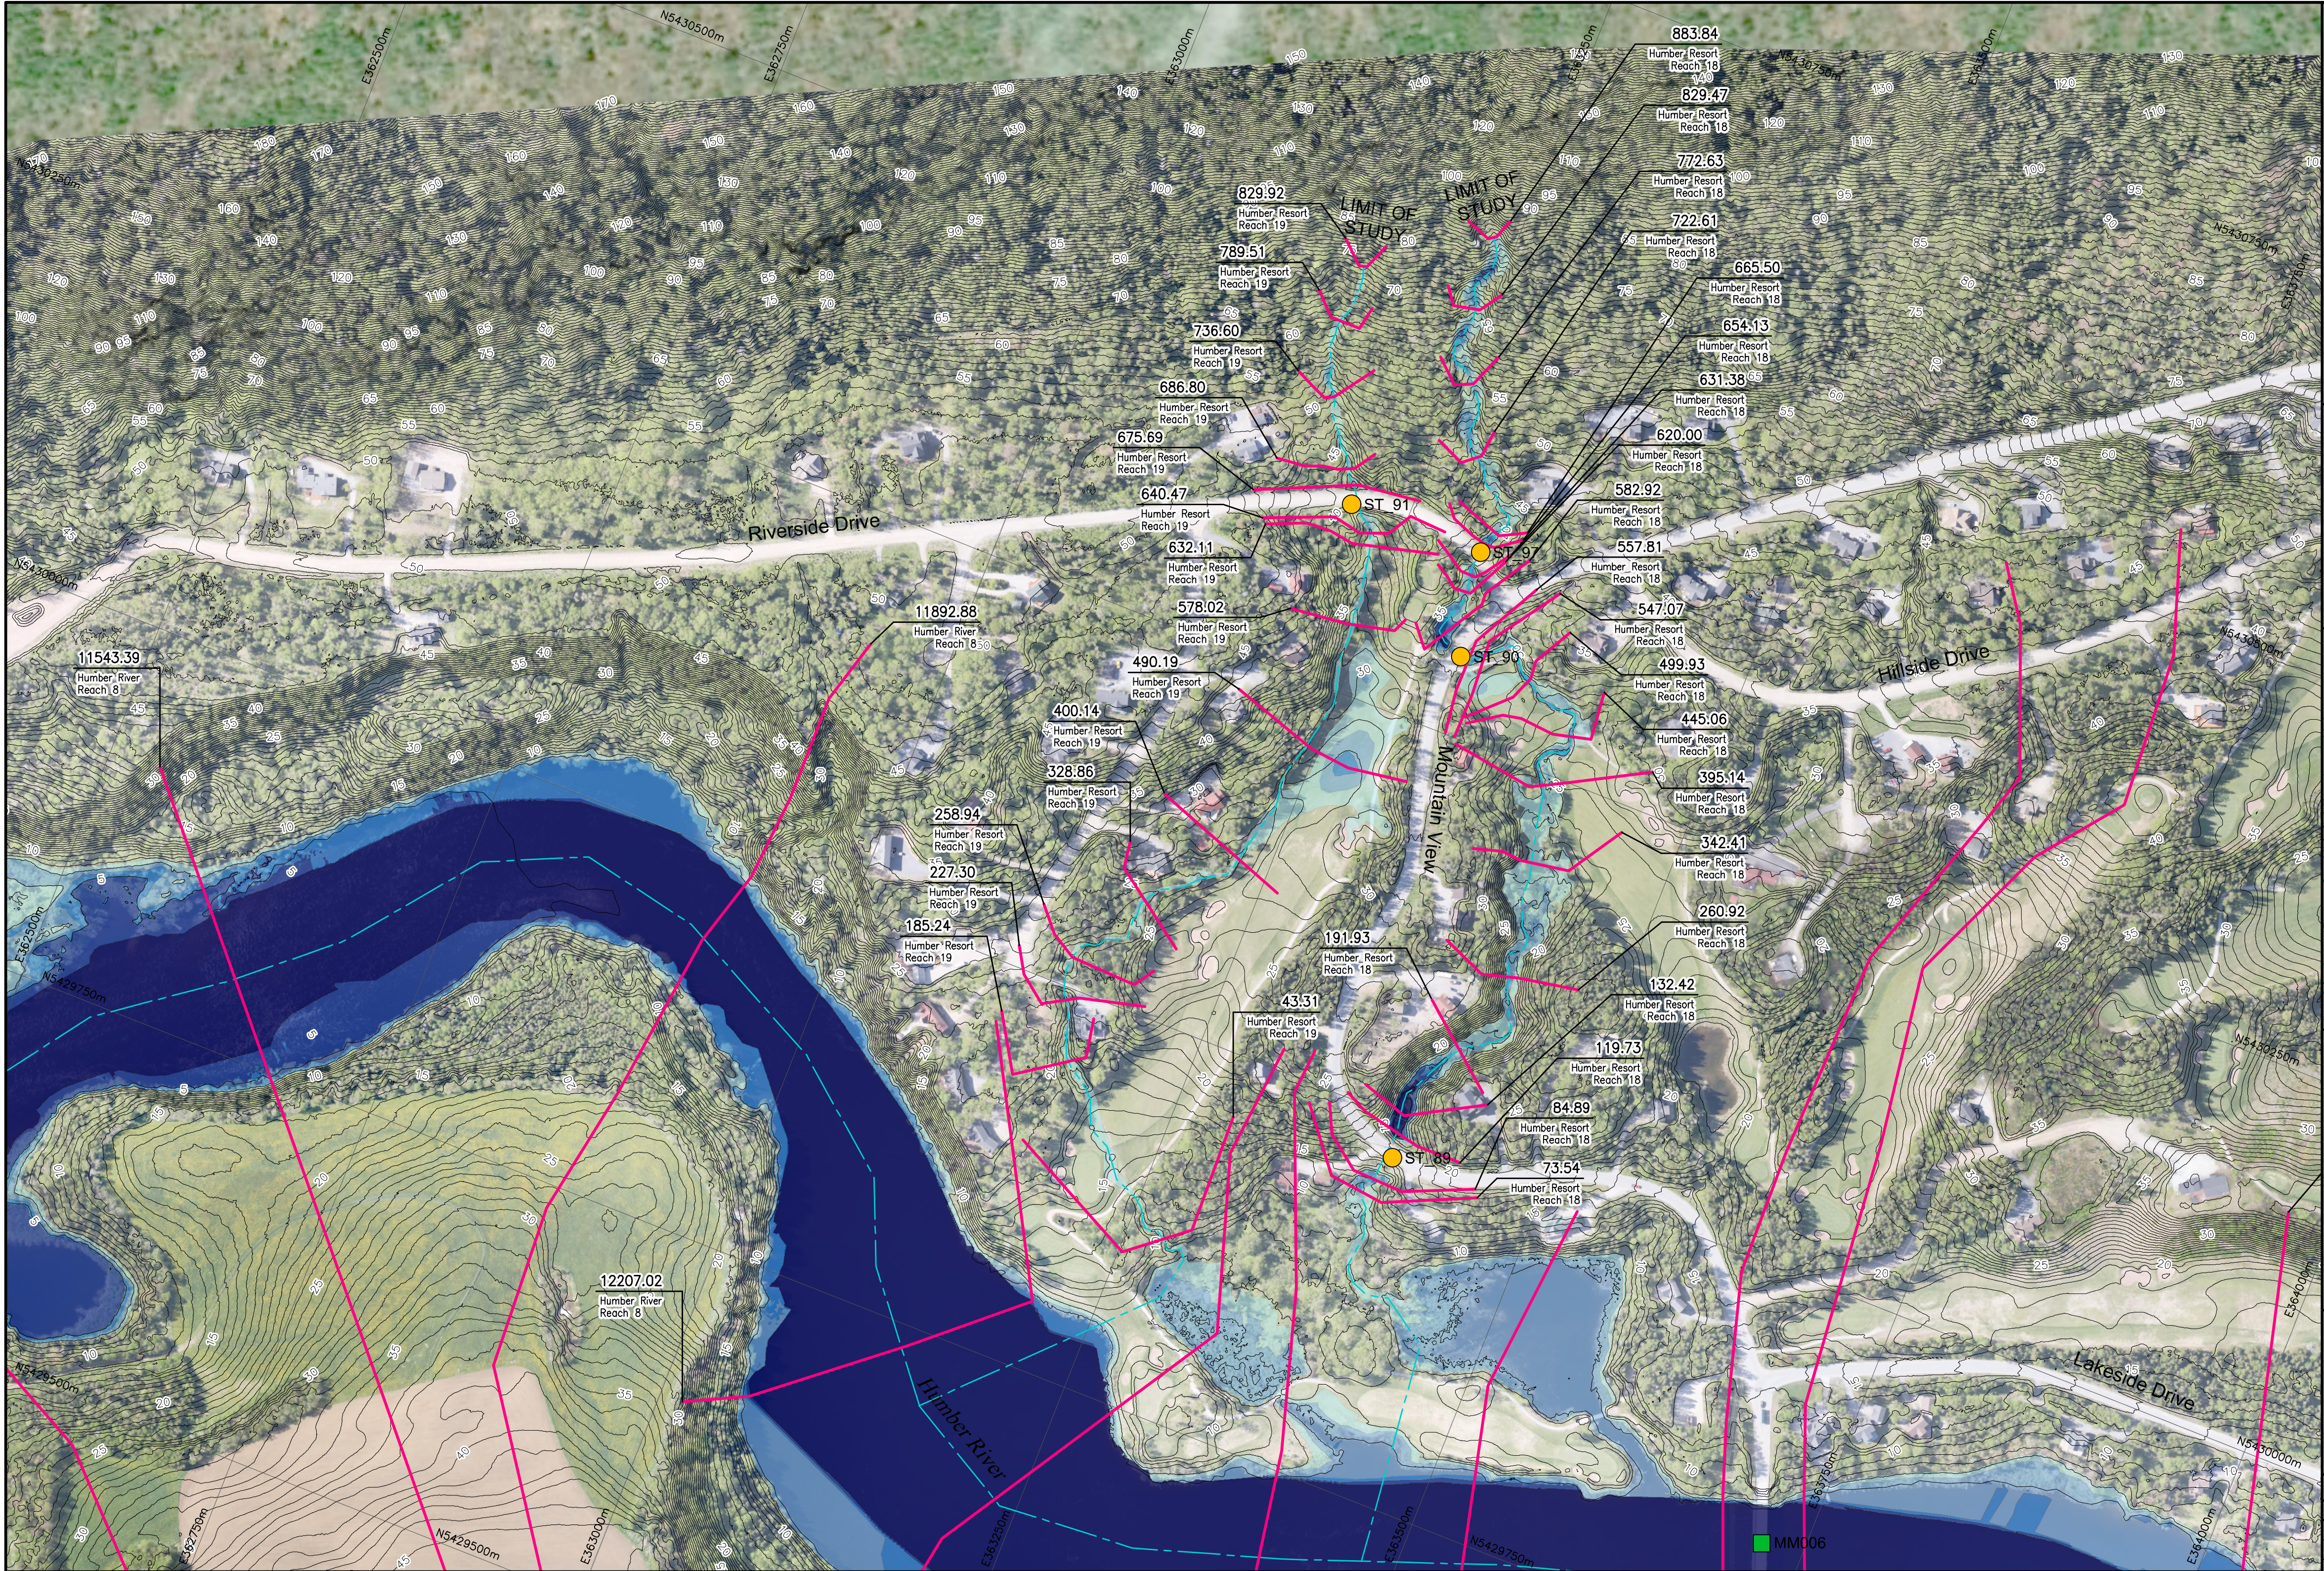
AERIAL PHOTOGRAPHY BY MOSAIC3D, JUNE 9th-14th 2019
CONTOUR INTERVAL: 1.0 METRE (DATUM CGVD-2013)
