# **Annual Compliance Report - 2020**

## **Code of Containment**

for the Culture of Salmonids in  
Newfoundland and Labrador

Department of Fisheries, Forestry and Agriculture  
Aquaculture Development Division

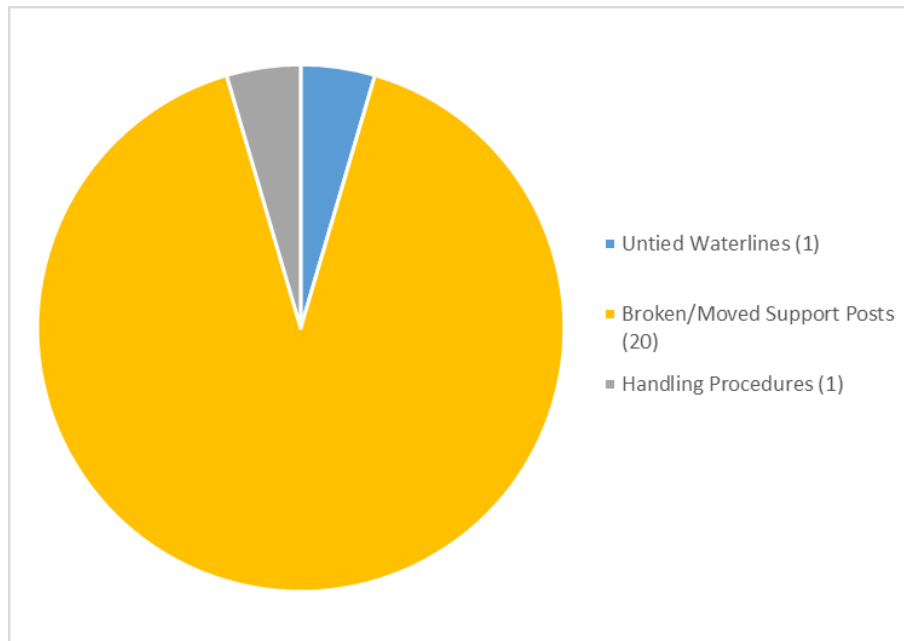
Figure 2: Spring Inspection Results

Figure 2 illustrates the non-compliances discovered during spring inspections in 2020.

- 20 of the incidents were either cage posts that were missing or cracked. Follow-up inspections confirmed all repairs necessary were completed, or the cages in question were replaced. In all instances, the potential for escapes was considered minimal.
- One incident was due to waterlines being untied. The company was notified of the non-compliance. Follow-up inspections confirmed all repairs necessary were completed, or the cages in question were replaced. In this instance, the potential for escapes was minimal.

- One incident was a handling procedure, with fish being counted outside of a cage without the use of a drop net. The company was notified of the non-compliance.

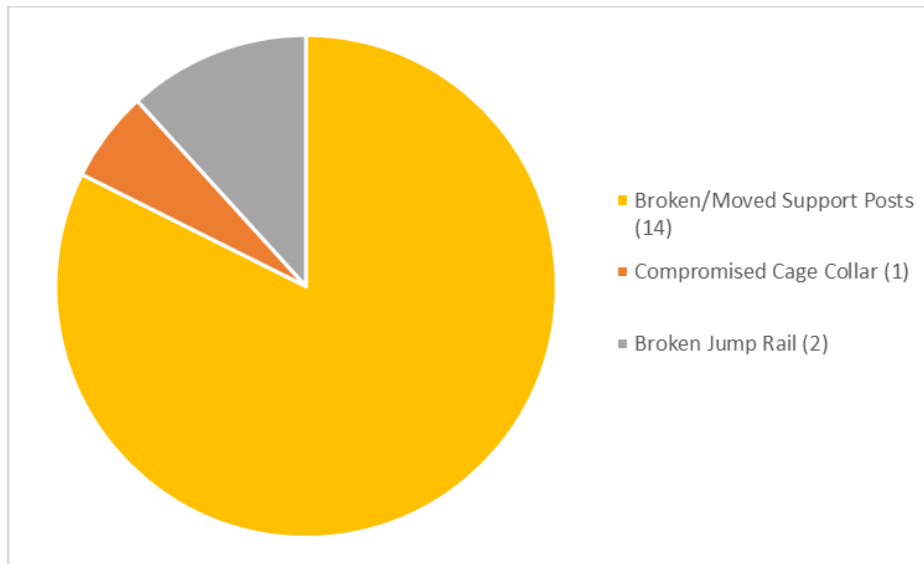
Figure 3: Fall Inspection Results

Figure 3 illustrates the non-compliances discovered during the fall inspections in 2020.

- 14 of the incidents involved cage posts that were missing or cracked. Follow-up inspections confirmed all repairs necessary were completed, or the cages in question were replaced. In all instances, the potential for escapes was considered minimal.
- One non-compliance was due to a compromised cage collar. The company was notified of non-compliance. Follow-up inspections confirmed all repairs necessary were completed. In this instance the potential for escapes was considered minimal.
- Two incidents involved broken jump rails. The company was notified of the non-compliance. Follow-up inspections confirmed all repairs necessary were completed.
