GOVERNMENT OF NEWFOUNDLAND AND LABRADOR Department of Transportation and Infrastructure	BRIDGE INSPECTION REPORT B07232024-2	
Date: 7/22/2024	Inspected By: D. Burns/J. Rowe/B. Grandy	Category: Eng. - Engineering	
BRIDGE INFORMATION			
Site:	2-122 - RUSHOON BAILEY BRIDGE		
Route:	210-21	Overall Length:	40 m
Year Built:	2000	Est: No	Overall Width: 7.3 m
Year Last Rehab.:		Est: No	Roadway Width: 4.1 m
Region:	CENTRAL EAST	Sidewalk Width:	1 m
Jurisdiction:	Provincial	Clearance to R.D. or N.W.L.:	4 m
Type of Structure:	09 - Bailey Bridge	Max Depth of N.W.L.:	1 m
Purpose of Structure:	04 - Over Non-Navigable Waters	Spans:	
Type of Handrail:	04 - Steel Rail	<u>Span No.:</u>	<u>Length</u>
Roadway Surface:	03 - Timber	1	27.4
Alignment Vertical:	01 - Good	2	0
Alignment Horizontal:	01 - Good	3	0
Restrictions:	No	4	0
		5	0
		6	0
BRIDGE PHOTOS

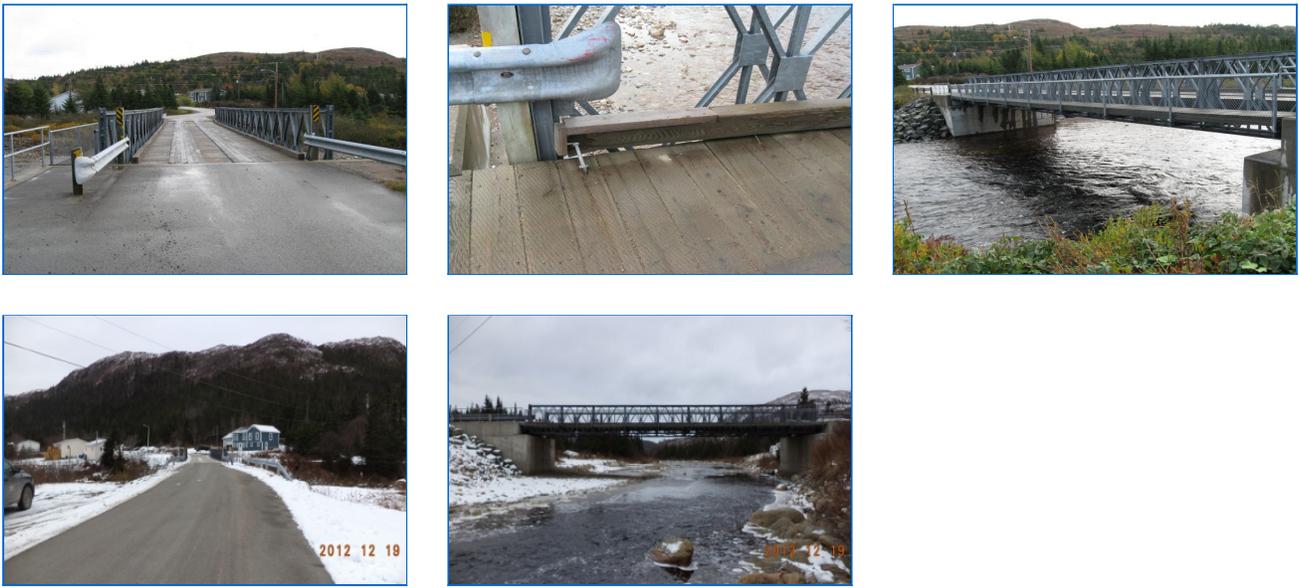
Comments:	Concrete abutments and wingwalls, all in fair condition. Very minor cracking in some areas. Honeycombing in

some areas near the cold joint of abutment 1 near graffiti.			
SUPERSTRUCTURE			
Condition:	F2 - Fair	Expansion Joints:	I - Inapplicable
Comments:	Single lane mabeey compact 200, 9 panels long. Some areas of minor rusting, especially on tops of panels. Minor dings on various panels on the right.		
DECK			
Condition:	P3 - Poor	Curbs:	F1 - Fair
Hand Rail:	F2 - Fair	Roadway Condition:	P1 - Poor
Approach Rail:	P1 - Poor		
Comments:	Raceway is rotten and deteriorating, causing various potholes. Right hand side curb has been struck various times and is starting to rot. Heavy sand and salt build up on deck. Approach rail has been struck several times and is bent, structural and guard posts are both starting to rot. Some rusting of the sidewalk handrail		
HYDROLOGY			
Water Velocity:	0.5 m/s	Ice Problem:	N - No Problem
Water Depth:	0.5 m	Scour Problem:	N - No Problem
Waterway:	01 - Adequate	Debris Problem:	N - No Problem

Comments:	Waterway was shifted into abutment 2 during Igor.		
REPLACEMENT/REHABILITATION			
Next Rehab. Date:	T.B.D.	Replacement Year:	T.B.D.
Antic. Rehab. Cost:	\$T.B.D	Replacement Cost:	\$T.B.D
Recommendations:	Repair timber raceway and approach rail/posts.		
OBSERVATIONS			
Overall Condition:	F2 - Fair	Requires Further Inspection:	No
Additional Observations:
