Site Inspection Summary

Abandoned Oil Wells - Shoal Point

Purpose of Inspection Ongoing Monitoring of Abandoned Oil Wells at Shoal Point

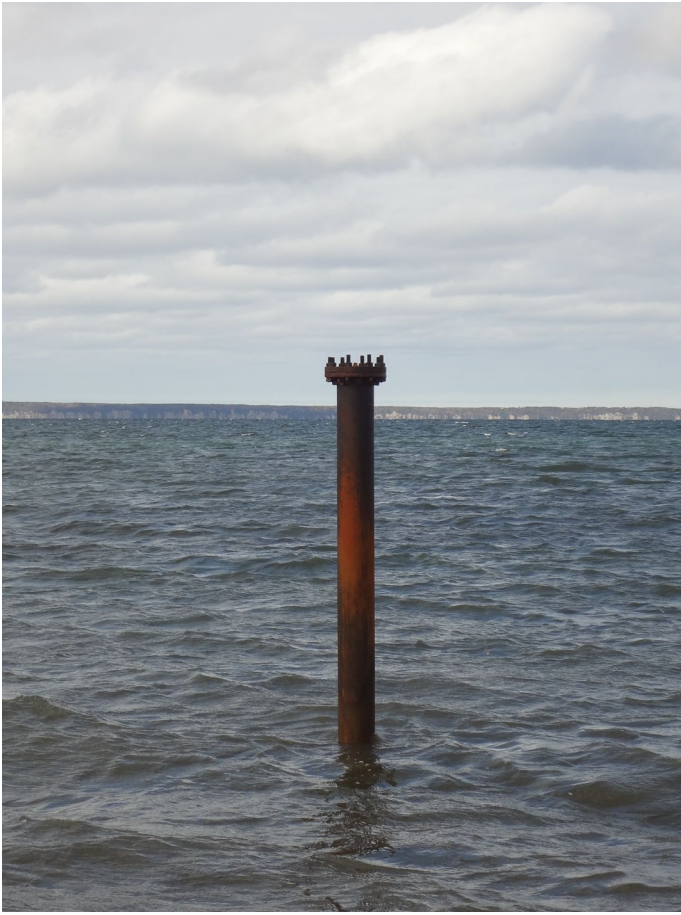
- There was no visible sign of oil in the vicinity of Well Repair #1. The plug placed in the top plate of the extension pipe has stopped the seepage of oil that had been occurring at this location.
- The wind was estimated to be 15-20 km/h SW (towards the shore). The water was relatively turbid and there was strong wave action.
- There was no visible sign of oil or oil odor detected in the area.
- Monitoring of the area for oil seepage will continue.

Photo 2 – Well Repair #1

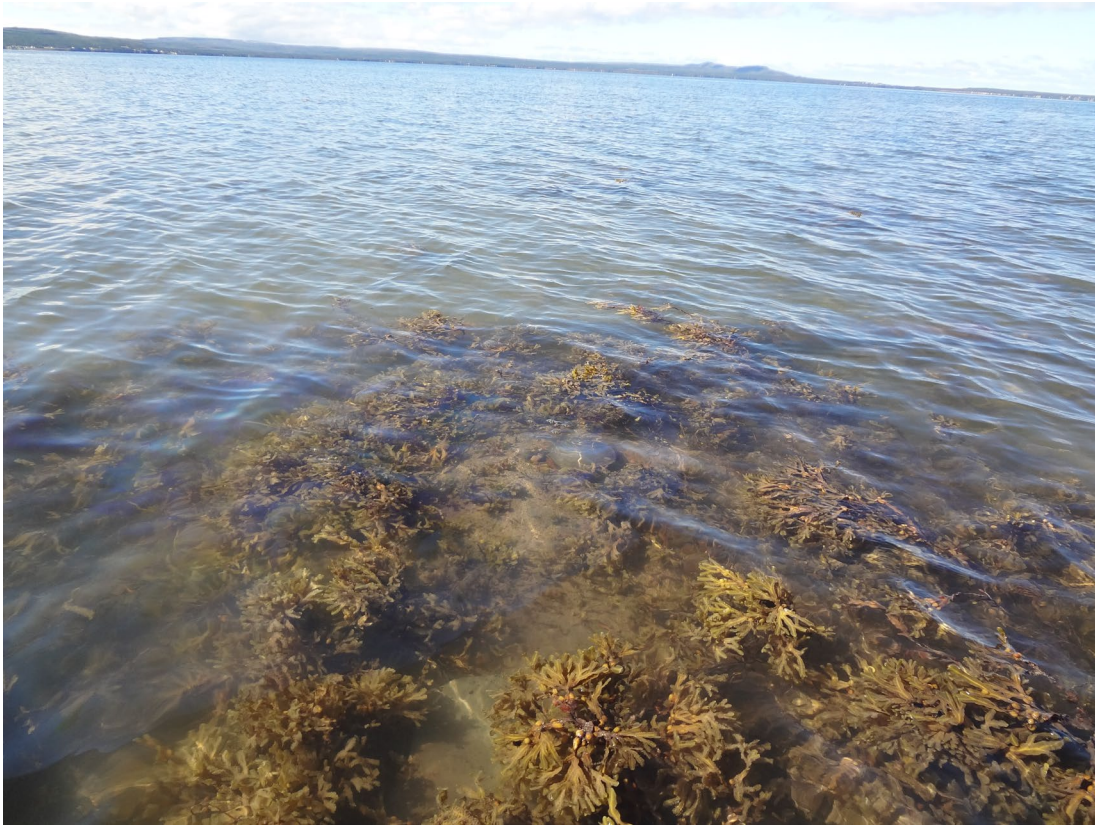
Photo 2 – Capped Well #1

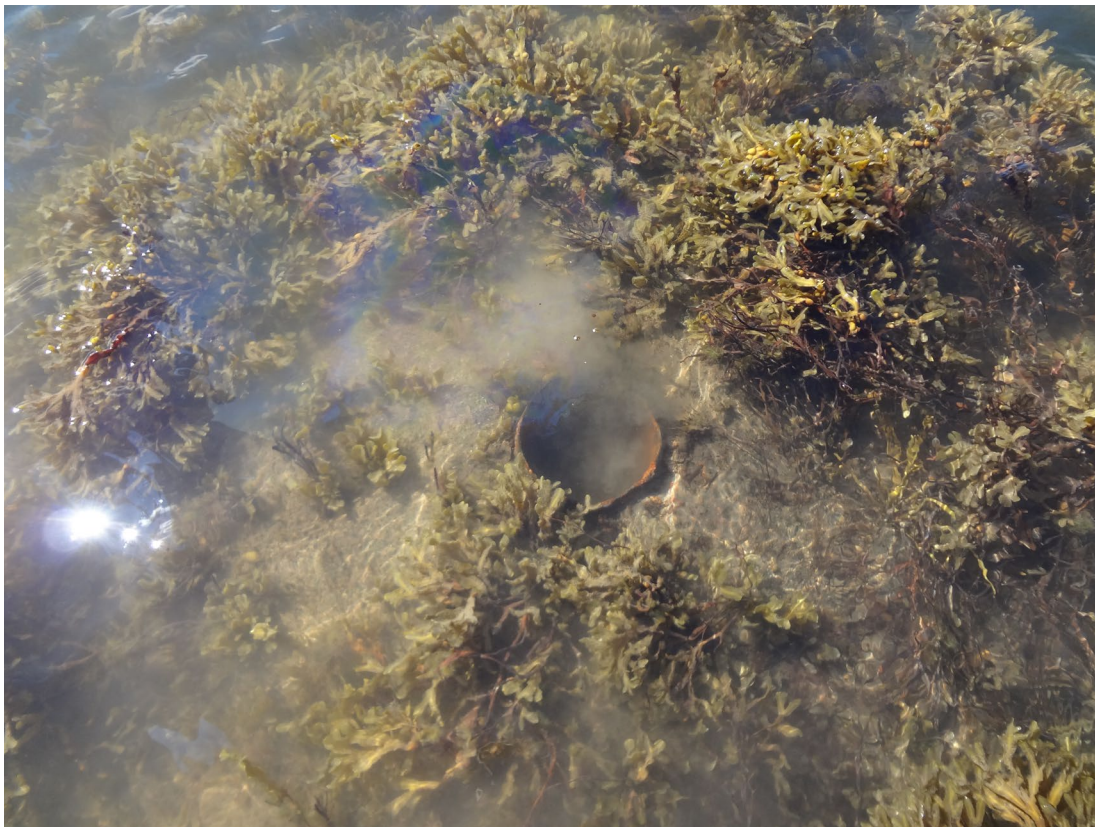
- Significant oil sheening was not observed in the bay.
- Bubbles and slight oil sheening were observed in the immediate area of the capped well (Well #1).
- The cap for Well #1 was removed. Oil bubbles were observed originating from within the pipe. Bubbles formed for a few seconds then ceased for 30 seconds to a minute.
- The plug has not eliminated oil release from Well #1. It could not be determined if a reduction in the amount of oil being released was achieved.
- Monitoring of the area will continue.

Photo 3 – Oil sheening and Bubbles at Well #1 (Cap Removed)

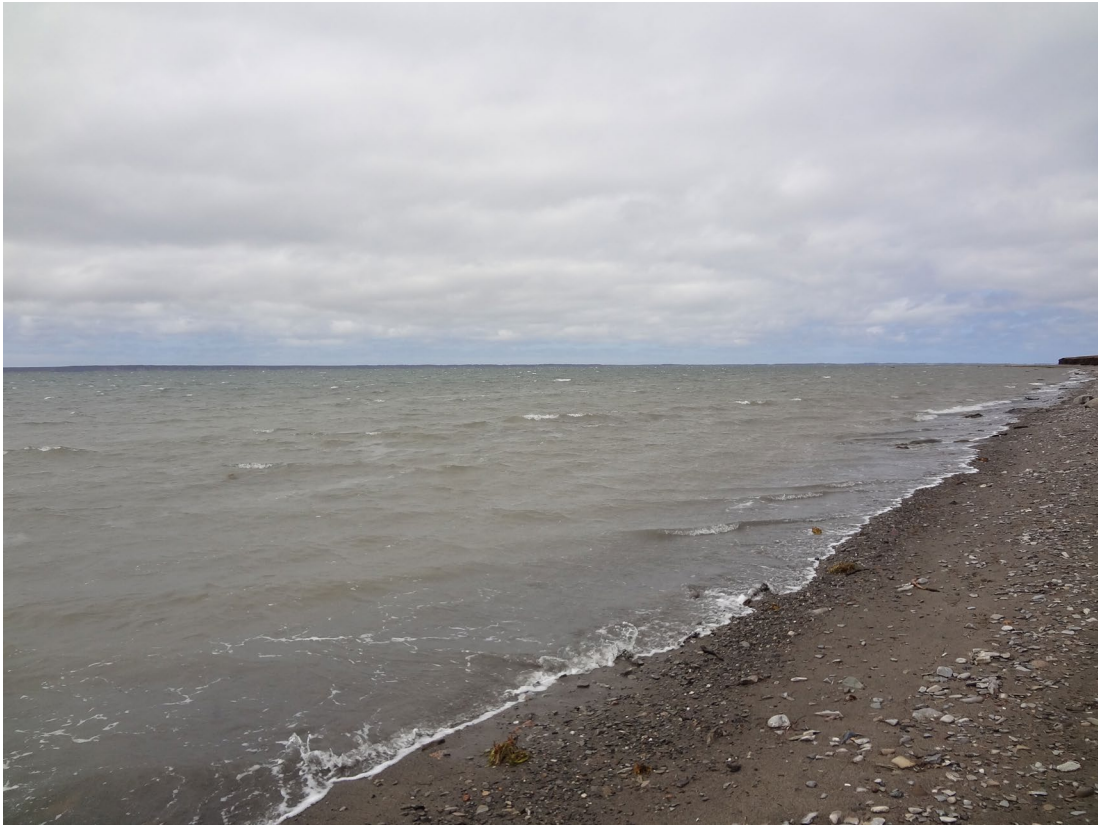
- Oil sheening was observed in the bay originating from the general area of Well #1.
- An oil odor was noted from the shore in the abandoned well(s) area
- Monitoring of the area will continue.

Photo 2 – Oil Sheening in Area of Well #1
