Groundwater Under Direct Influence of Surface Water (GUDI) – an Evaluation for Public Water Supplies in Newfoundland and Labrador

Government of Newfoundland and Labrador, Department of Environment and Conservation, Water Resources Management Division

Prepared by: AECOM 1701 Hollis Street SH400 (PO Box 576 CRO) Halifax, NS, Canada B3J 3M8 www.aecom.com

Date: June, 2013

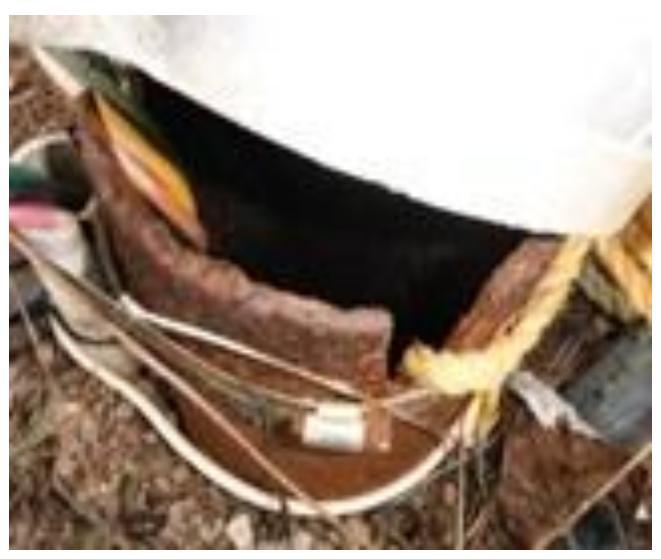
**Photo 2** – Drilled well in Sheaves Cove is unsanitary due to the lack of a well cap, saw cuts in the casing, and insufficient height of casing above ground. The exposed electrical wires also present a threat of electrical shock.

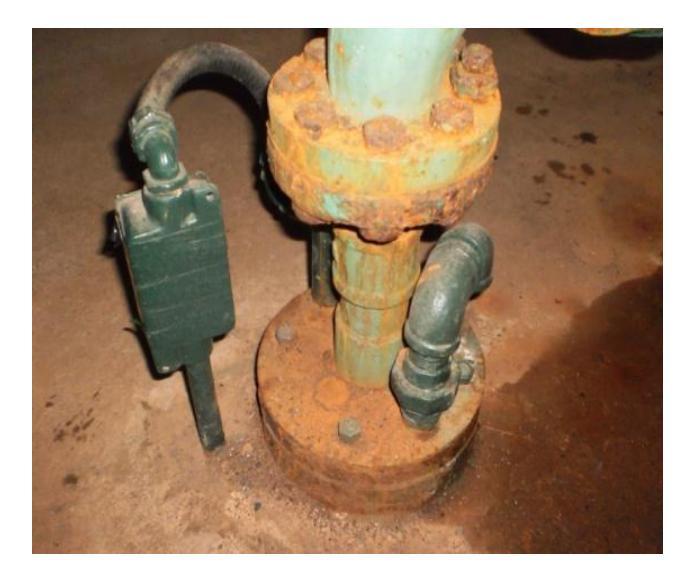
**Photo 3** – Well #1 in Holyrood may be unsanitary due to penetrations in the well cap and the insufficient well casing height (< 30 cm).

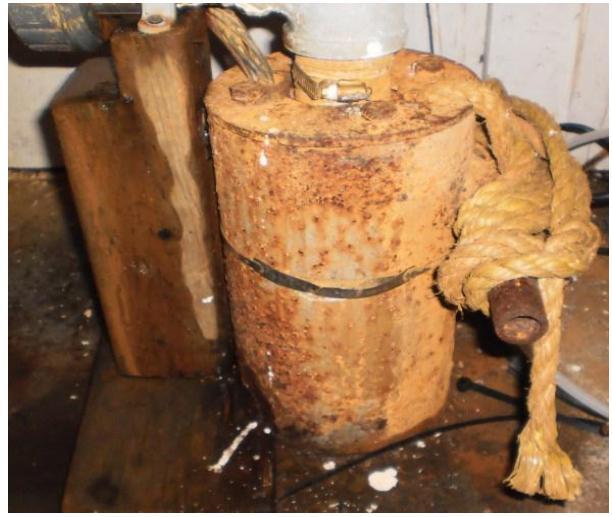
**Photo 6** – Drilled well in Marysvale is unsanitary because of penetrations in well seal, it is not properly vented and the well casing stick up is not > 30 cm above the ground surface. Pump seems to be supported on well seal using a gear clamp, which is inappropriate.

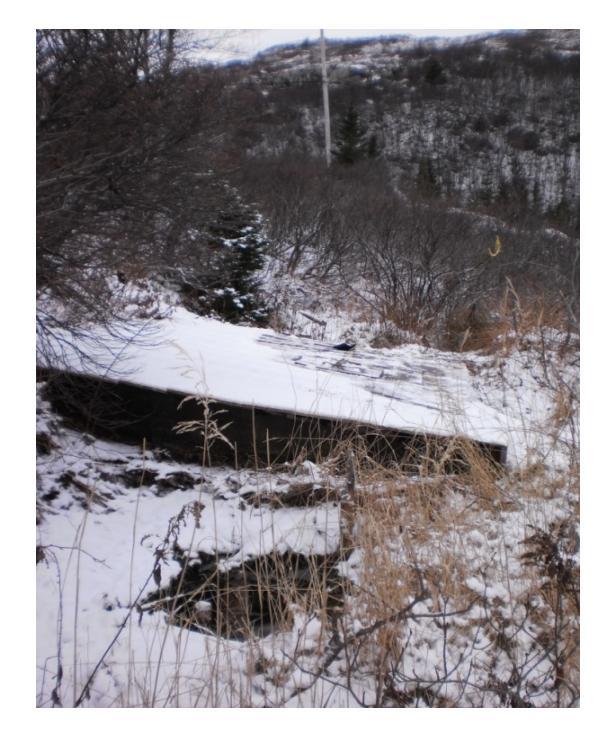
Side View of dug well.

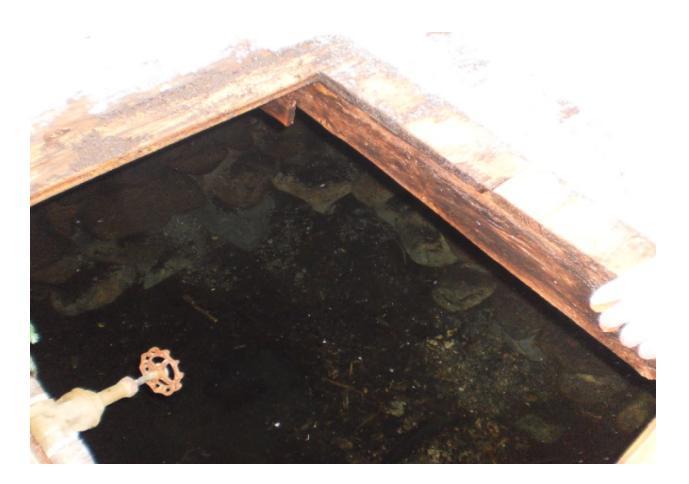
View of interior of well - rock lined

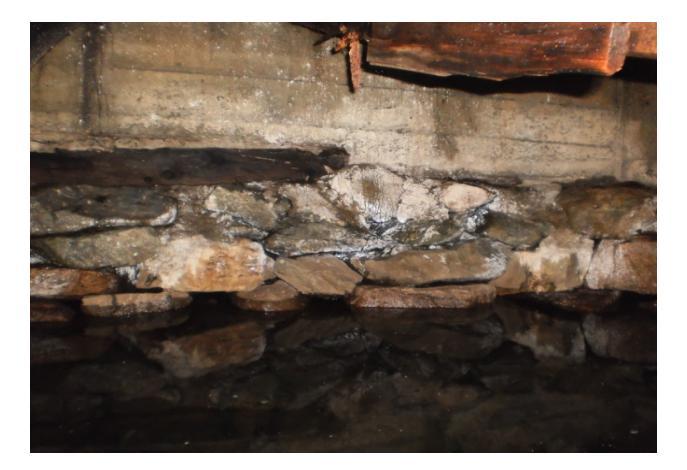
Concrete wall above rock-lined wall and plywood cover.

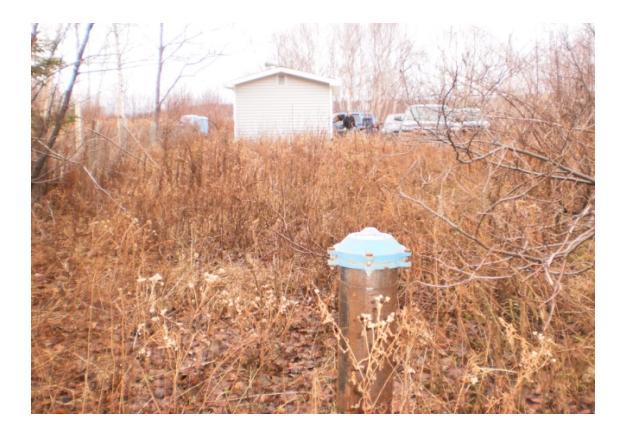
Well 1b "Dry" in foreground, pumphouse in background

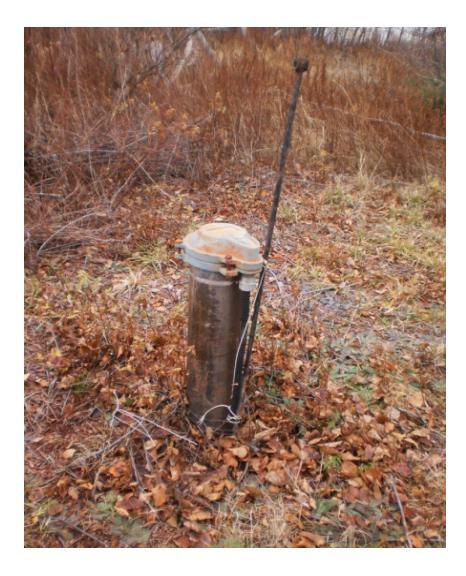
Well 1C "Emergency" Active well

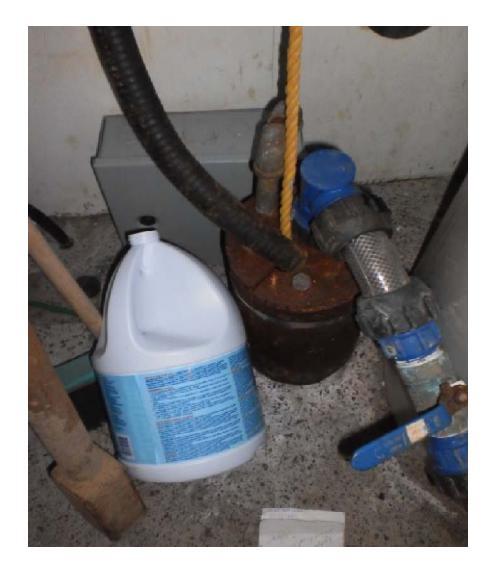
Well 1A - original well located in the pumphouse

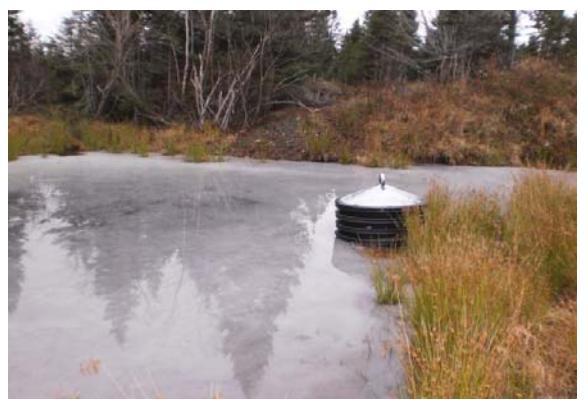
Surface water pond and infiltration gallery that is connected to the water storage tank in the pump house

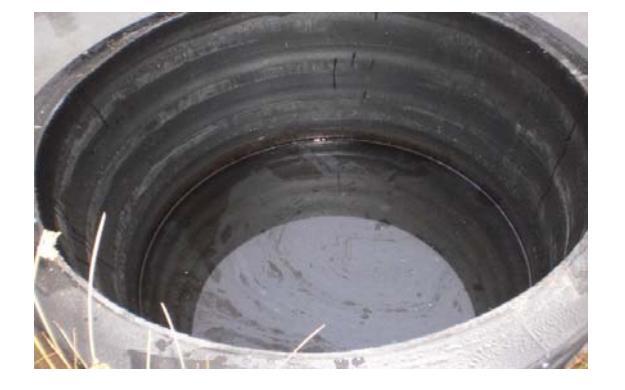
Interior of infiltration gallery

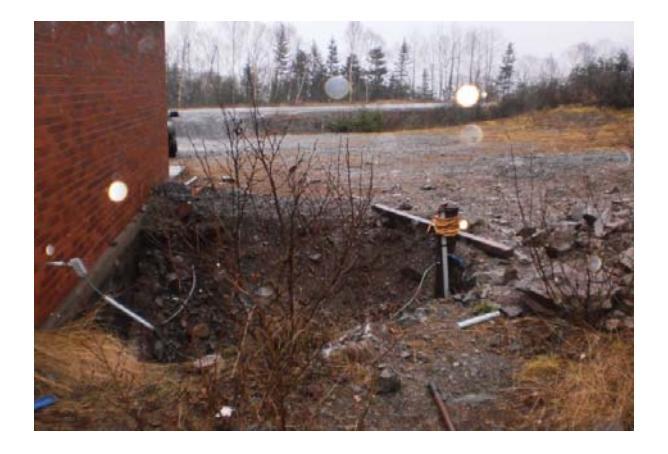
Well #1, Looking toward TCH

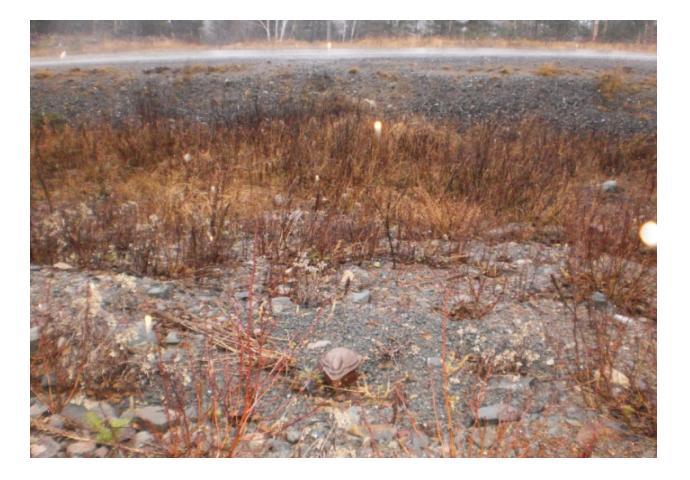
Well #2 - Proximity to highway

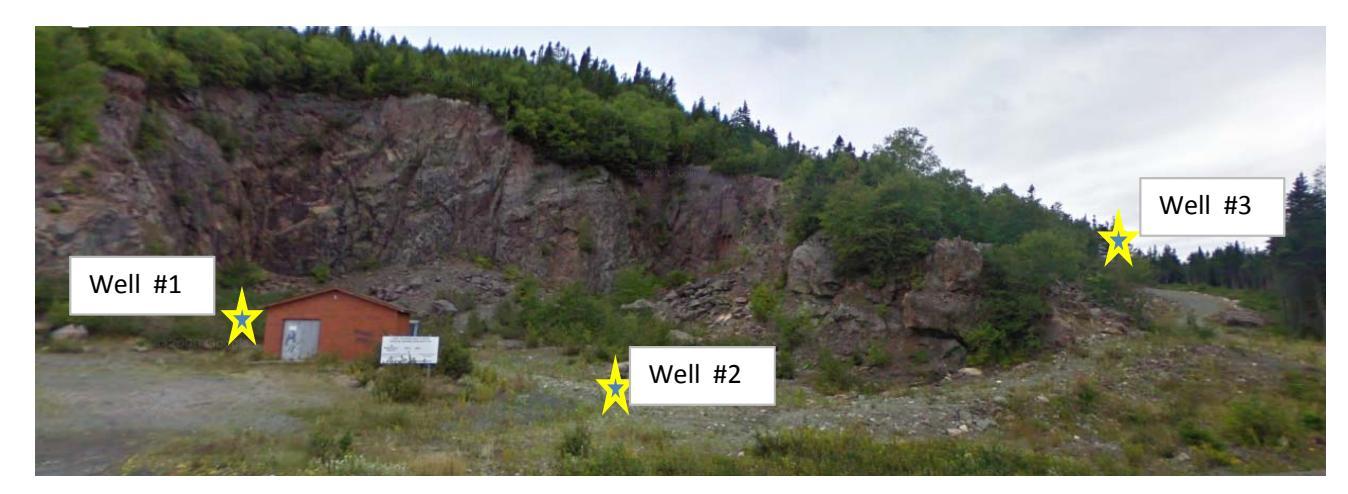
Deep Bight - view from the Trans Canada Highway (looking west). Approximate well locations

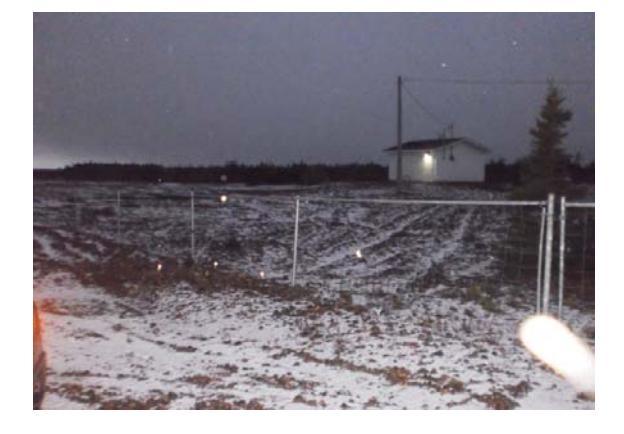
Pumphouse and well head protection area

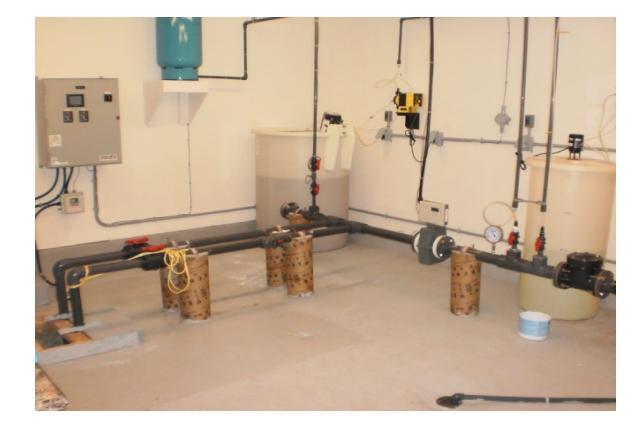
Interior of pumphouse

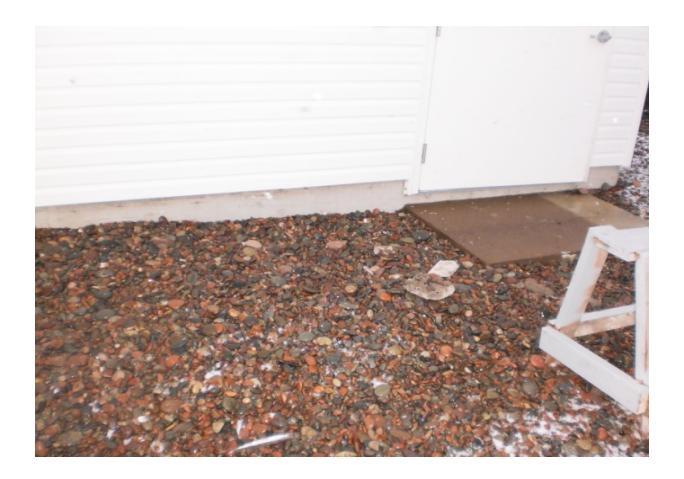
Beach gravel

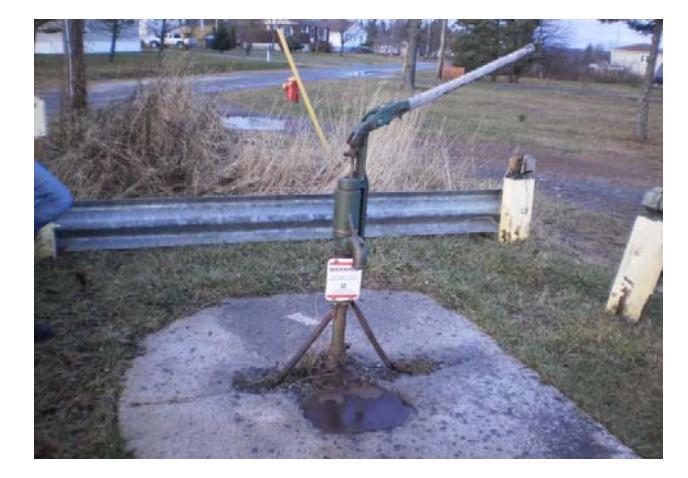
View of handpump well with traffic protection

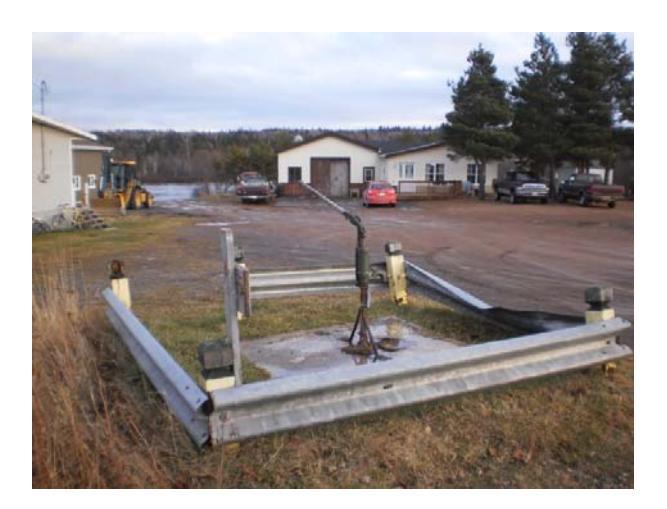
View of proximity to river

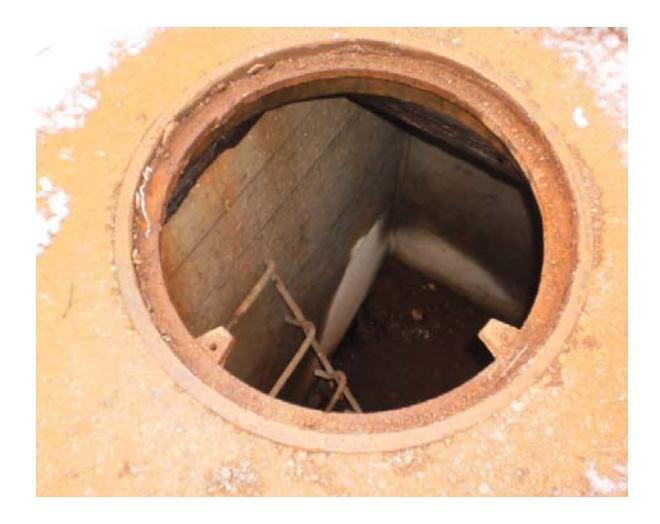
Access to well

Well pit access for Well #3

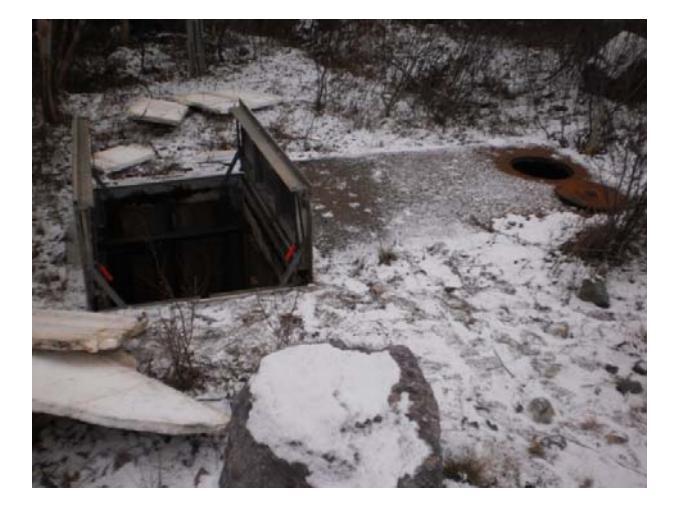
Pit access looking west towards watercourse

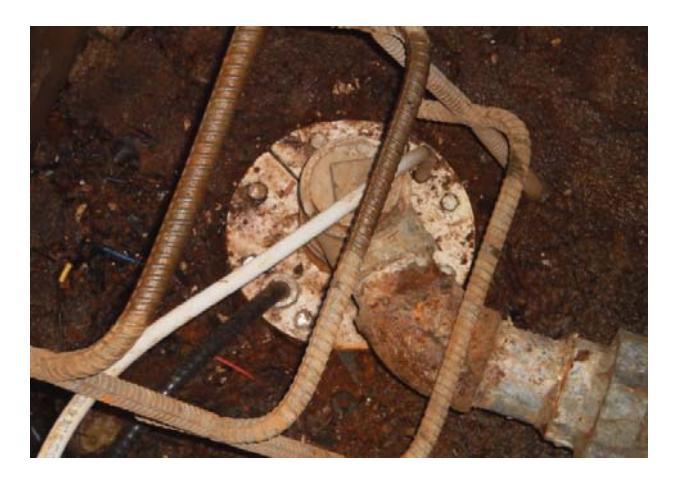
Well head - Well #3

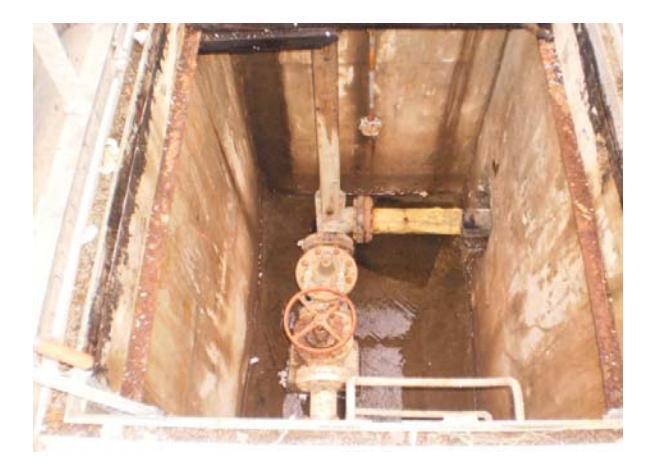
Well #3 - close up view

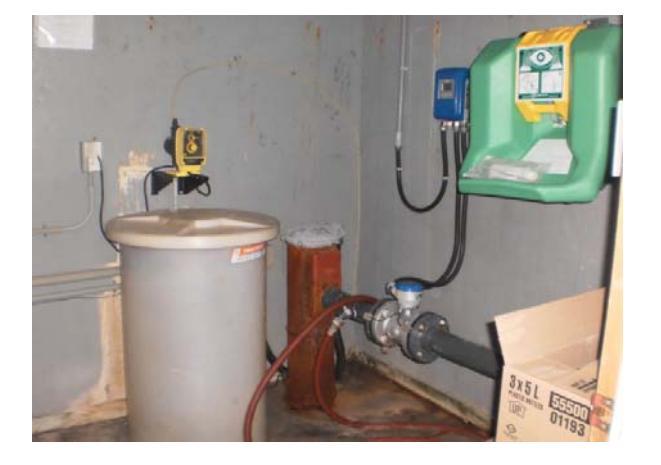
Pumphouse interior

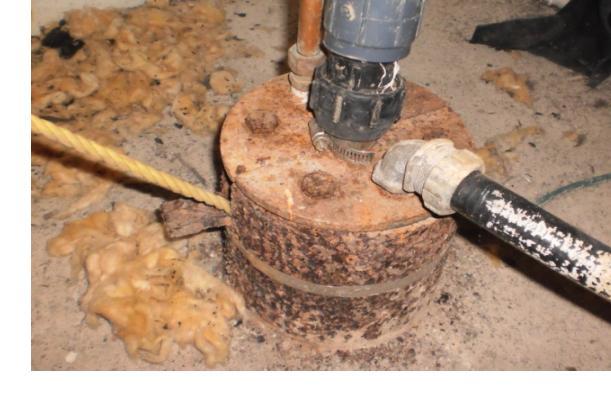
Water storage and well head

Well head - unsanitary

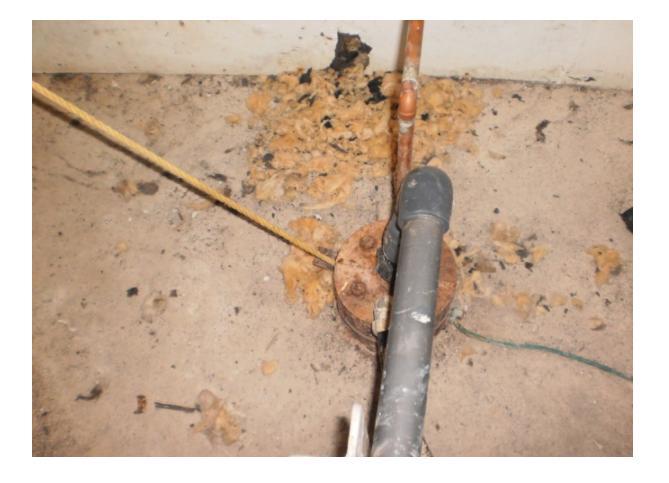
Rodent feces near well head

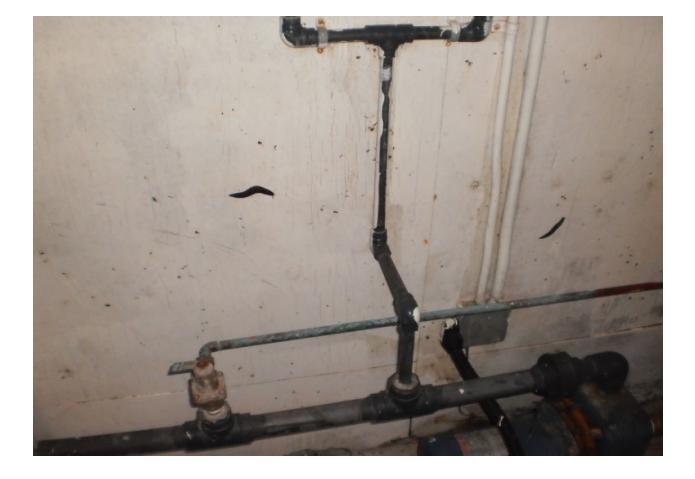
Slugs on walls of pumphouse

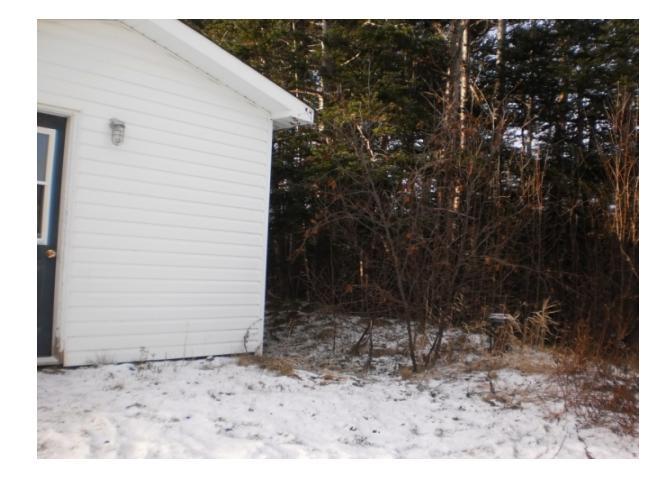
Well #1 in relation to pumphouse

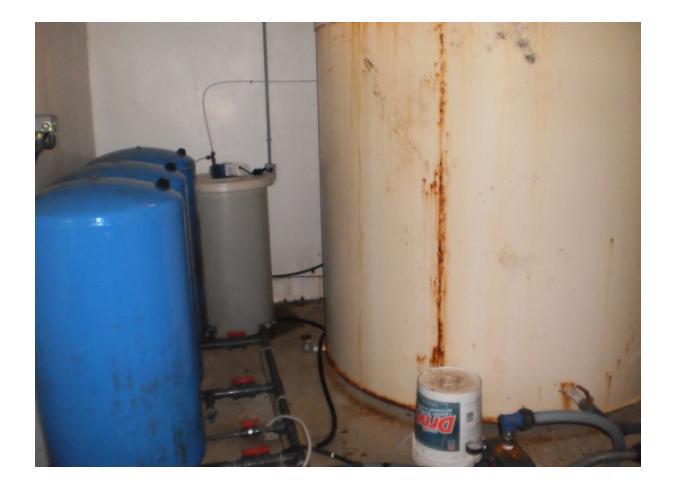
Pressure tanks and water storage tanks

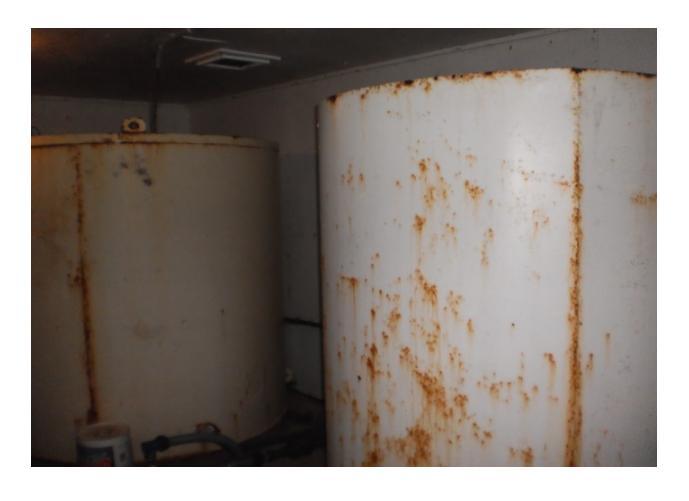
Water storage tanks

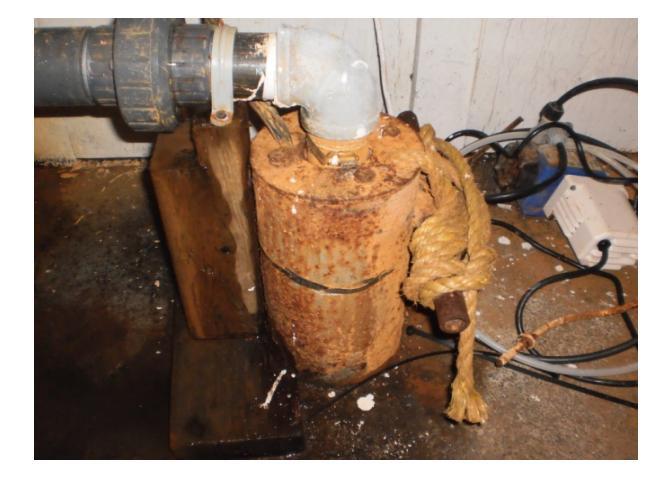
Well head, well #1

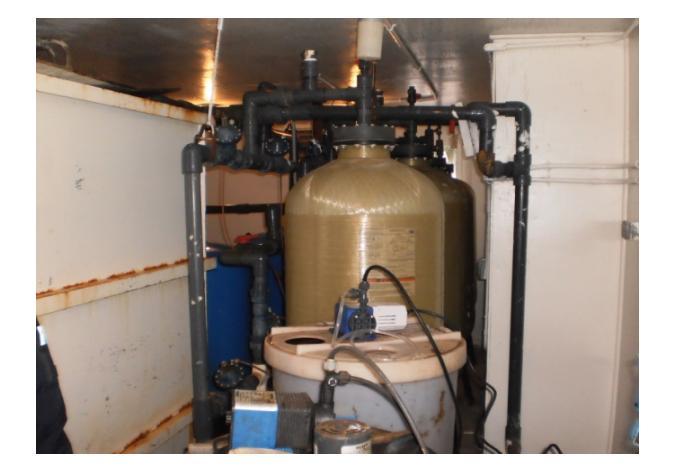
Treatment and storage equipment

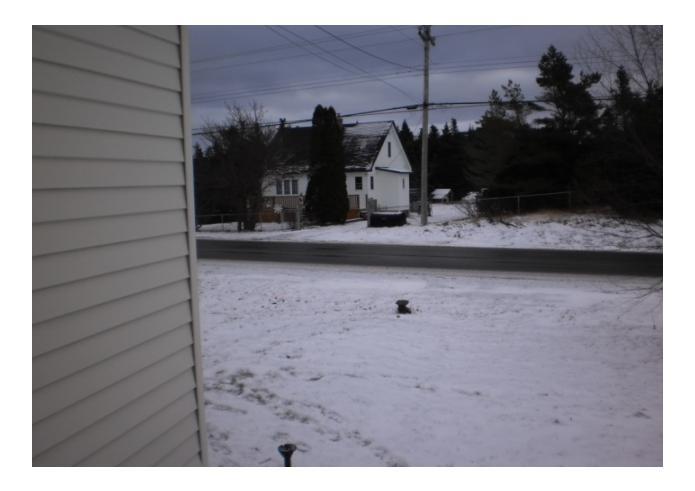
Proximity of pumphouse building to road

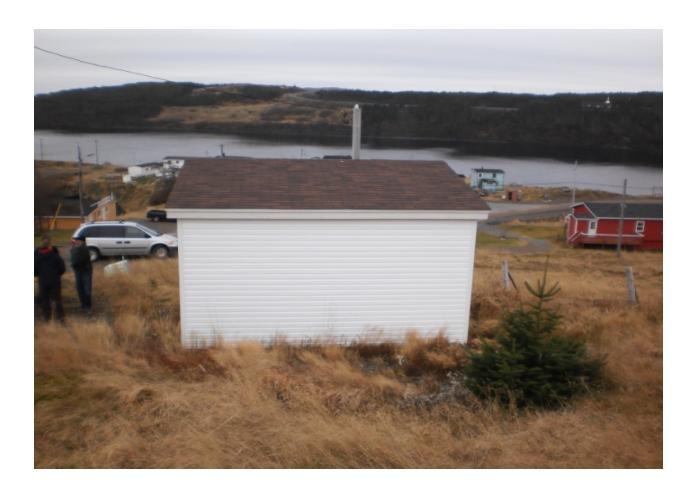
Back of pumphouse, looking south

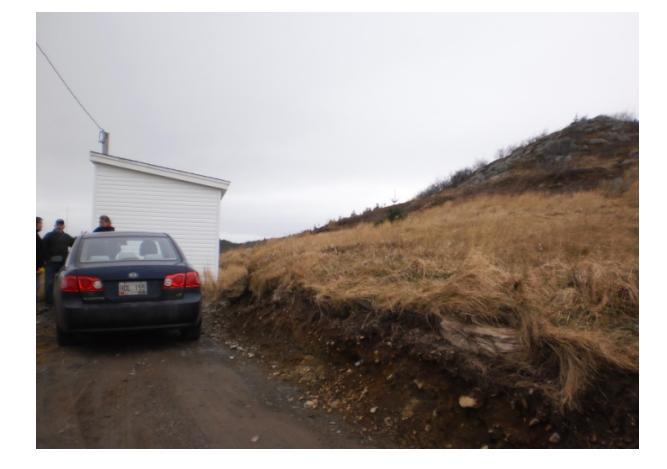
Profile view of pumphouse, looking west

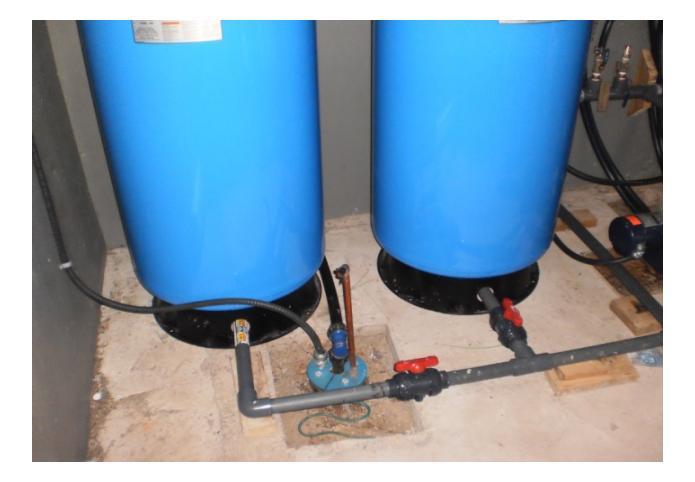
Well head and pressure tanks

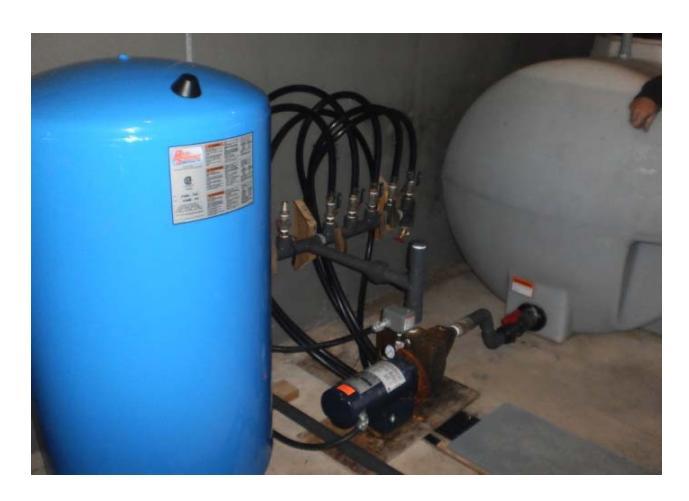
Distribution lines and storage tank

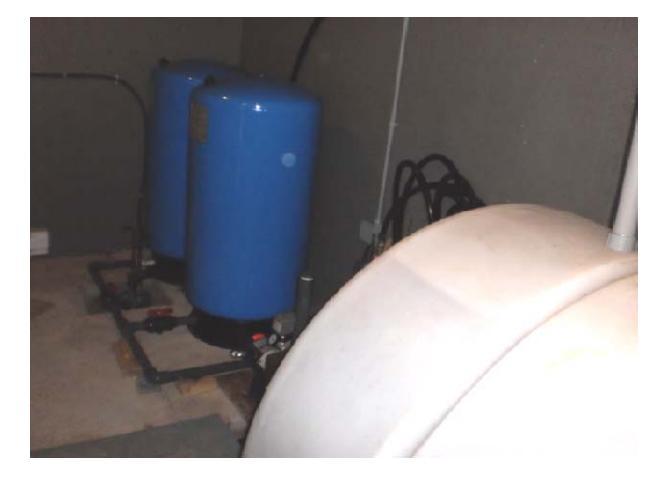
Interior of pumphouse

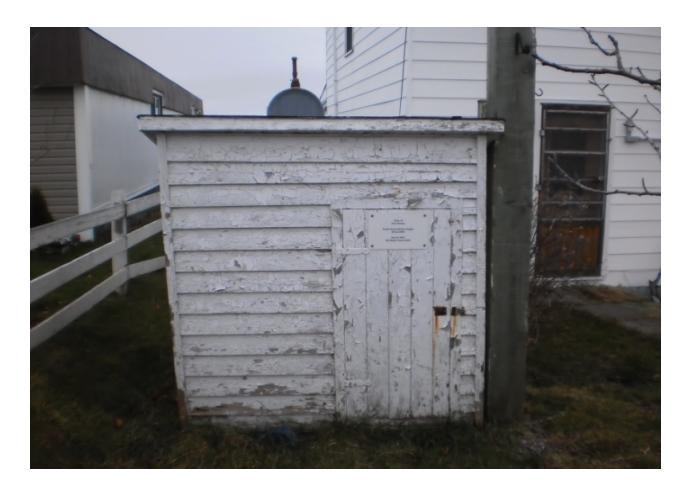
from well):	None	
	Future Land Use Changes that could impact wells:		
48 N 4	Other please specify (i.e. sources of microbial contam.):		
15. Notes:	Well is > 30 years old. Water quality issues in this we be within 5 metres of well	ell associated with Hurricane Igor. Wellhead is not sanitary. Above	e ground fuel storage tank obeserved to

Pumphouse (Note: above-ground fuel tank is directly behind the pumphouse

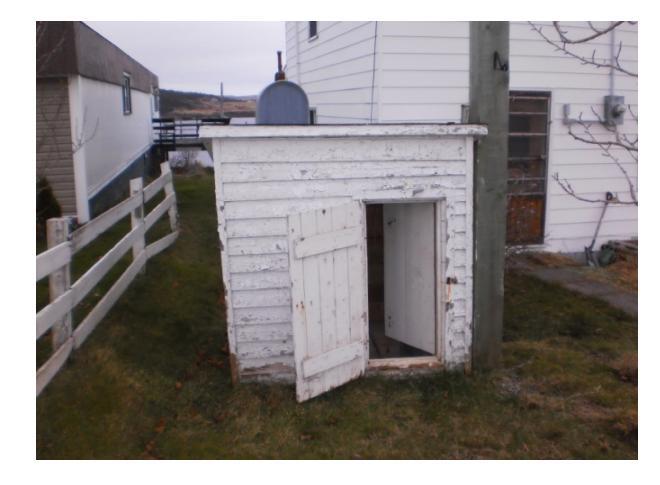
Openings of pumphouse

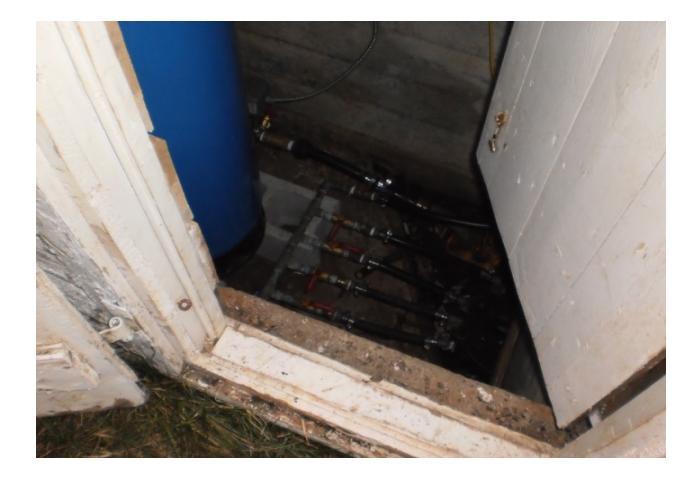
Well is located in back corner of pumphouse and is at depth

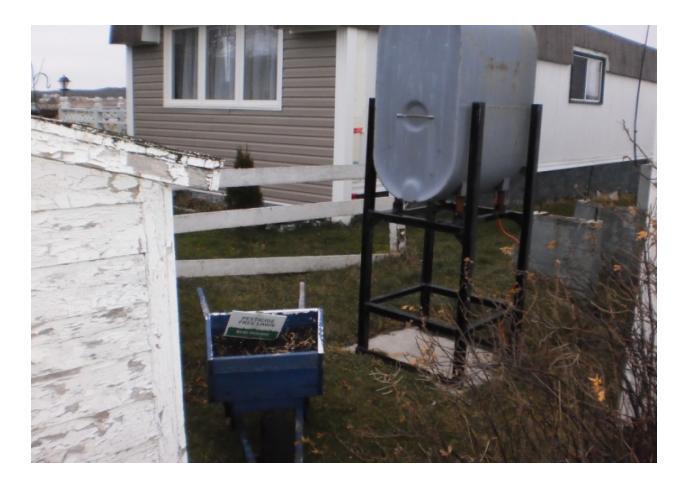
Close-up view of well head

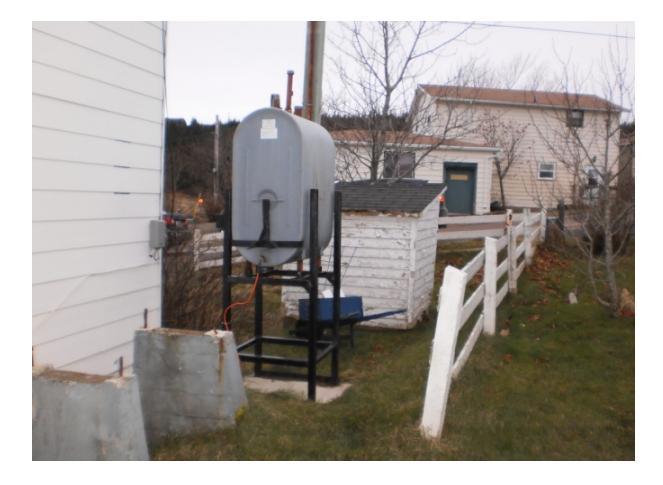
Proximity of domestic fuel tank to well

Pumphouse and domestic fuel oil tank, looking west

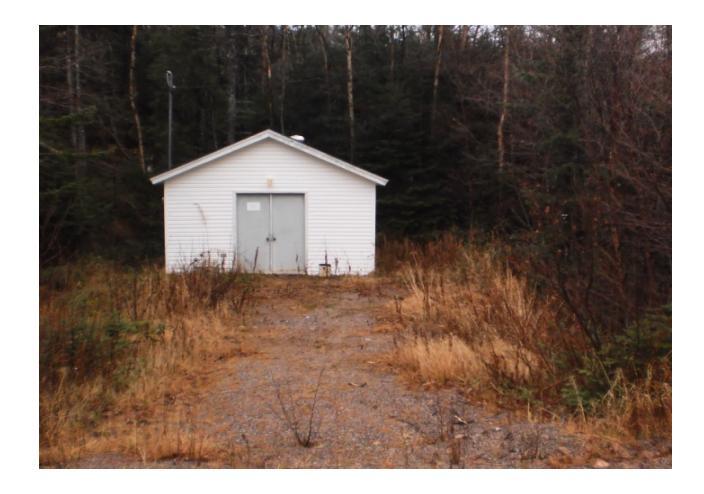
Pumphouse

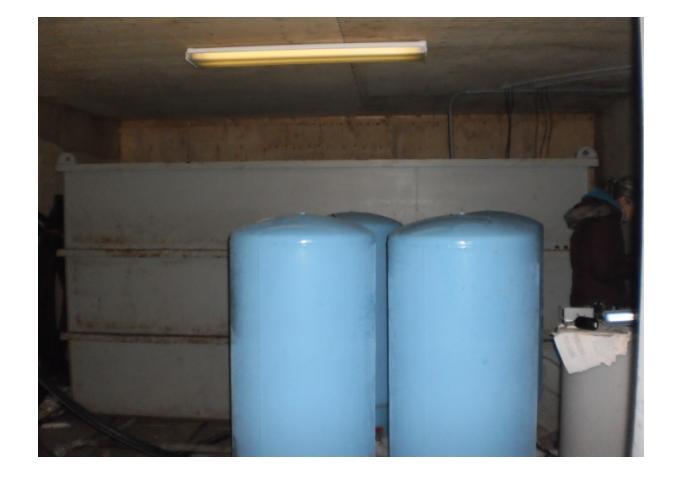
Pumphouse interior

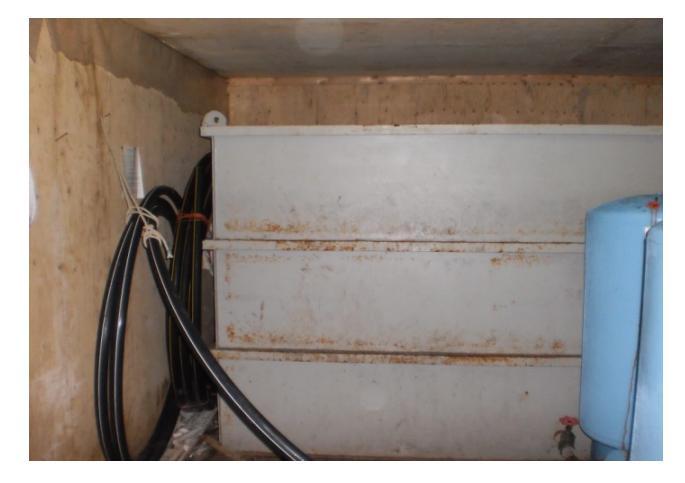
Pumphouse interior

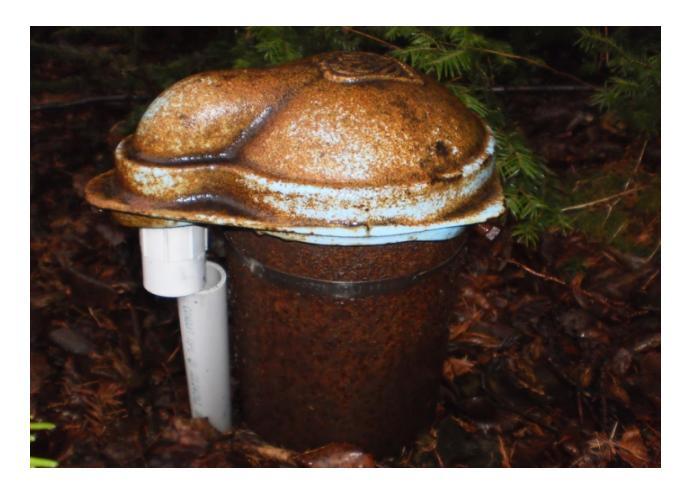
Close up view of well head

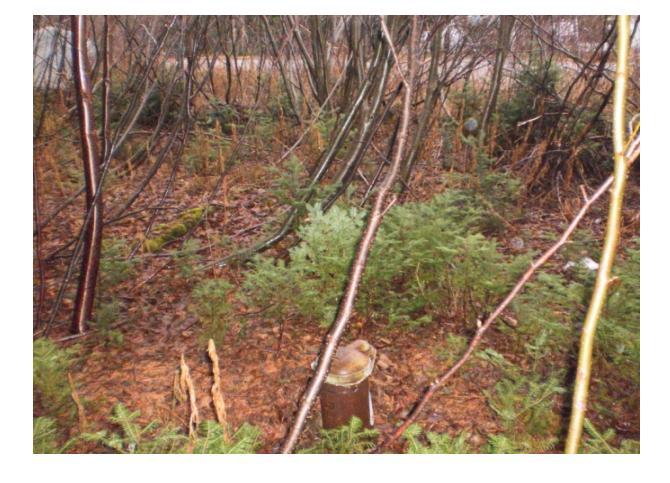
Well in foreground, Hollett Point Road in background

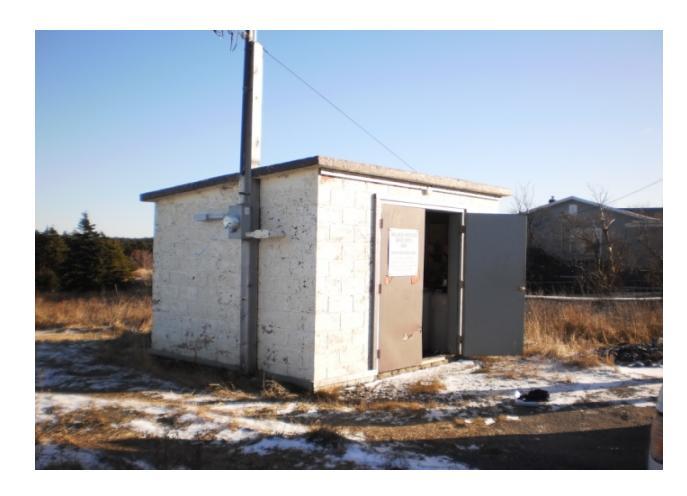
Pumphouse - front view

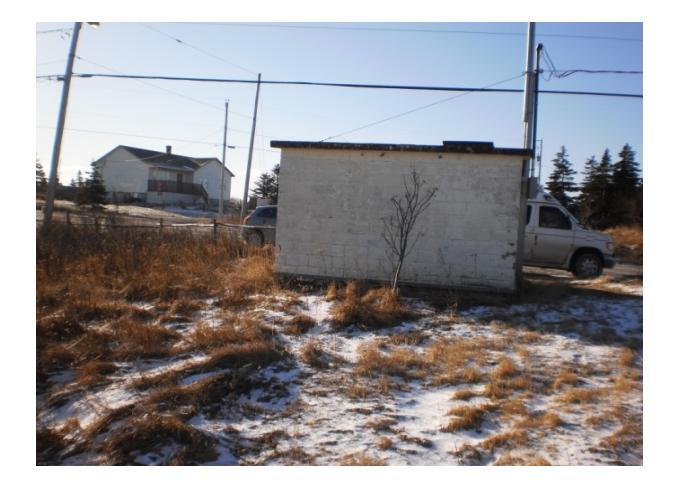
Pumphouse - view from rear, looking west

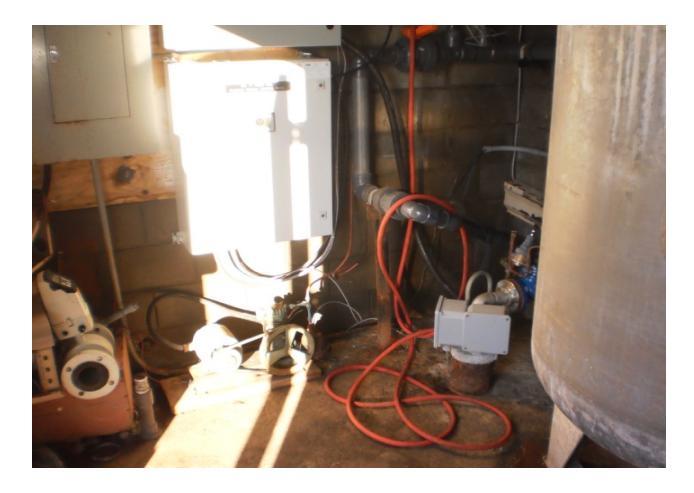
Interior and well head

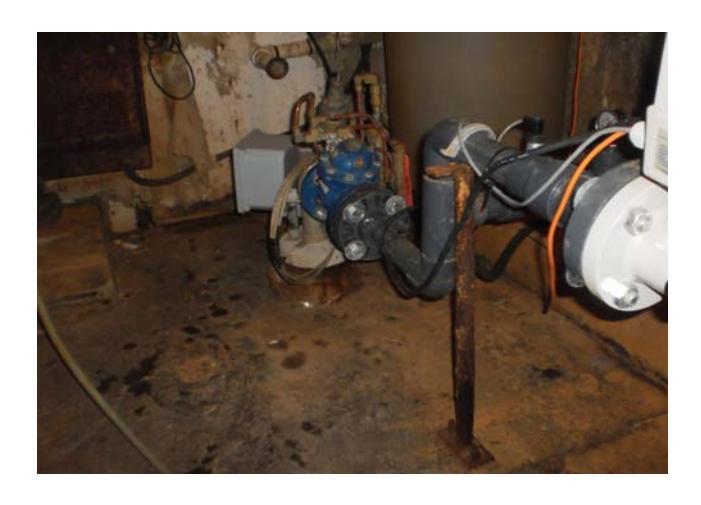
Well head

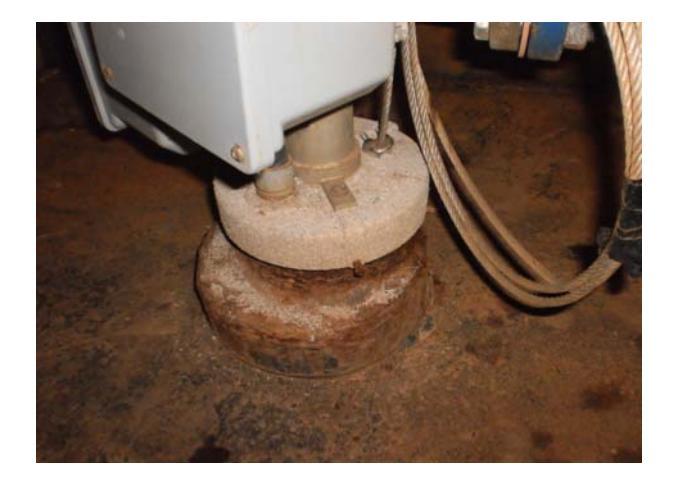
Close-up view of well head

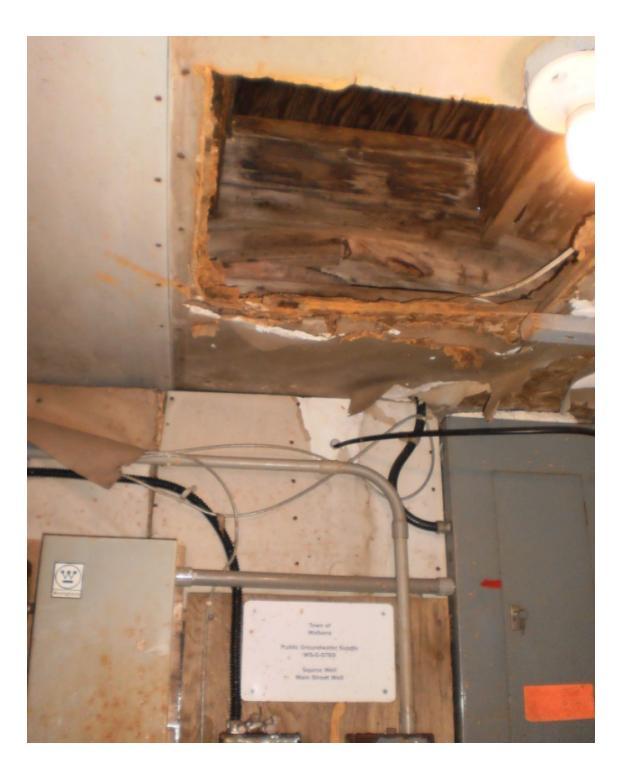
Interior of pumphouse - unsanitary conditions

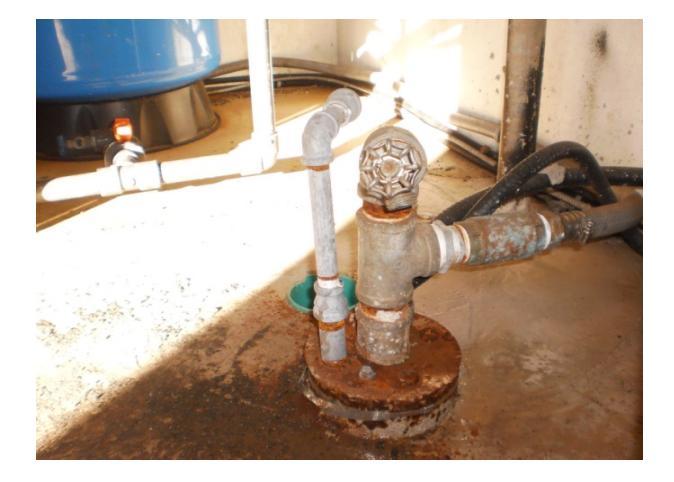
Well head

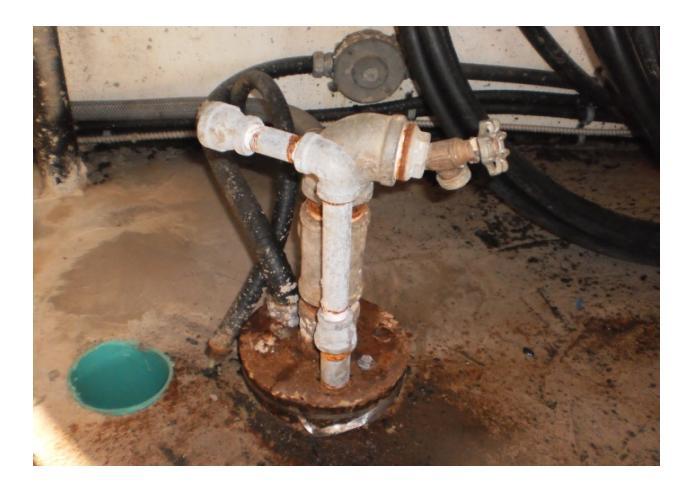
Well head - side view
## AECOM

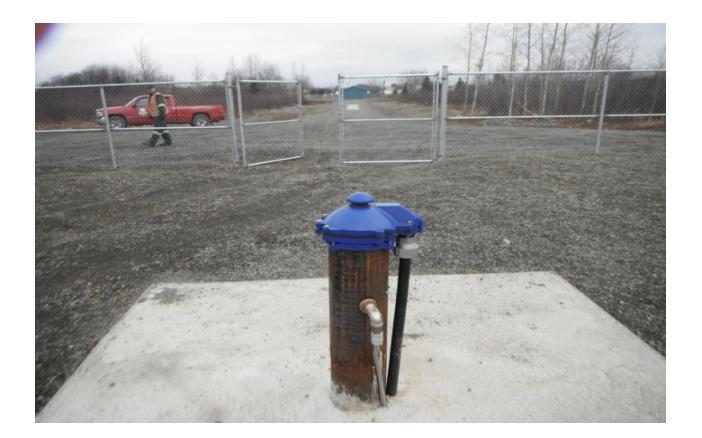
Well B - Note: Water treatment building in background

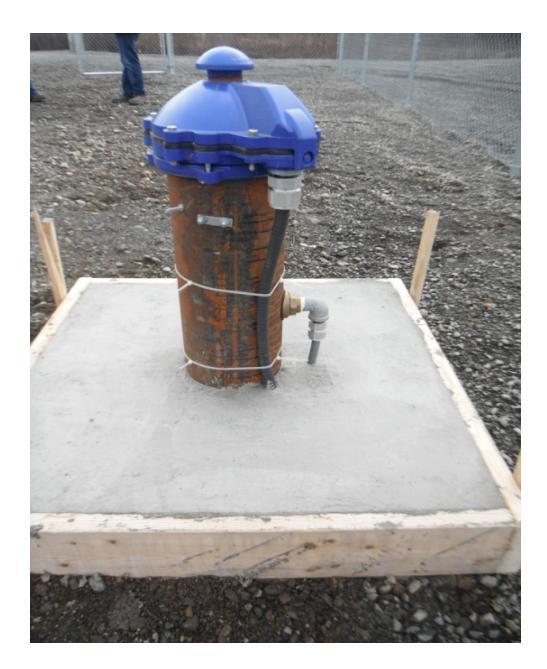
Well C - New well near water treatment building

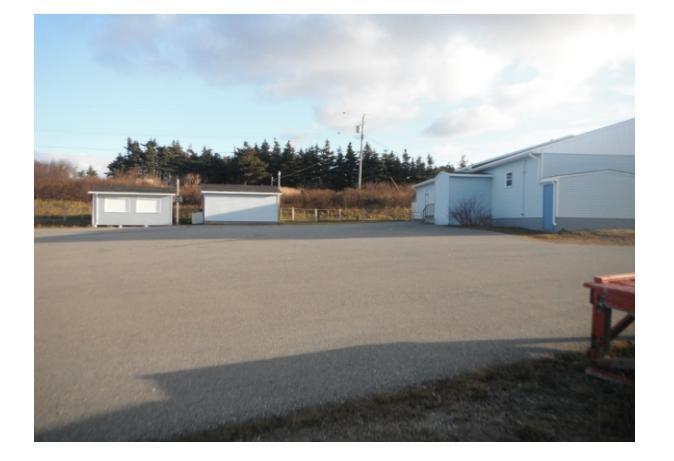
Pumphouse (middle) Lion's Club (right) Well behind fence in between pumphouse and Lion's Club

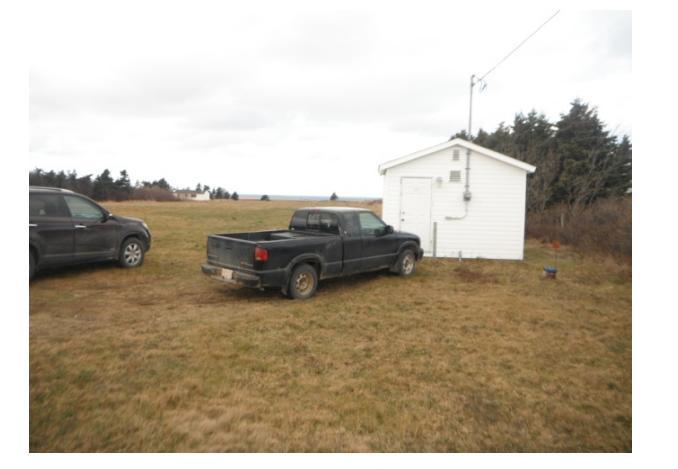
Pumphouse, well head in foreground

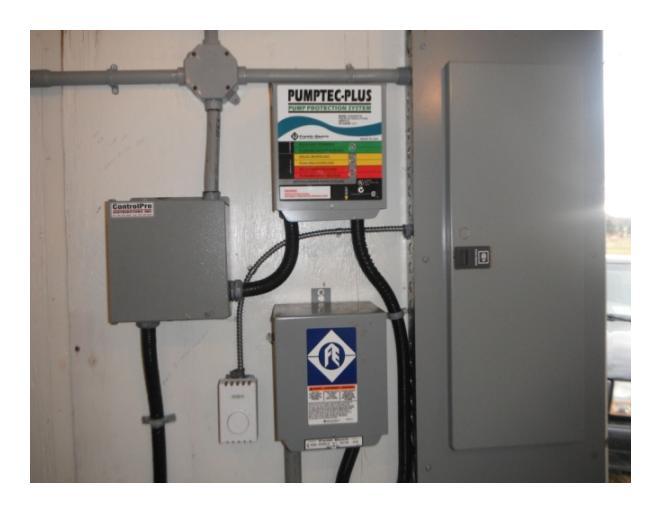
Interior

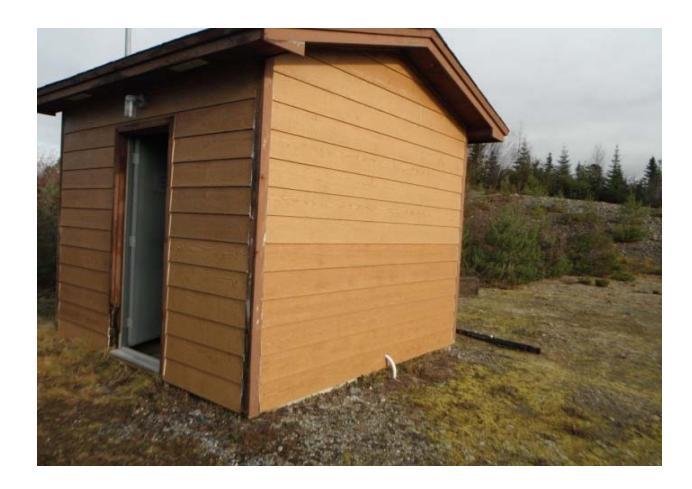
Pumphouse

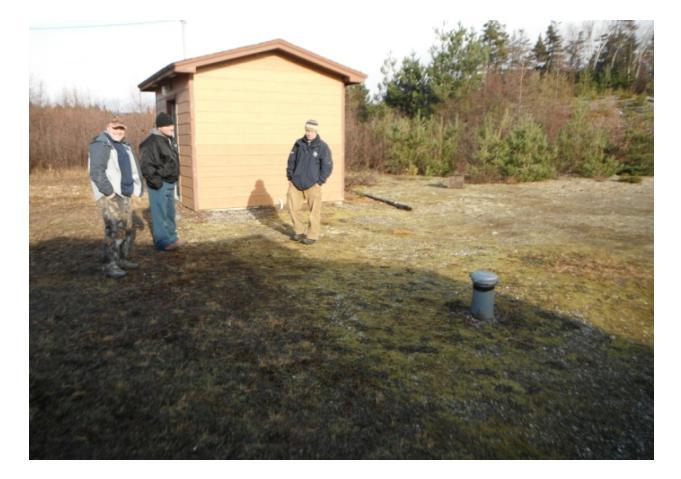
Well in relation to pumphouse

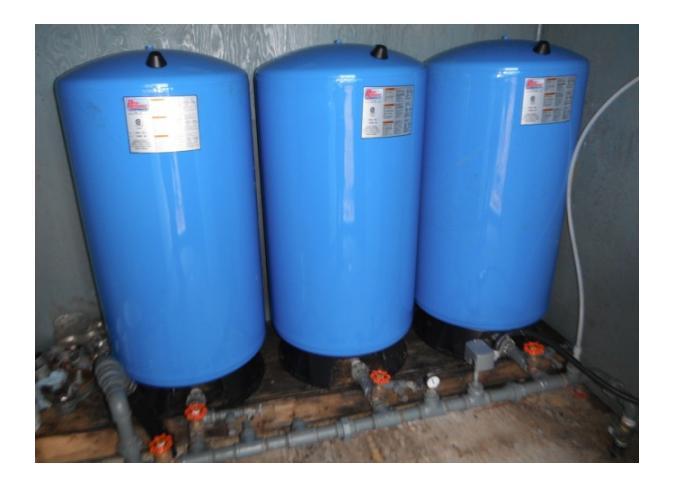
Pressure Tanks

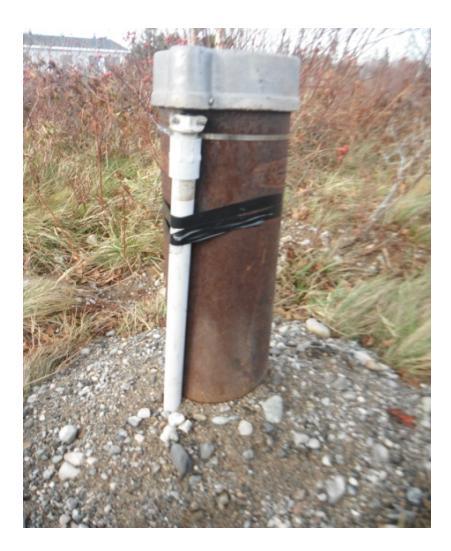
Well head

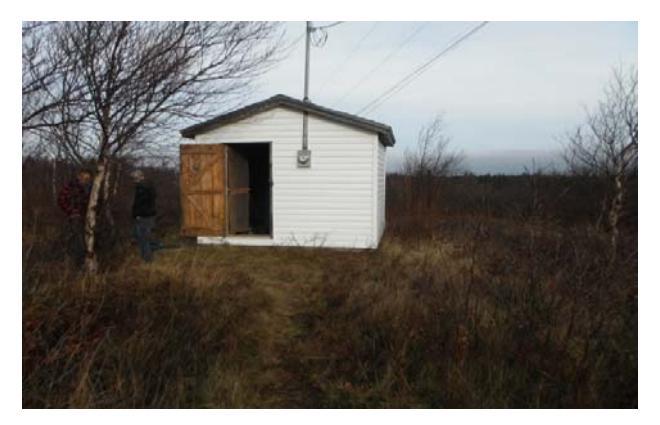
Pumphouse

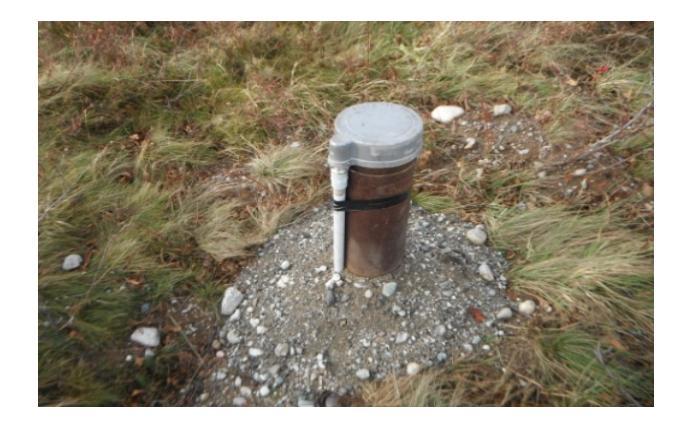
well head
