Groundwater Under Direct Influence of Surface Water (GUDI) – an Evaluation for Public Water Supplies in Newfoundland and Labrador

Government of Newfoundland and Labrador, Department of Environment and Conservation, Water Resources Management Division

Prepared by: AECOM 1701 Hollis Street SH400 (PO Box 576 CRO) Halifax, NS, Canada B3J 3M8 www.aecom.com

Date: June, 2013

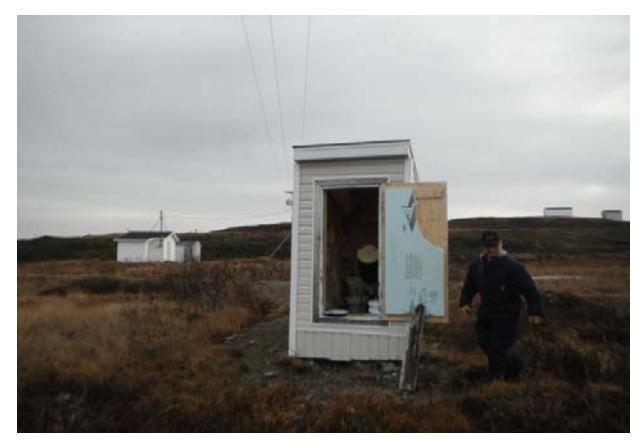
Well head and enclosure

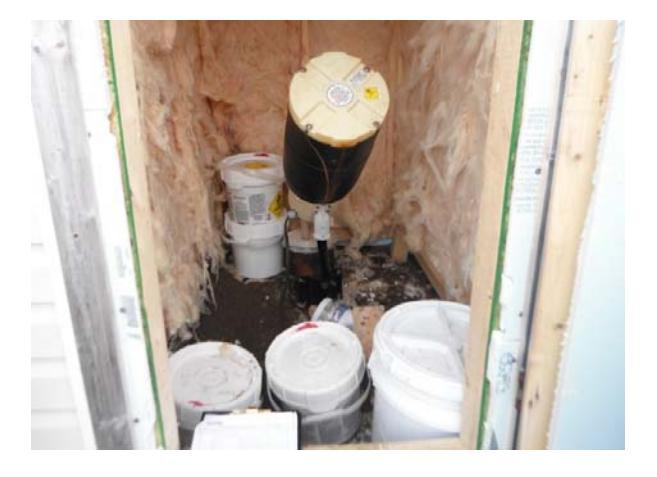
Well head with chlorine gas

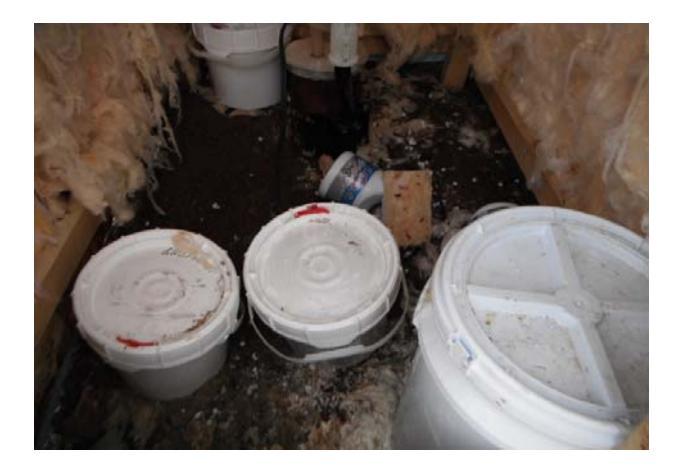
Well head

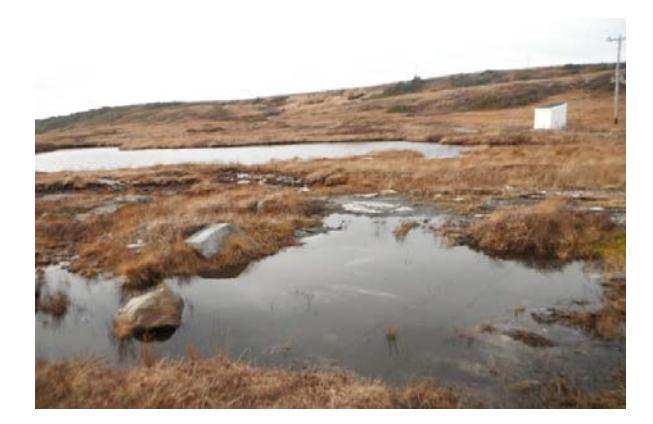
Well head relative to surface water body

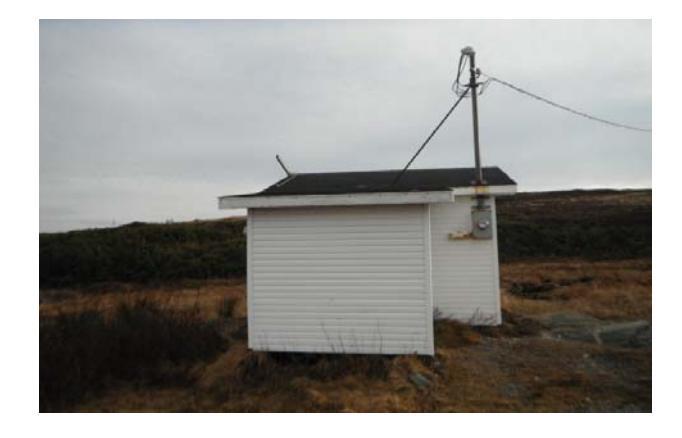
Treatment / buliding Distribution

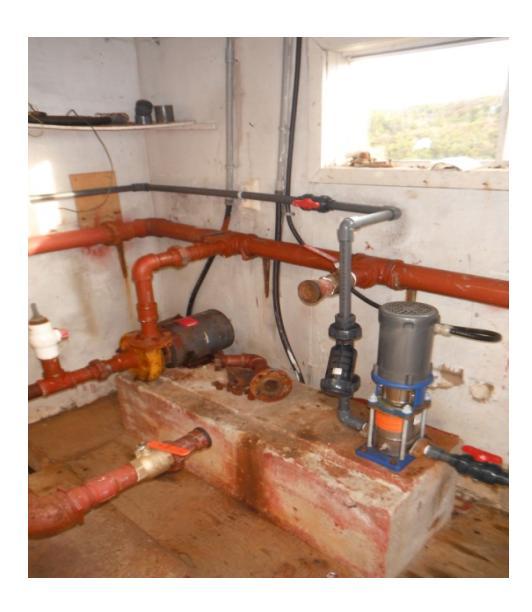
Interior of treatment Distribution building

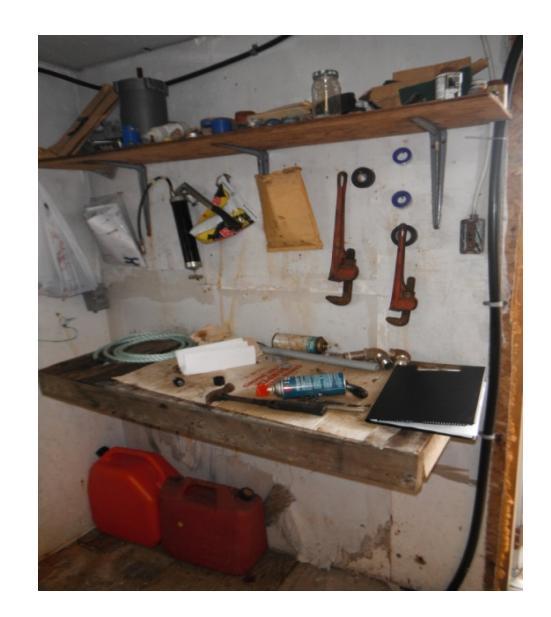
Interior of treatment Distribution building

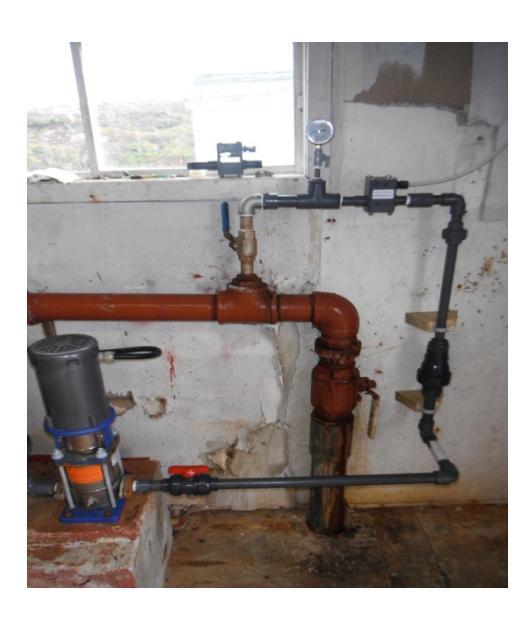
Interior of treatment Distribution building

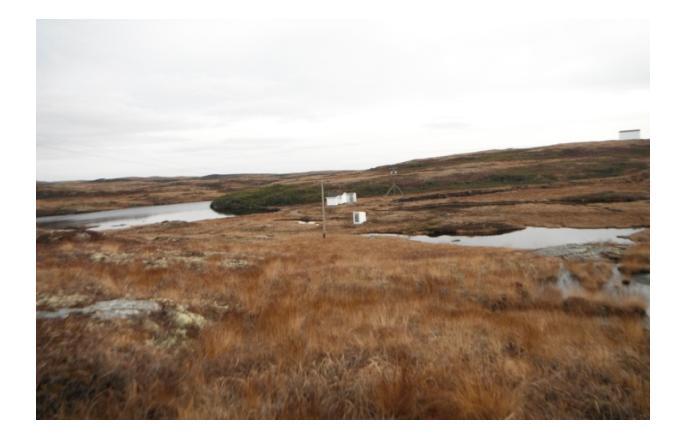
Well head and water treatment distribution building and surrounding environment

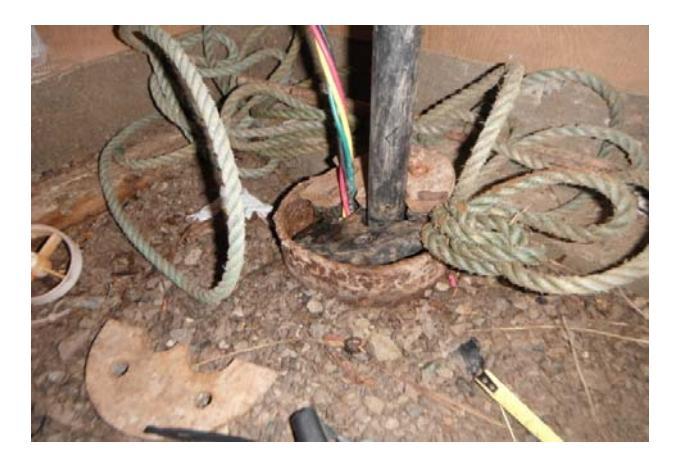
Well head

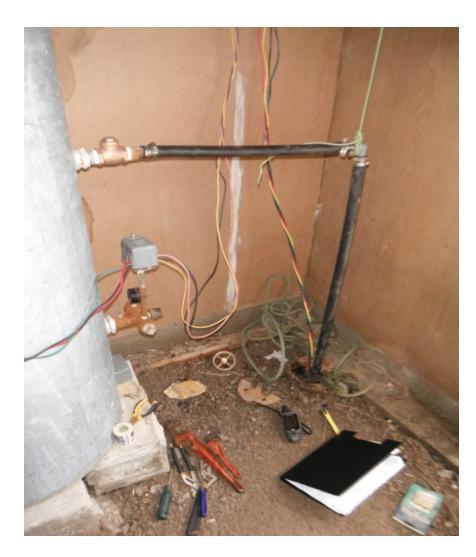
Pumphouse

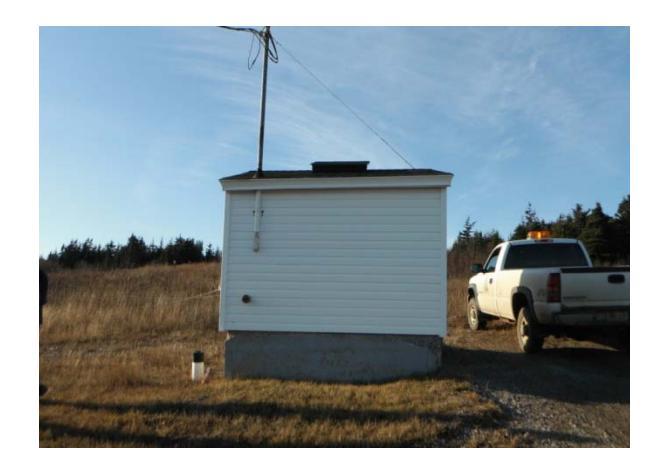
Well and pumphouse - North direction

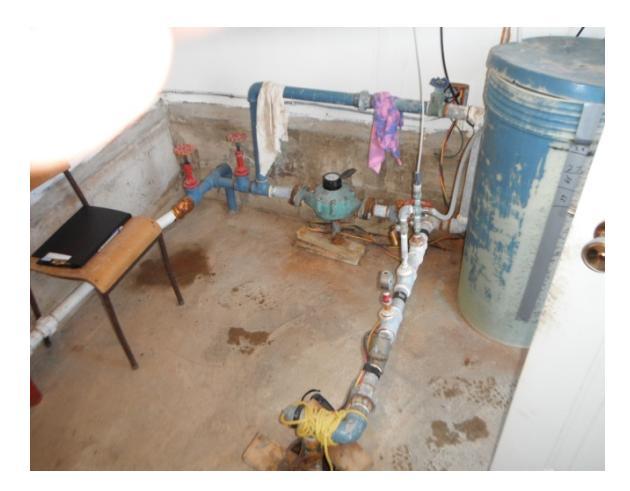
Well #1 and infrastrusture

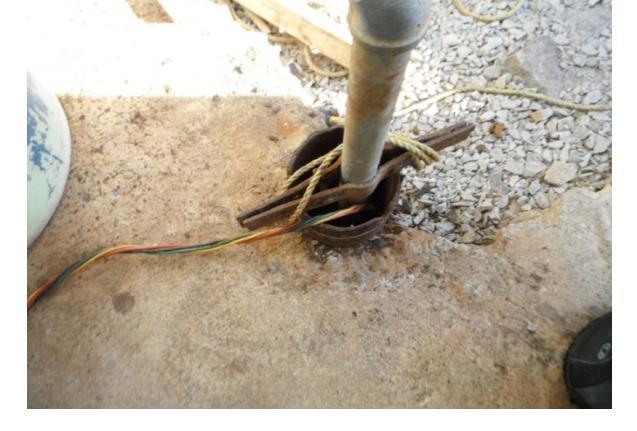
Well #3 close-up view

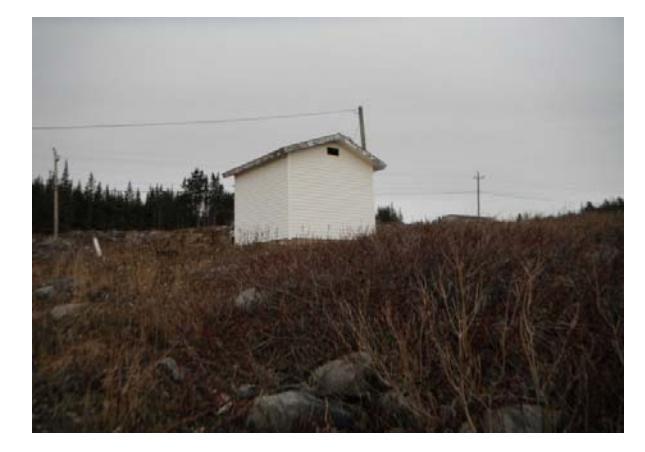
Rear view of pumphouse

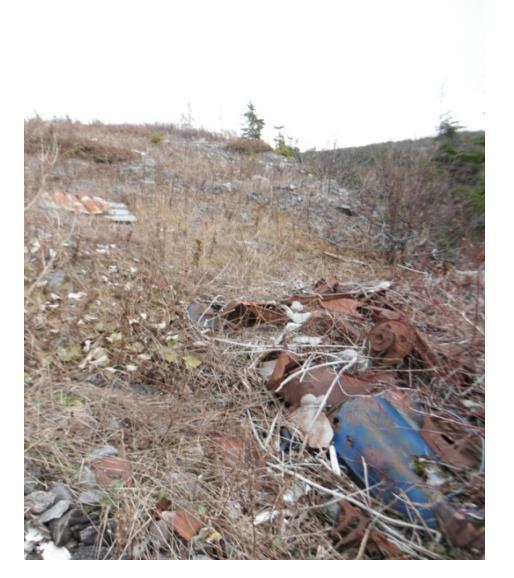
Metal debris near pumphouse

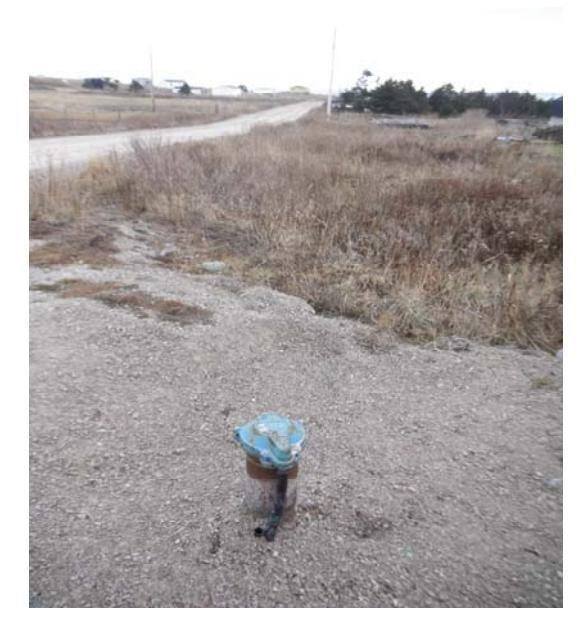
Well head relative to road

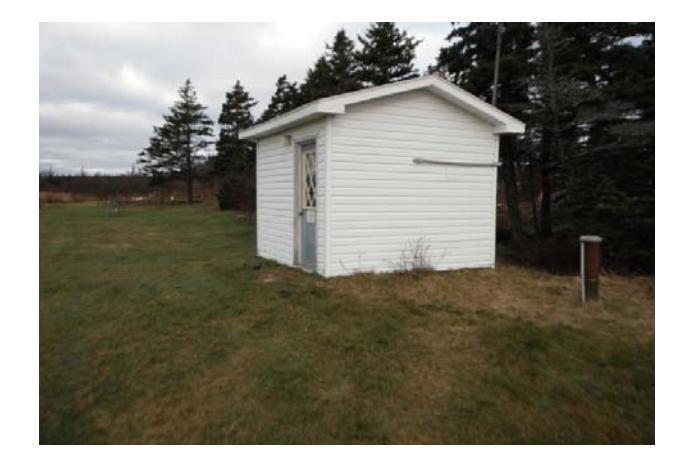
Well and pumphouse - North direction

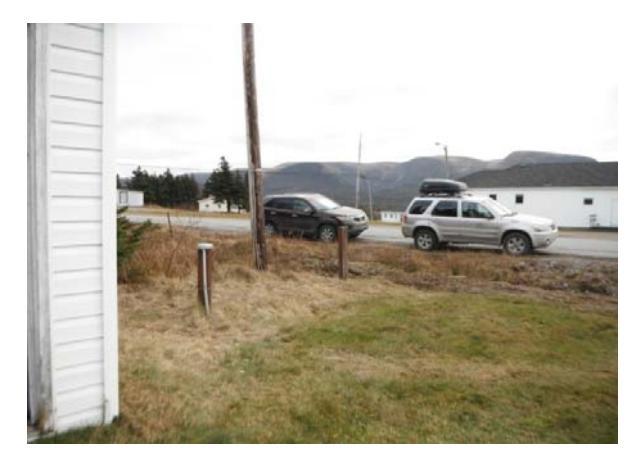
Proximity of well to road

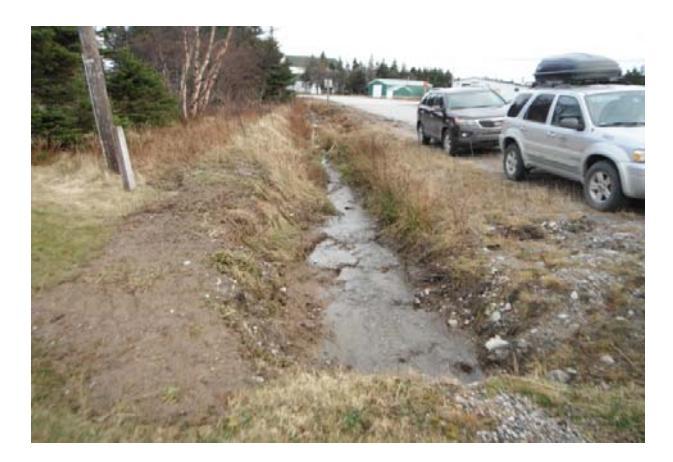
Ditch in close proximity to road

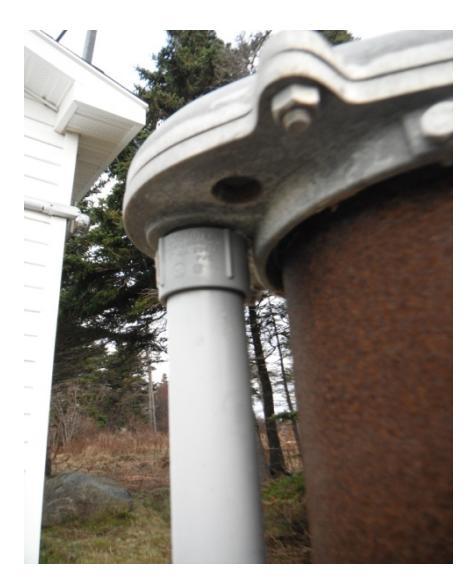
Vent in well cap

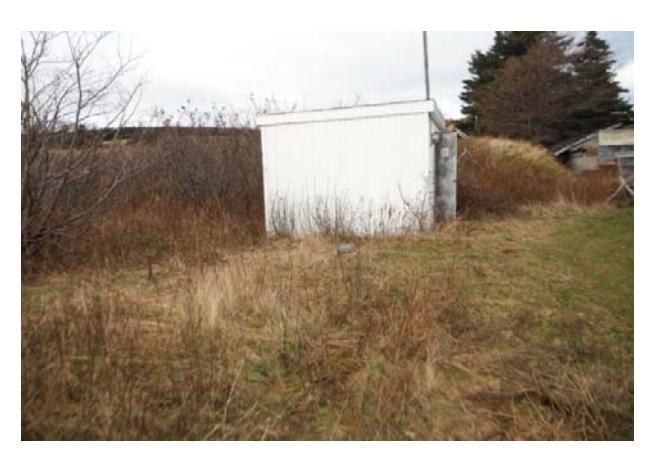
Well in relation to pumphouse

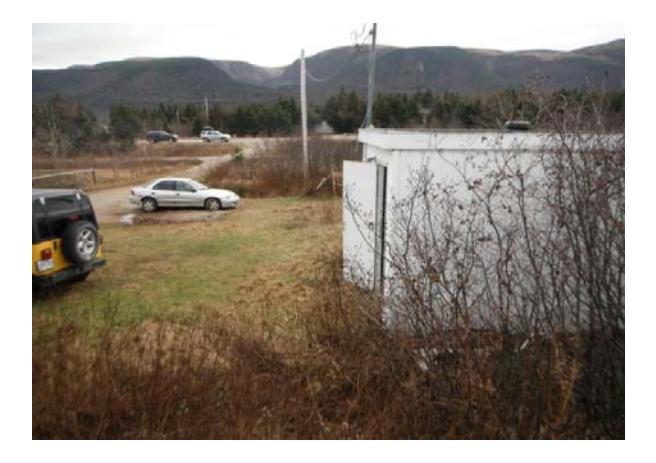
Pumphouse in relation to road
