**PHASE I ENVIRONMENTAL SITE ASSESSMENT
FORMER RAMBLER MINE PROPERTY
BAIE VERTE, NEWFOUNDLAND**

SUMMARY

Davis Engineering & Associates Ltd. (DEAL) was commissioned by the Provincial Department of Natural Resources (DNR) to conduct a Phase I Environmental Site Assessment of the Former Rambler Mines Property in Baie Verte, Newfoundland and Labrador. Based on a review of information supplied by the Client as well as observations made during the site investigation, the property assessment has revealed the following:

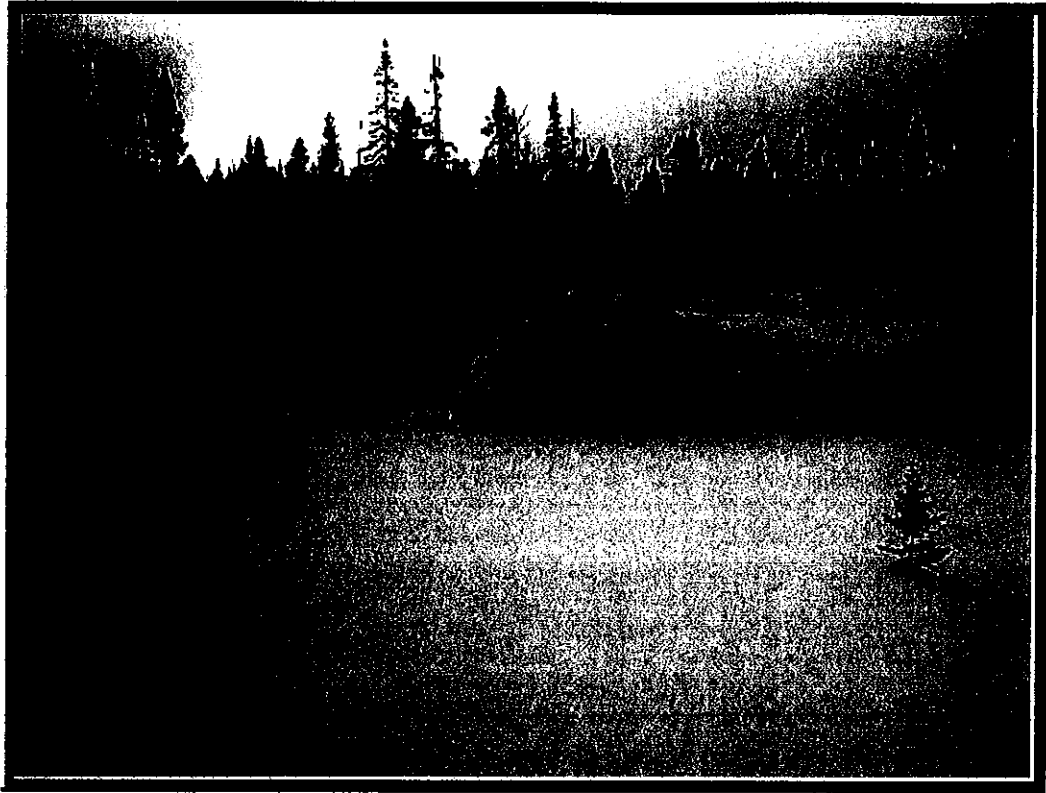
Photograph 17: Big Rambler Pond Mine Open Pit

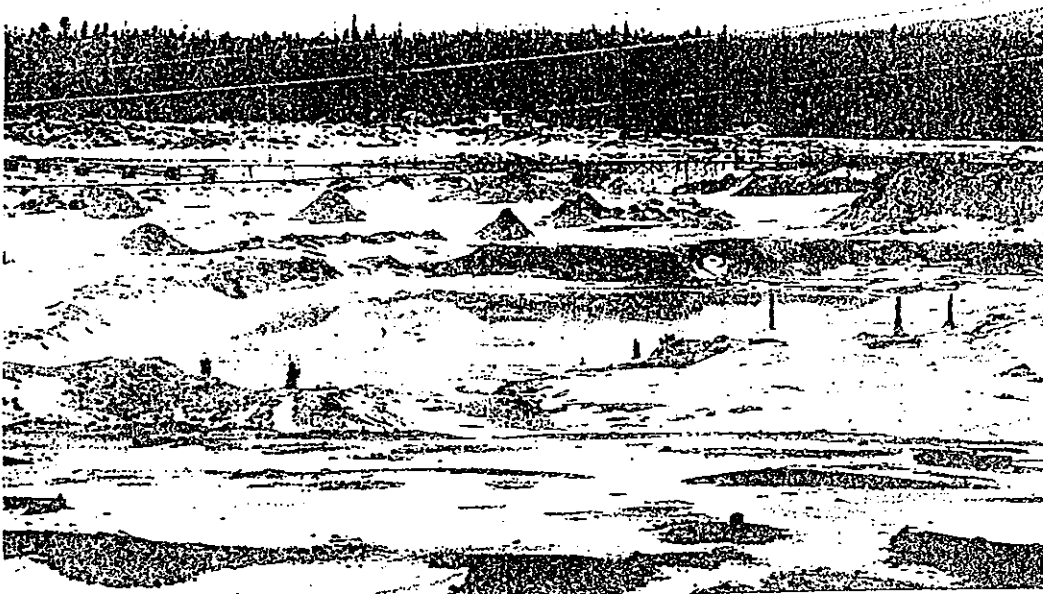
Another major component in the reclamation plan was to deal with public safety and airborne contaminants and fill and level the areas where Raymo Processing had in excess of 3 meter test pits, within the old Ming Minerals (Rambler) tailings. (Photo 4a).

These open pits caused hazard to snowmobilers in the area. High winds are capable of blowing dry stacked tailings around to surrounding areas making conditions similar to a dust storm. (photo 4a).

4(a) Tailings Test Pit Area
