Marystown Harbour Bridge

Condition Assessment Report

223049.10 | April 2023

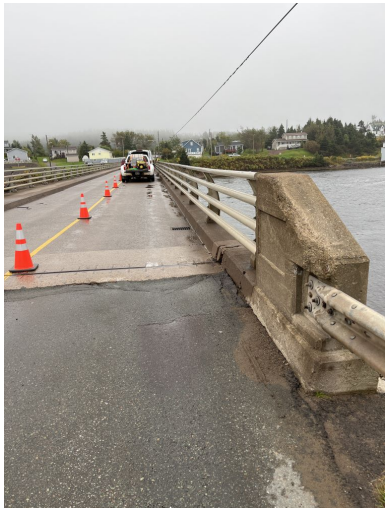
Photo ID 695 Location North
Element Group Joints
Element Type Armoring
[2022-09-29 9:00:25 AM](#)

Looking South

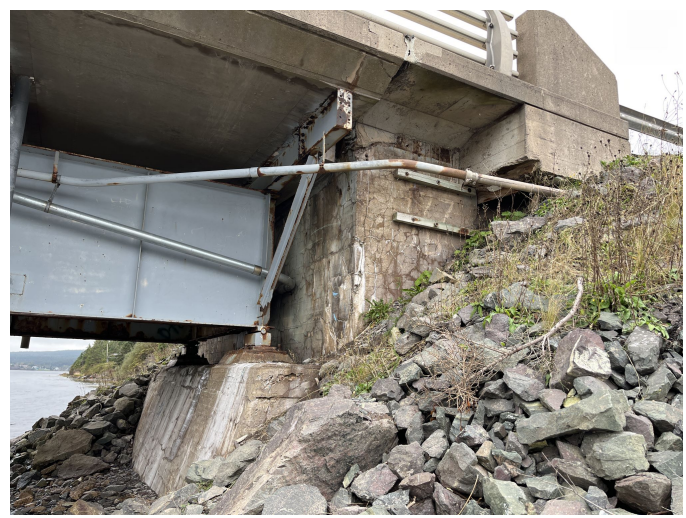
Photo ID 700 Location Northeast
Element Group Abutments
Element Type Wingwalls
2022-09-29 1:36:27 PM

Northeast wingwall

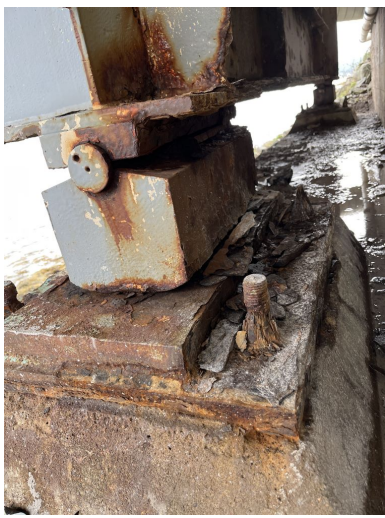
Photo ID 741 Location North Abutment
 Element Group Abutments
 Element Type Bearings
 2022-09-29 2:59:19 PM

Northeast bearing.

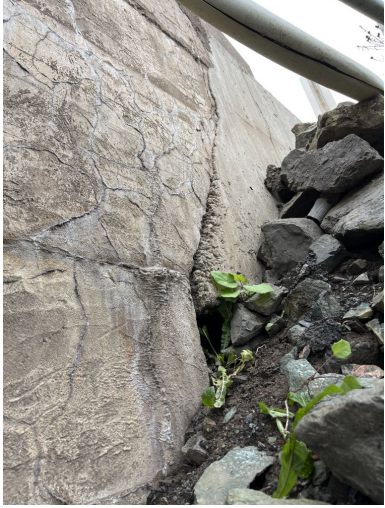
Photo ID 821 Location Southwest
Element Group Abutments
Element Type Wingwalls
2022-09-29 5:21:23 PM

Southwest wingwall

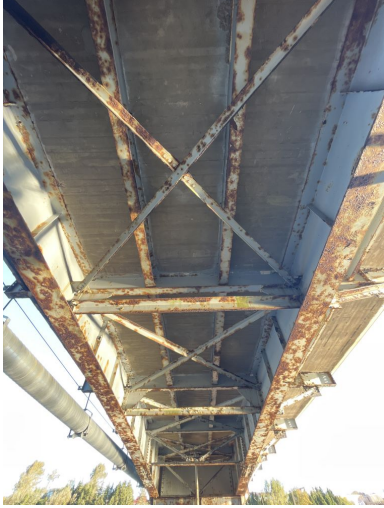
Photo ID 840 Location South
Element Group
Element Type
2022-09-30 8:33:14 AM

Deck soffit middle looking north

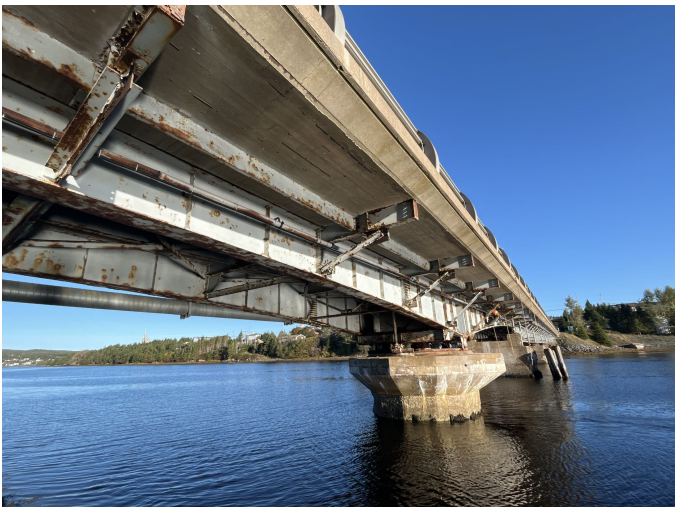
Photo ID 845 Location Southeast
Element Group
Element Type
2022-09-30 8:38:11 AM

East girder swing span looking west

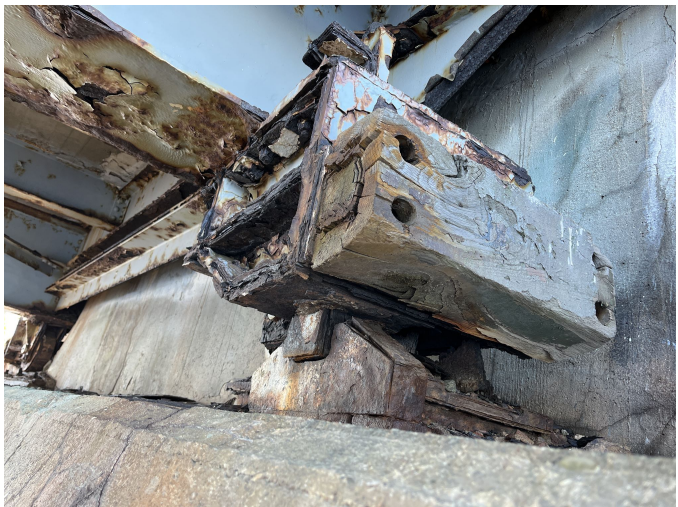
Photo ID 864 Location Southwest
Element Group Abutments
Element Type Bearings
2022-09-30 8:50:49 AM

Southwest bearing

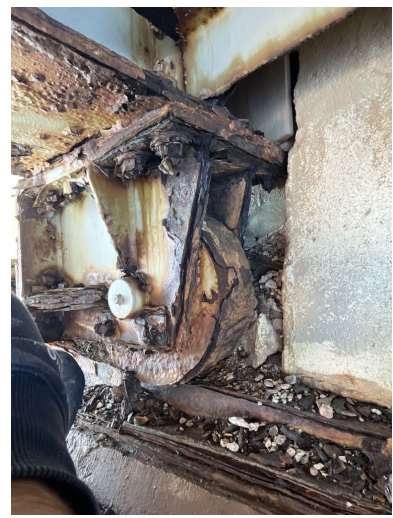
Photo ID 877 Location Southeast
Element Group Abutments
Element Type Bearings
2022-09-30 9:01:32 AM

Southeast bearing

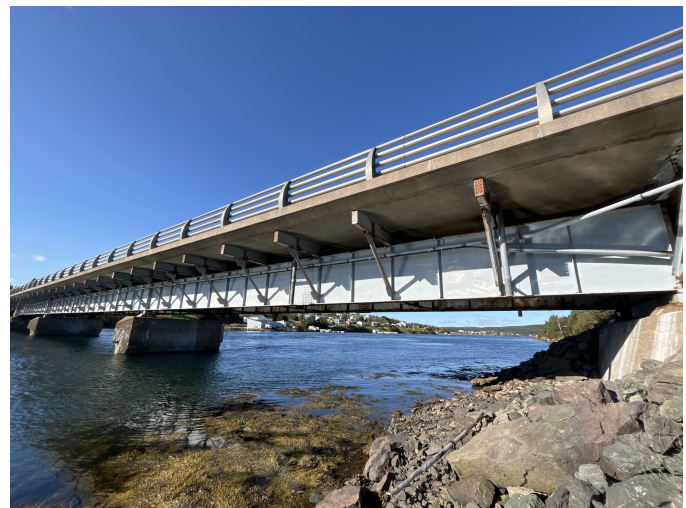
Photo ID 918 Location North
Element Group Beams
Element Type Girders
2022-09-30 10:03:56 AM

East girder

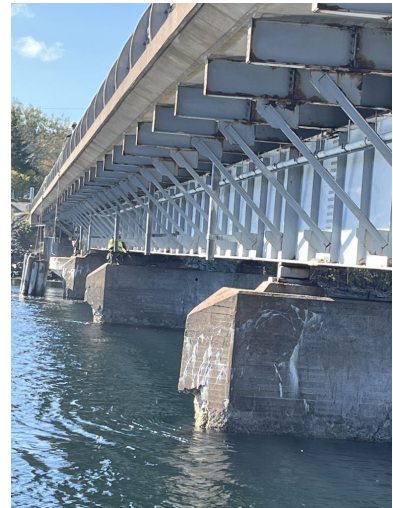
Photo ID 957 Location Pier 1
Element Group Piers
Element Type Shaft
[2022-09-30 10:28:58 AM](#)

Erosion Pier 1

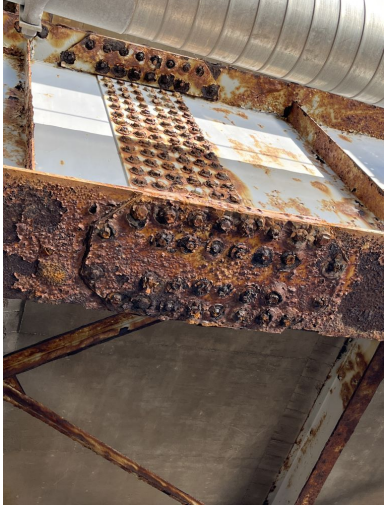
Photo ID 997 Location North
Element Group Beams
Element Type Girders
2022-09-30 4:26:56 PM

West girder splice northwest. Typical corrosion.

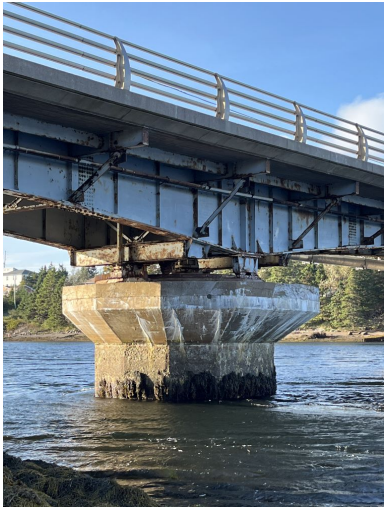
Photo ID 1009 Location South
Element Group Piers
Element Type Shaft
2022-09-30 5:11:17 PM

Swing pier

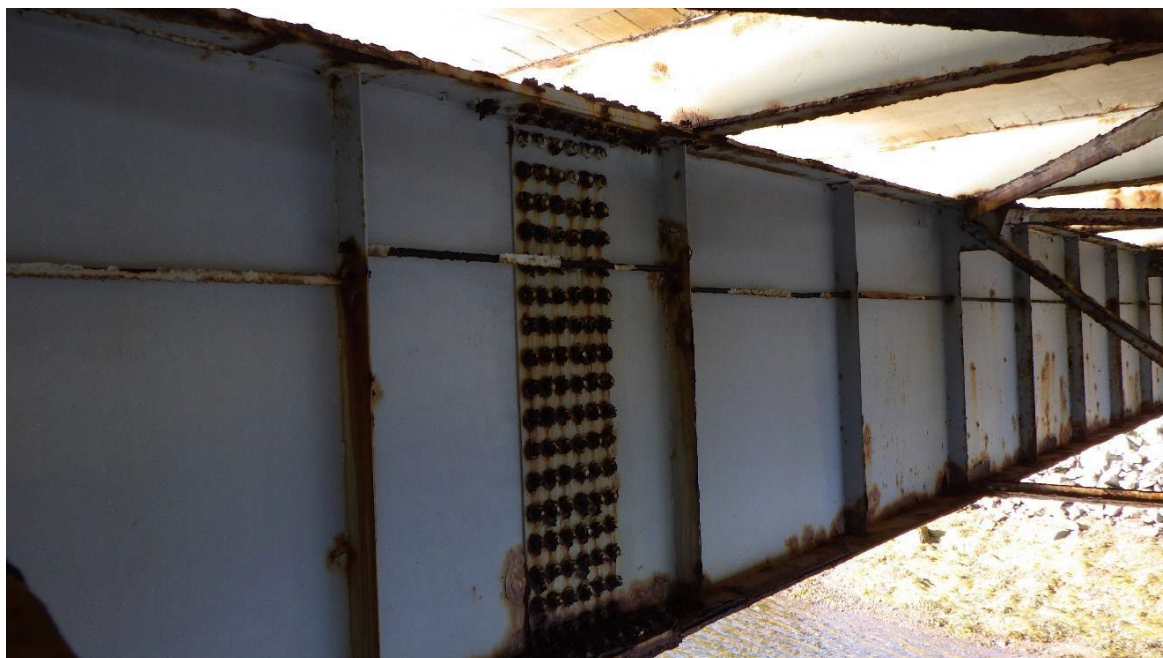
Figure 8. East girder

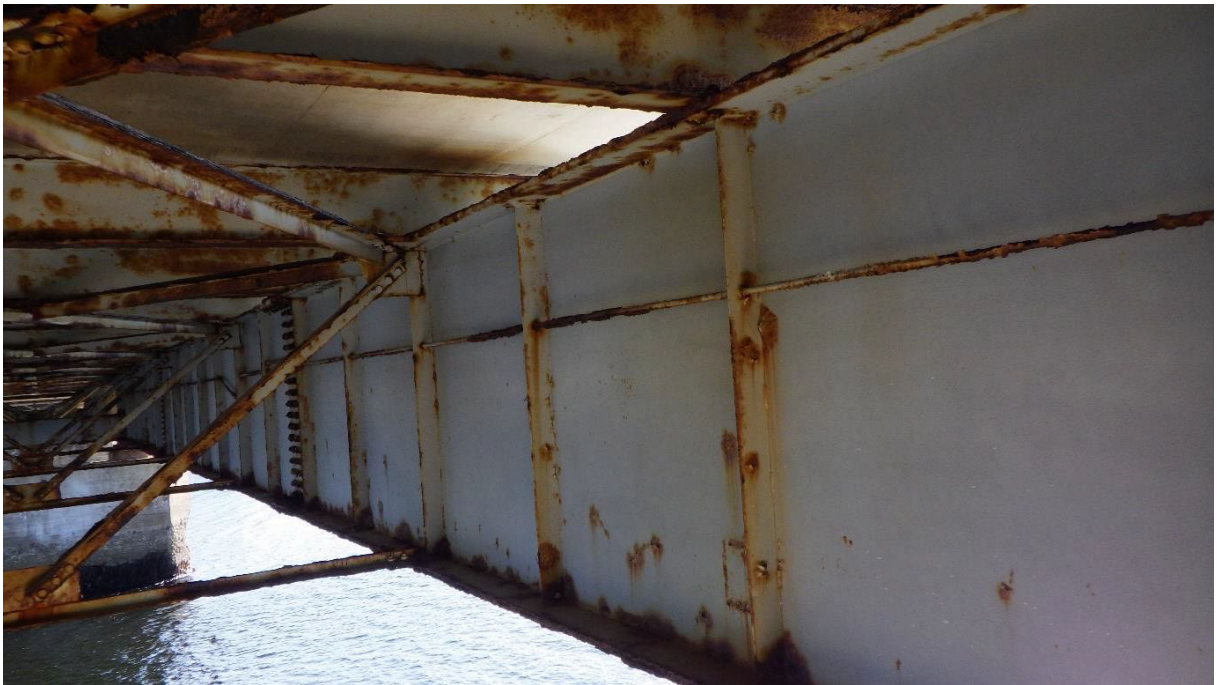
Figure 9. West Girder

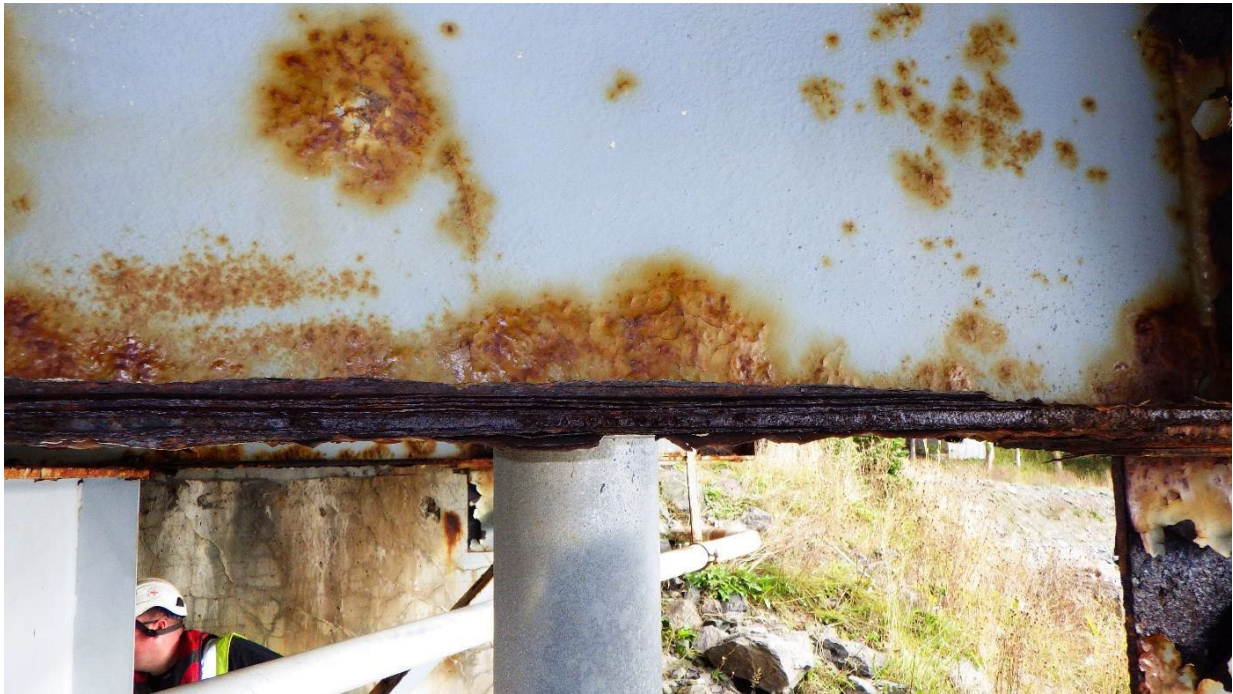
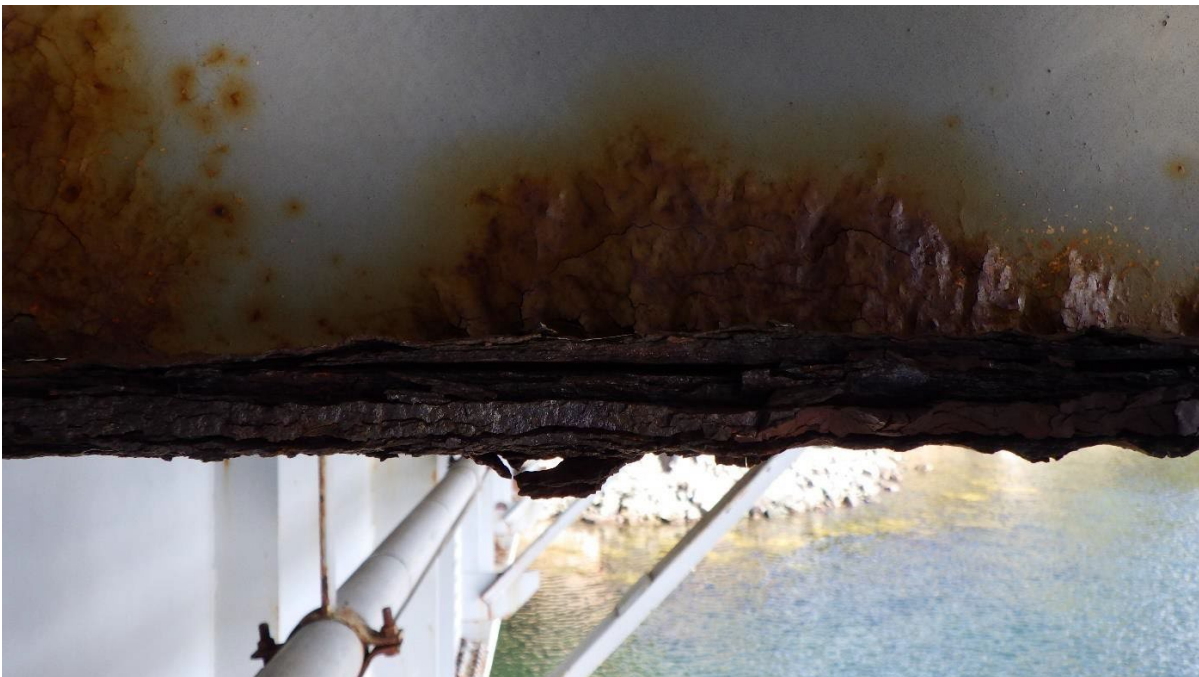
UT Readings not obtainable due to severe material loss/ corrosion

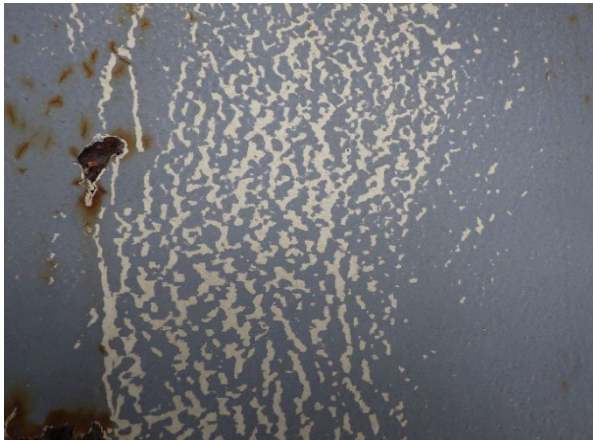
General condition of the coating of the swing pier structure. Examples of coating failures are blistering, staining, undercutting, rust spotting. A test was performed with a dull scraper and the gray topcoat layer came off and turned white (Fig#20). DFT were taken over Two locations, the average DFT 632.968 micrometers.

Fig #20 – Scrap test, dull scrapper.

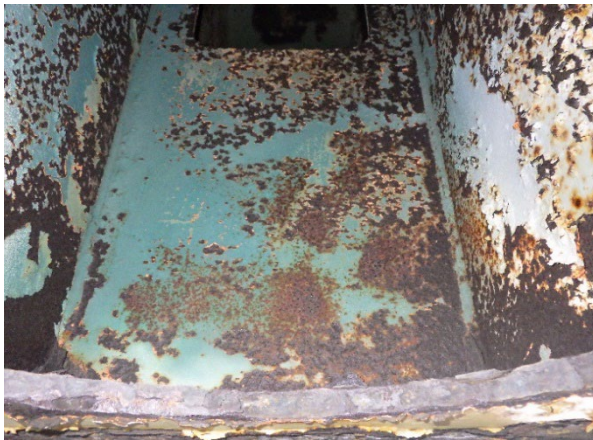
Fig #22 – Inside center support.
